Miscellaneous Report NOR-Y-4

THE 1971 THOMPSON SMOKE EASEMENT SURVEY

R. A. BLAUDEL

Canadian Forestry Service
Department of the Environment
April, 1972

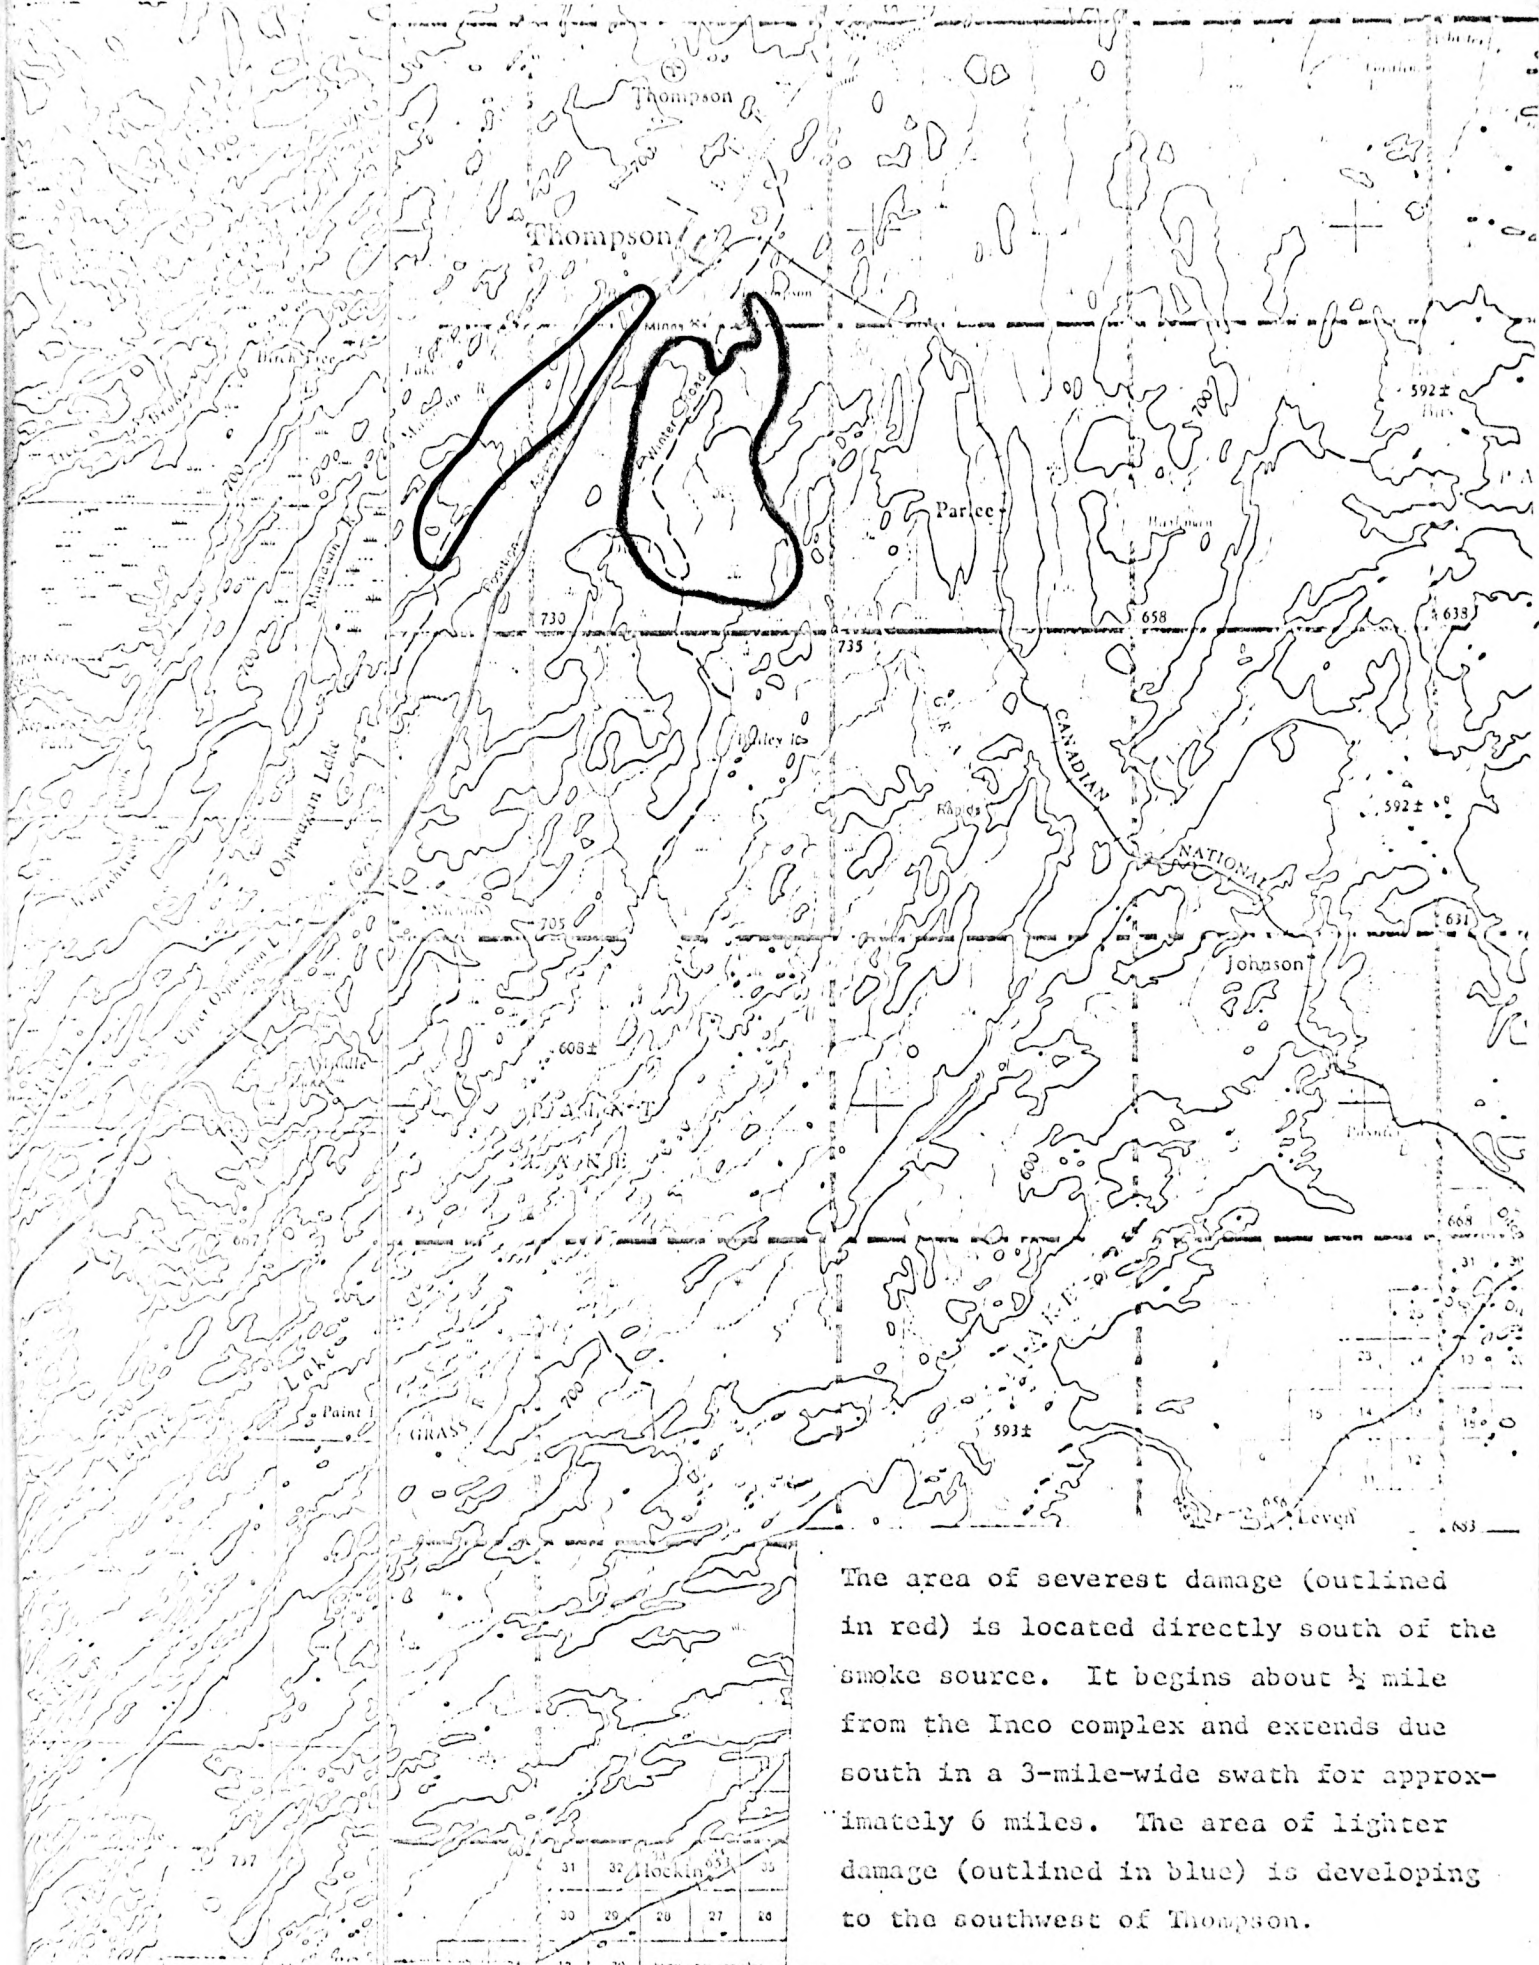
Map of the Thompson Area

roughly delineating the damaged forest areas visible from the air

The area of severest damage (outlined in red) is located directly south of the smoke source. It begins about ½ mile from the Inco complex and extends due south in a 3-mile-wide swath for approximately 6 miles. The area of lighter damage (outlined in blue) is developing to the southwest of Thompson.

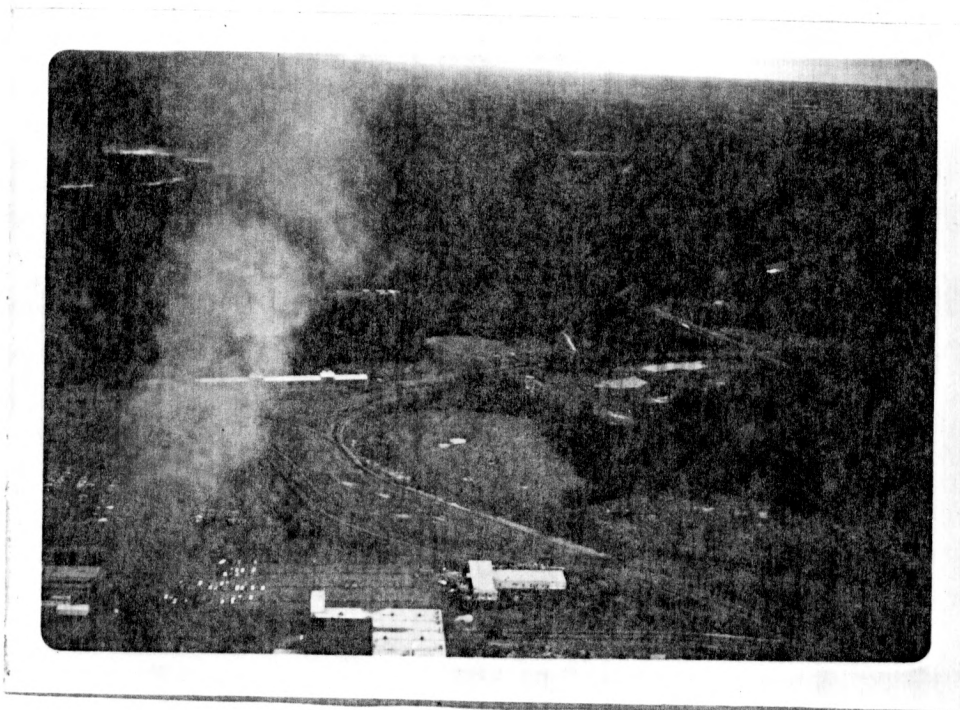
The physical properties of the smoke from Inco's main stack indicate that gases other than SO_2 and particulate matter are also being emitted.

#1. Smoke issuing from Inco's main stack.
Note the color and density.

2. The color, density and odor of the smoke plume indicated the presence of sulfur dioxide and other emissions. It is recommended that the smoke be monitored to determine the amount of SO₂ and other pollutants emitted (e.g. oxides of lead, arsenic, nitrogen, antimony etc.).

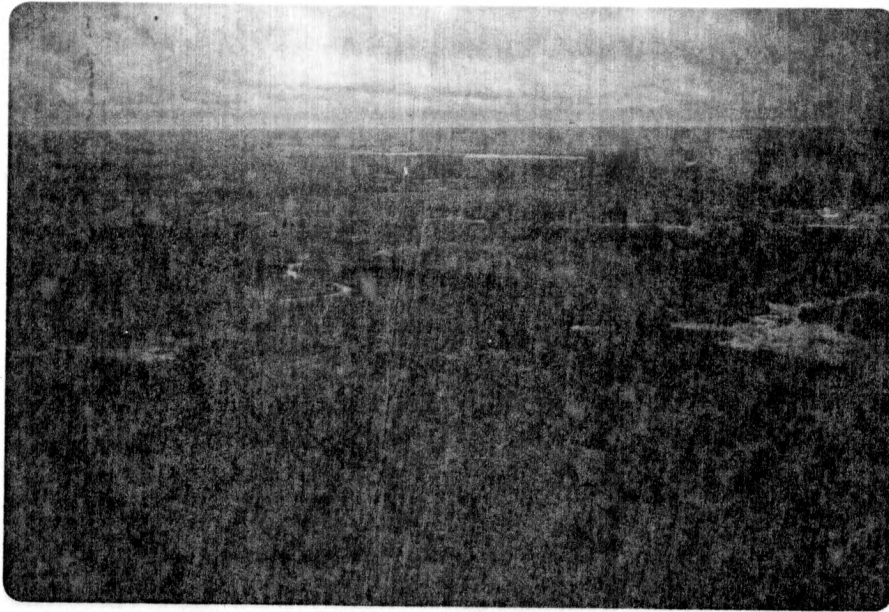
The color and density of the emission facilitated aerial observation of smoke pluming characteristics (photo #2) and detection of impingement areas (photo #3). During the aerial survey the smoke was impinging on a forested area due south of the Inco plant. This area displayed notable forest fume damage symptoms.

- #2. A fanning smoke plume moving due south of the Inco plant into a forested area displaying fume damage. Note the browned, discolored patches of forest along the smoke's path.

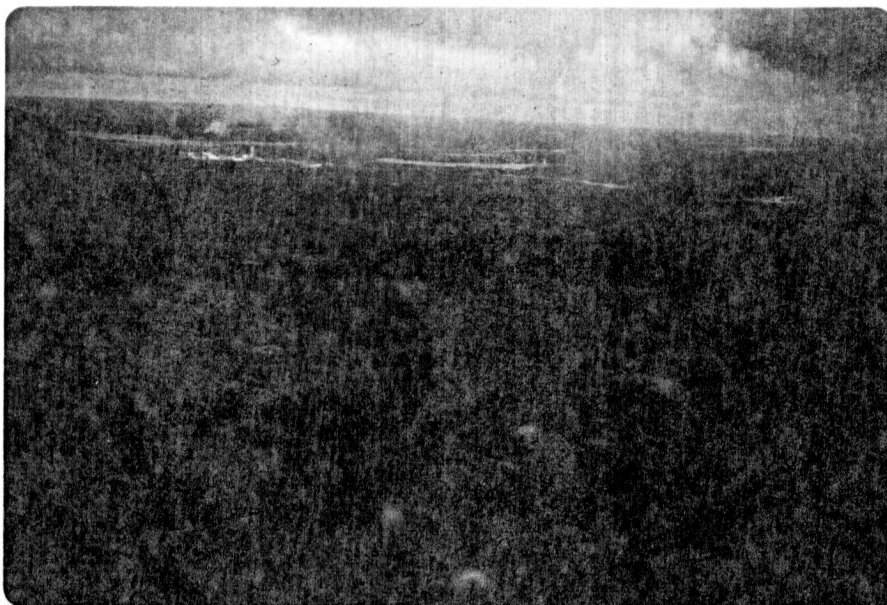
- #3. A looping smoke plume moving south of plant and impinging at various points in the damaged area.

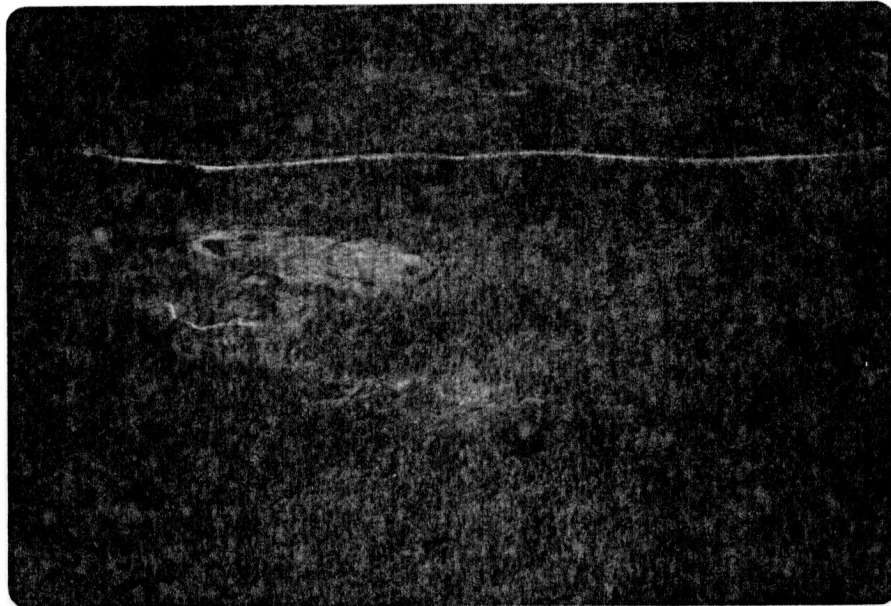
The severest forest damage was observed in the smoke impingement area due south of the Inco plant (refer to map pp. 2). From the air this stand damage appeared as grey, discolored patches (photo #4). Stands of dead and partially defoliated, declining trees account for these discolored patches (photo #5).

#4. Grey, discolored patches of the forest in the southern smoke impingement area.

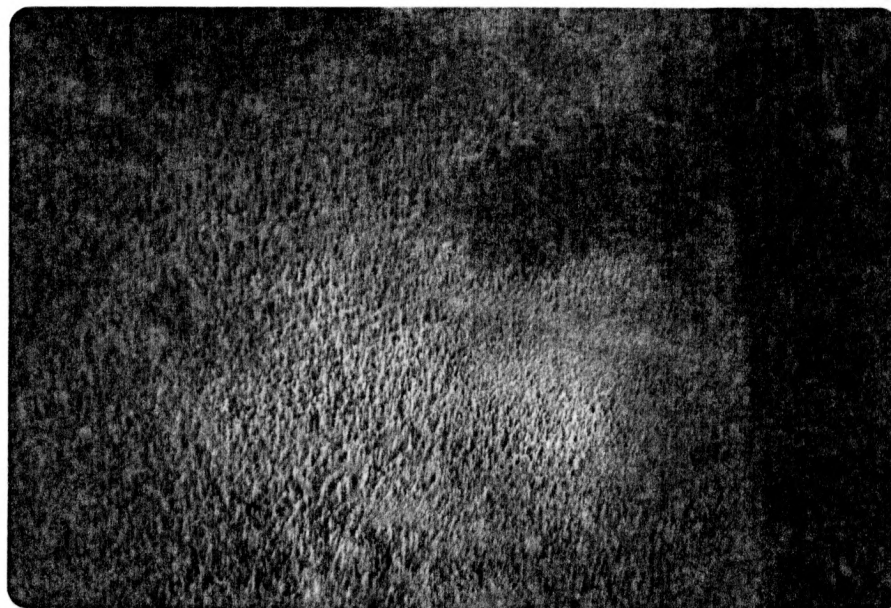
#5. Defoliated dead trees and partially defoliated, chlorotic declining trees account for the greyed, discolored appearance of the forest.

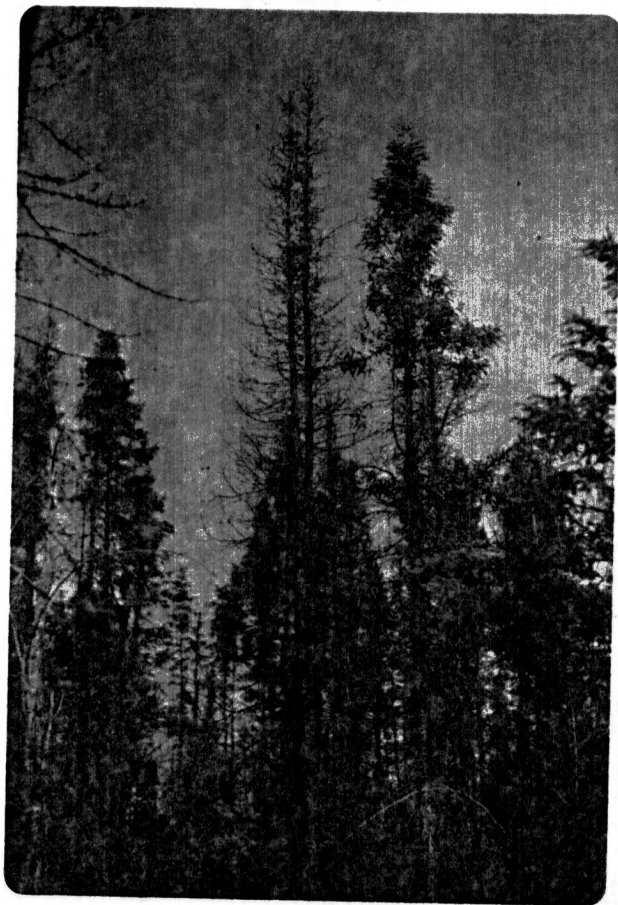
Jack pine and black spruce were the main components of the overstory in the area examined. Both of these species were found to be severely damaged. The damage ranged from partially defoliated trees in extremely poor condition to completely defoliated dead trees (photo #6, 7, 10).

#6. Damaged conifers in the impingement area. Note the completely defoliated dead trees and the sparsely foliated trees in extremely poor condition.

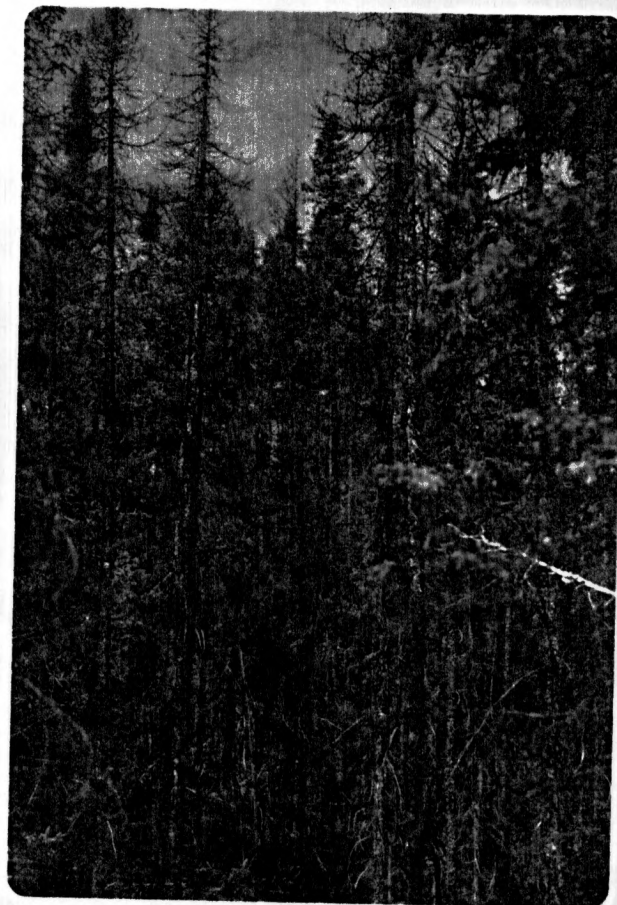
#7. The remaining live mature conifers were of poor thrift and displayed emission damage symptoms.

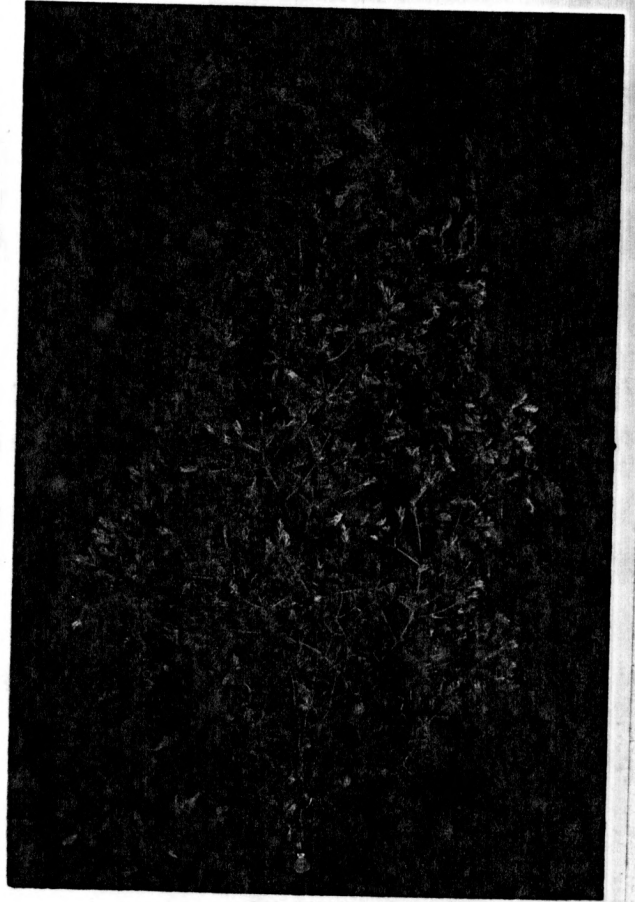
The larger spruce remaining alive in the area were rapidly declining. Short, stubby, discolored crowns resulting from foliar chlorosis and defoliation were common (photo #8). Dwarfed internodal growth also resulted from the necrosis and premature drop of the foliage. (photo #9).

#8. The severely shortened live crown of a 30-foot high black spruce. Note the discoloration (chlorosis) of the foliage facing the smoke source.

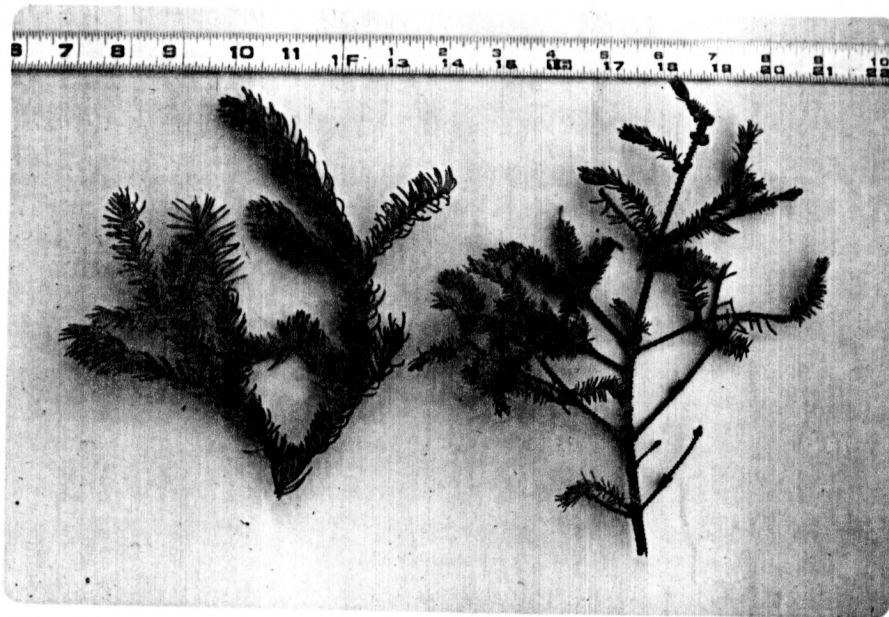
#9. Normal smoke damaged
foliage from older spruce.

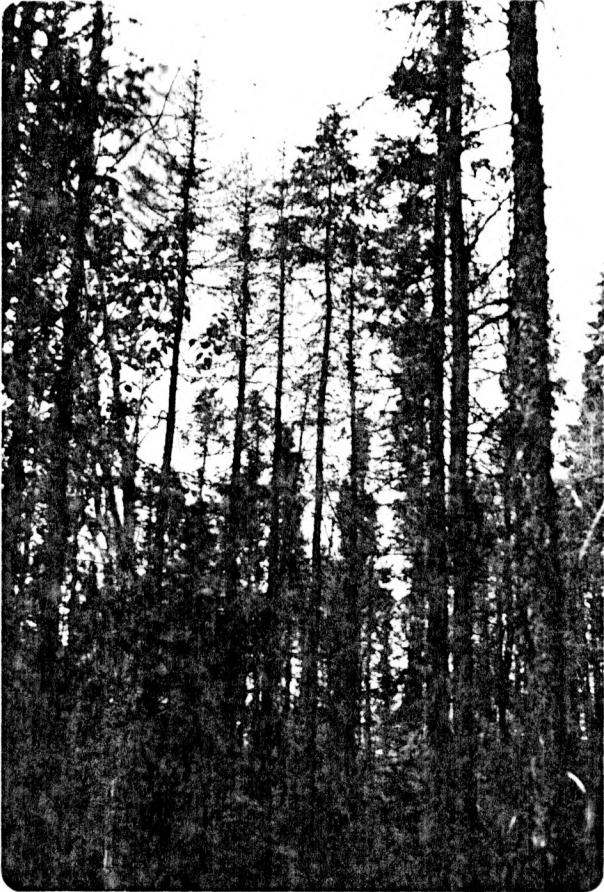
The overstory pine in the affected area suffered the highest mortality rates. The trees remaining alive had declined to a point near death (photo #10). Sparse, discolored foliage on extremely brief crowns were typical of the fume damage symptoms (photo #11).

#10. Dead and dying overstory pine and spruce.

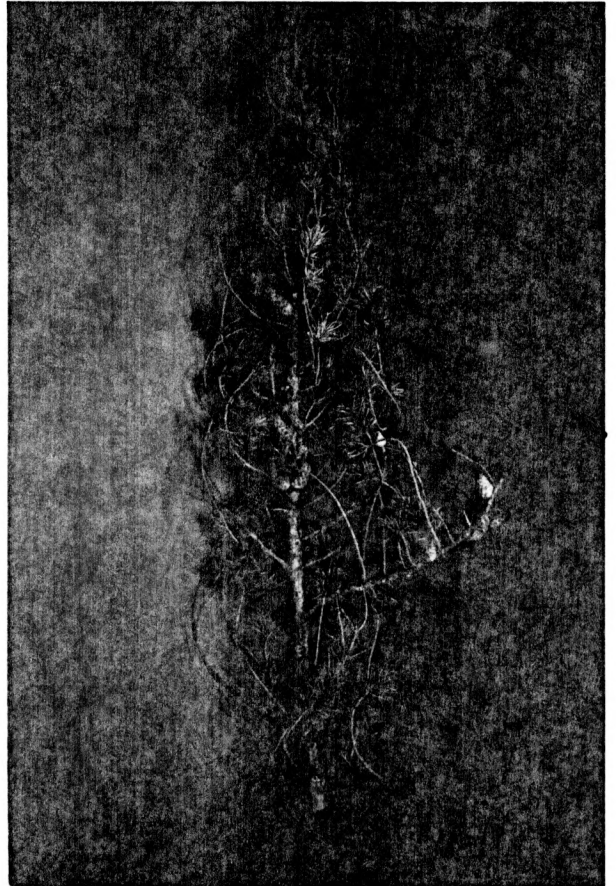
#11. The remaining live crown taken from a 40-foot tall jack pine. Note the sparse, discolored foliage.

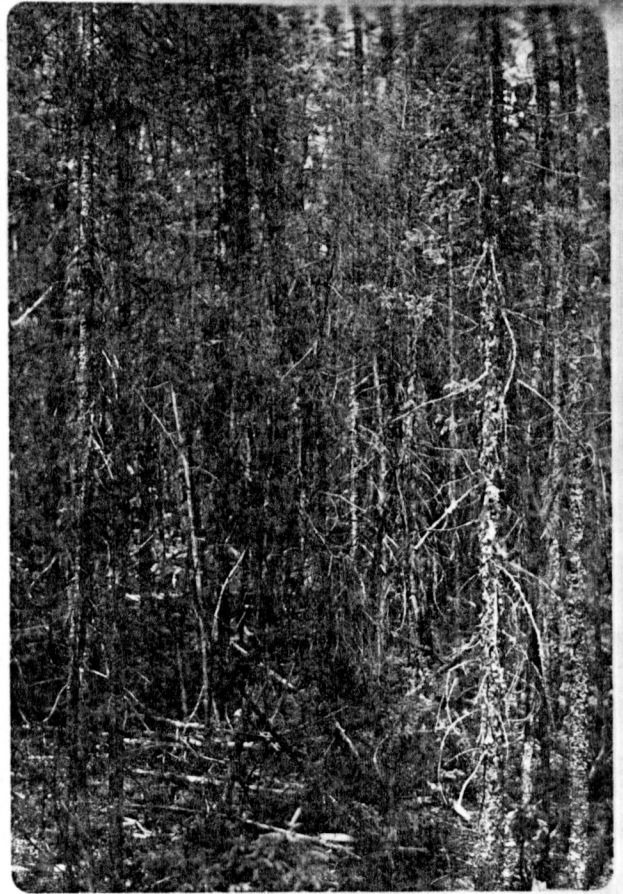
The younger established trees in the area were also severely damaged by the smoke (photo #12). The smoke damage symptoms of needle necrosis, erratic needle lengths and early defoliation were common on the young spruce still alive (photo #13).

#12. Severely damaged immature conifers.

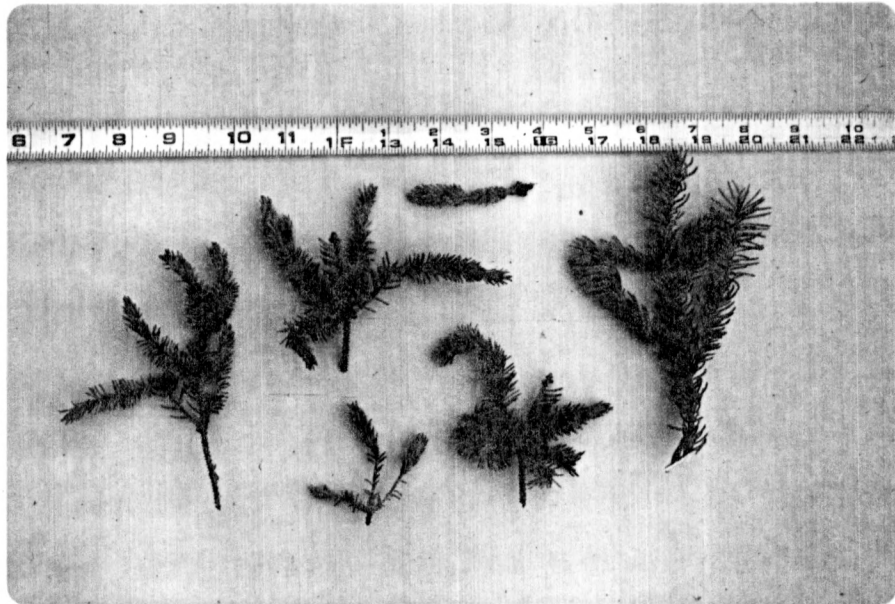
#13. Smoke damaged foliage (left) compared to a branch of normal foliage (extreme right), all from immature spruce trees.

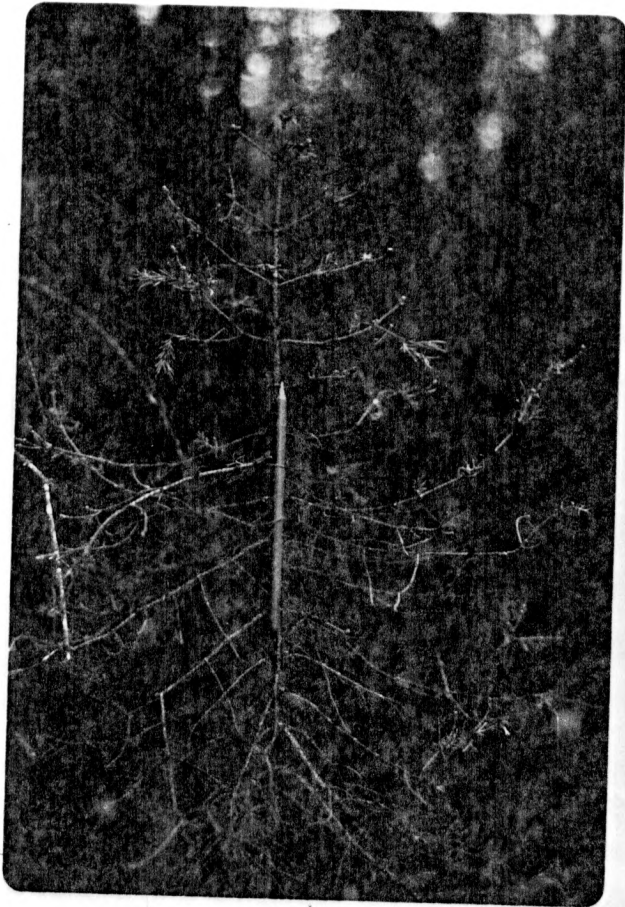
Many of the young trees had been recently killed (photo #14) and the remainder were declining rapidly (photo #15).

#14. A recently killed young spruce tree (identified by the retention of necrotic needles).

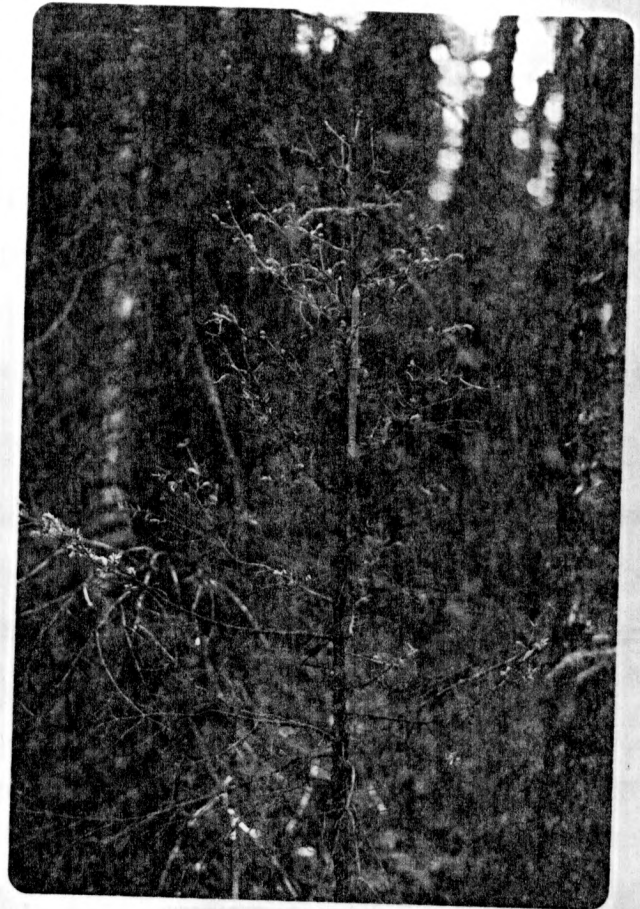
#15. A badly defoliated, rapidly declining young spruce tree.

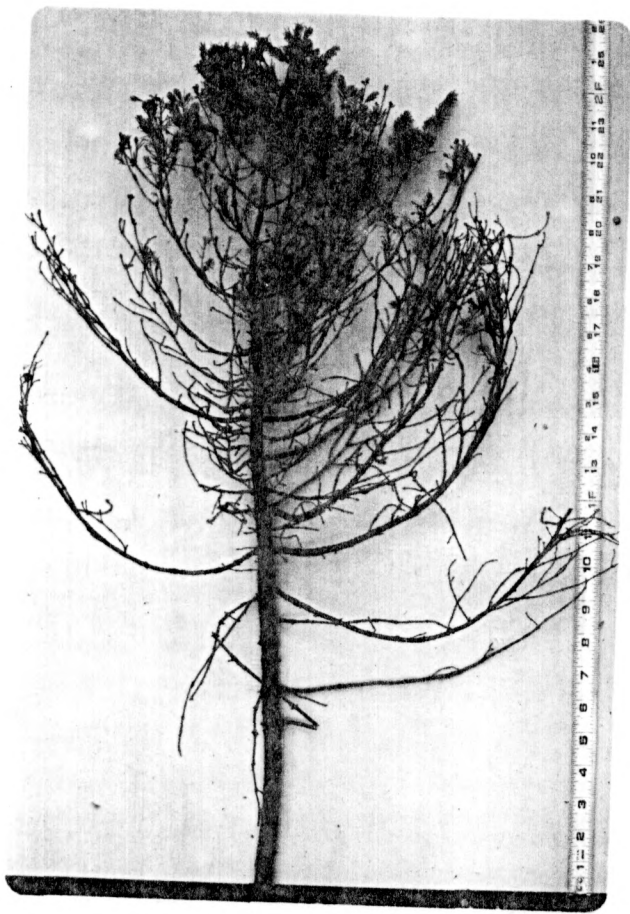
The regeneration in the location examined commonly suffered severe damage. The young conifers usually displayed the typical smoke damage symptoms of foliage discoloration, needle growth stunting and early defoliation (photo #16). Mortality among the regeneration was also commonplace (photo #17).

#16. A very young tree displaying foliage discoloration, needle stunting and partial defoliation.

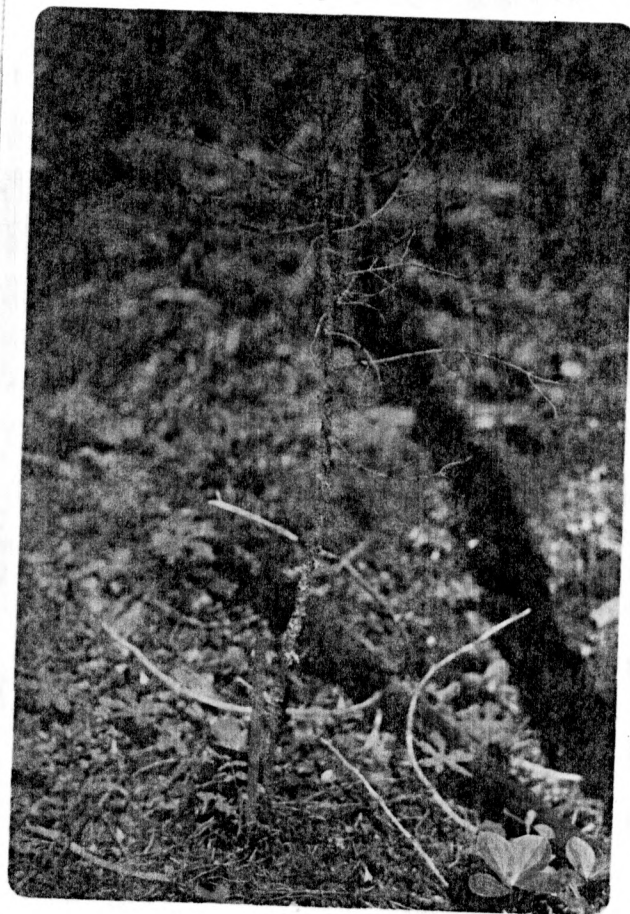
#17. A dead seedling. These were common.

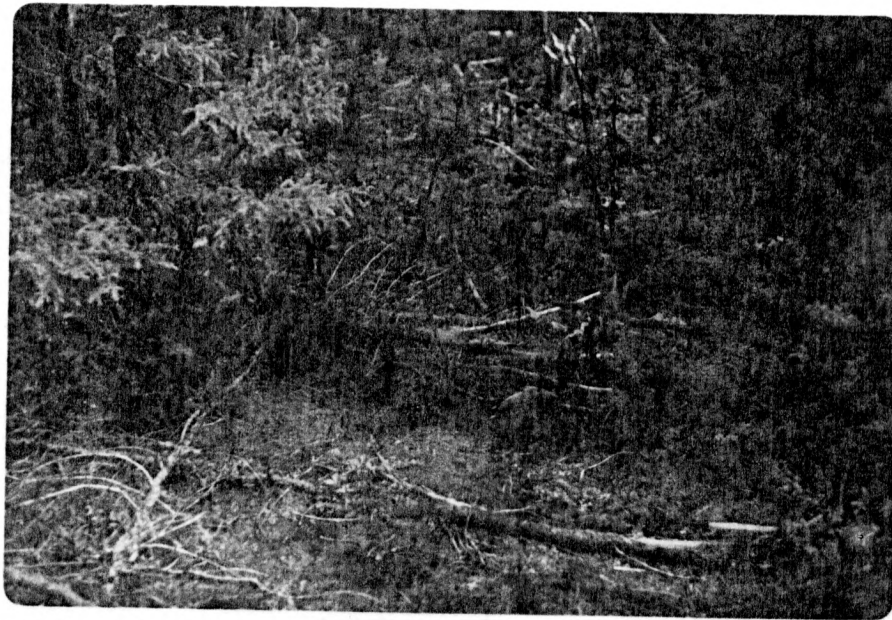
The ground vegetation left alive in the location examined was extremely sparse and reduced to a very few species (photo #18). Many of the lichens and mosses normally present were dead, even though rainfall had been abundant in the area (photo #19).

#18. Typically sparse, live ground vegetation.

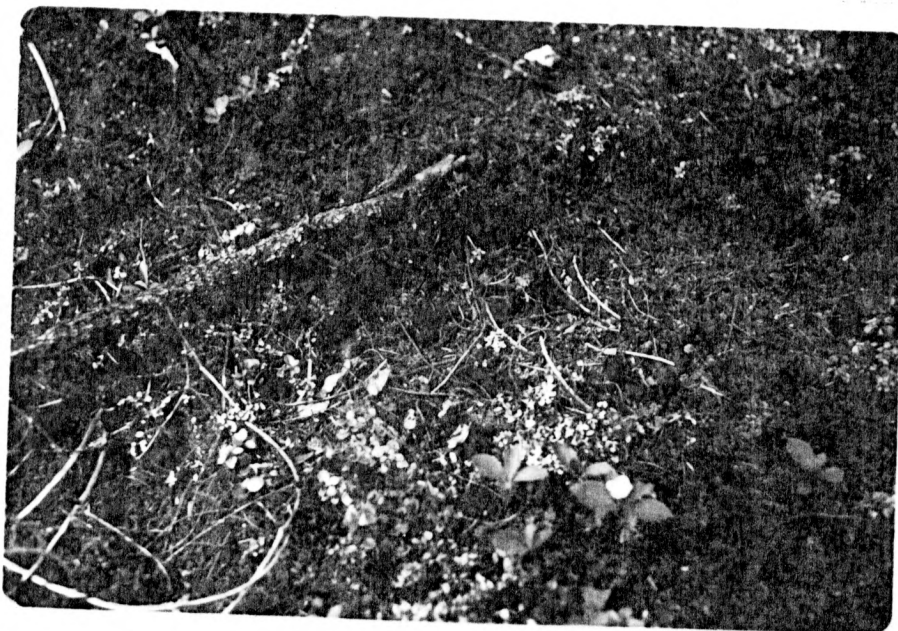
#19. Dead lichens and dead mosses.

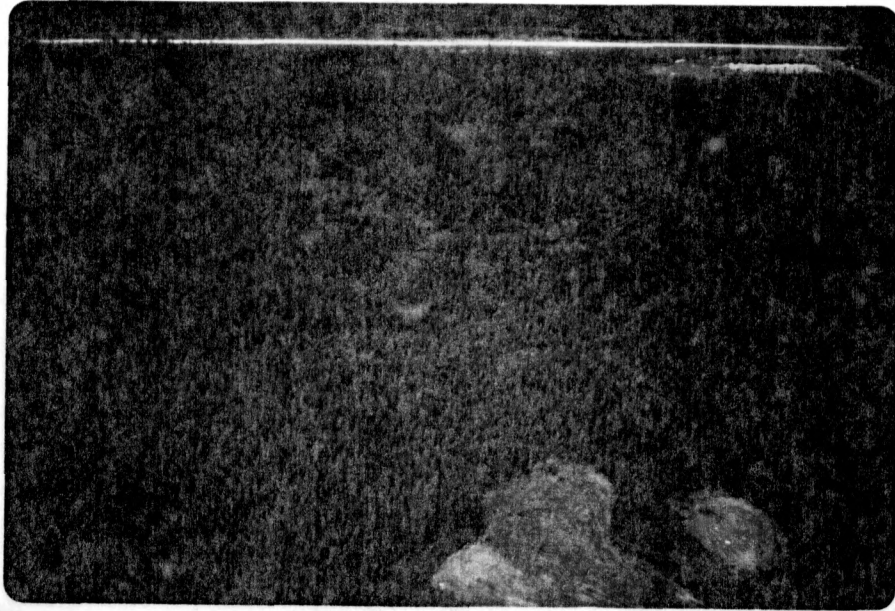
Another damaged area appeared to be developing to the south-west of the emission source (refer to map pp. #2). The damage was much less obvious from the air than that in the southern area, however some notable patches of damage were present (photo #20 and 21). No ground examination was carried out in this area.

#20. Grey, discolored patches of forest in the south-western area.

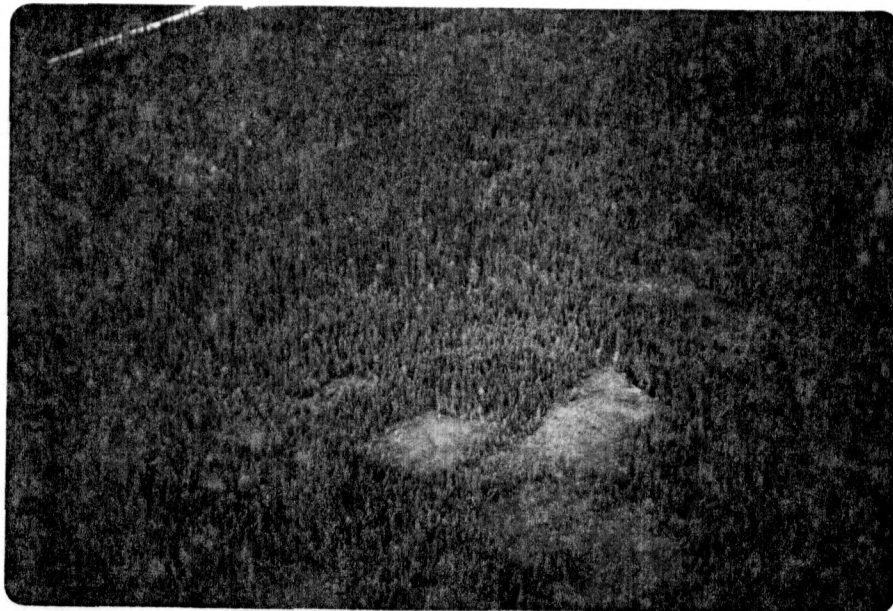
#21. A small patch of dead trees in the area.

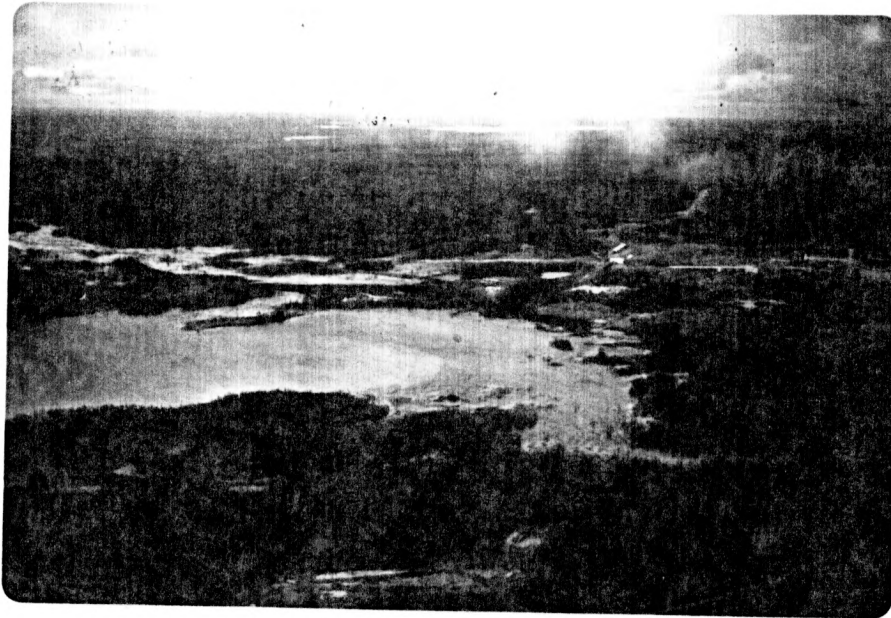
The effects of water effluents were noted on the forest community in the immediate vicinity of the plant (photo #22). Tree mortalities were apparently caused by effluent water inundation.

#22. The forest damaged by water.

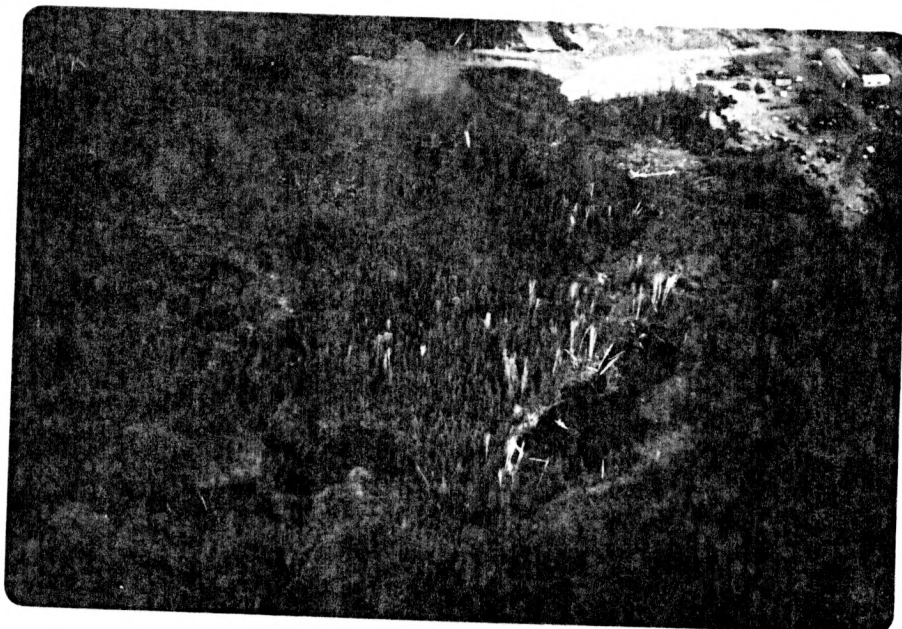
#23. Drowned trees.
