FOREST FIRE RESEARCH INSTITUTE

PERFORMANCE TESTS ON
WAJAX MARK 26
CENTRIFUGAL PUMP

1970

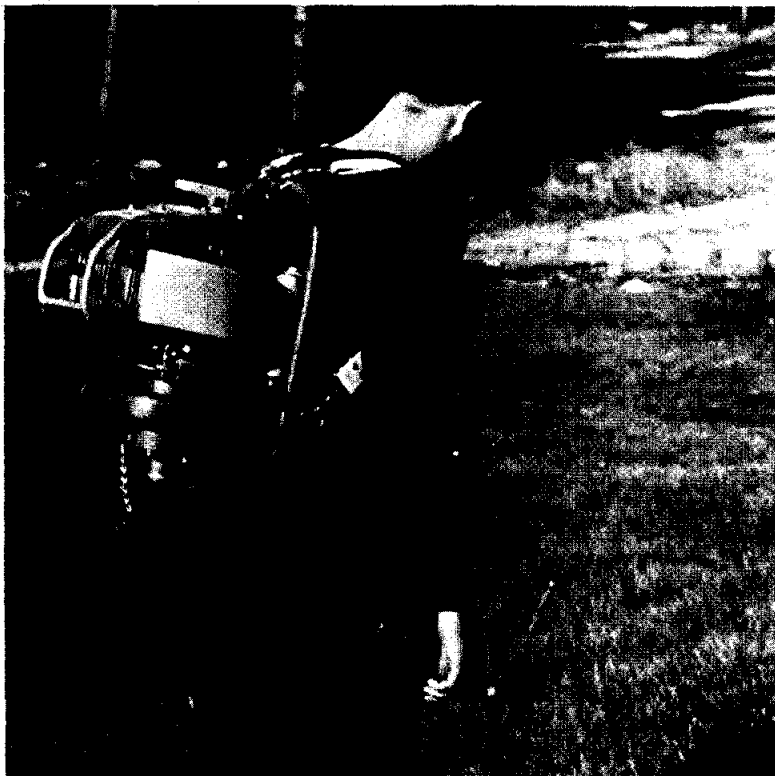
Photo No. 6 *Pump carrying pack.*

The manufacturer has provided a padded carrying pack for back-packing the pump over a considerable distance. It is made from heavy canvas duck and equipped with clip-on $1\frac{1}{2}$ " shoulder straps and a 2" waist belt. The unit's base frame slips into a pouch and is further secured by two safety straps. It was found that the upper safety strap failed to secure the base frame adequately since it was possible for the strap to slip over the frame and allow the pump to fall. However, the unit may be secured to the carrying pack by placing the top of the base frame under the shoulder straps where they fasten to the top of the pack. Some modification to the carrying pack will be required before it can be safely used in the manner in which it was designed. (Photo No. 6)

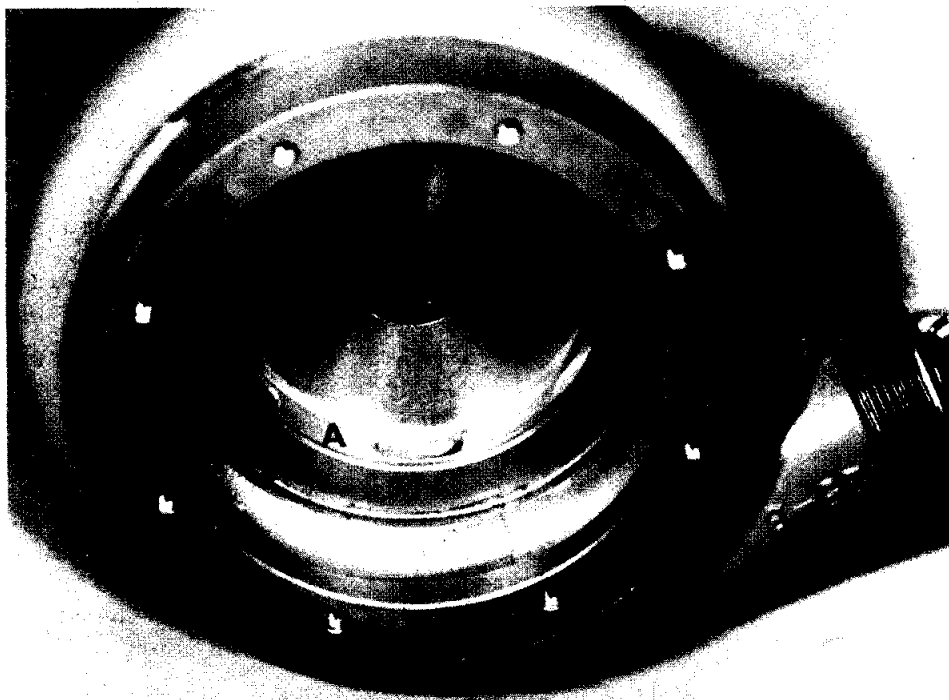
Photo No. 12 *Pump body after muddy water
test -- Unit "A". Note
groove (A) around rim of
discharge channel.*

The inside of the pump body was smoothed and polished from the abrasive action of the sand particles. There was noticeable wear around the rim of the discharge channel where a pronounced groove had formed (Photo No. 12).

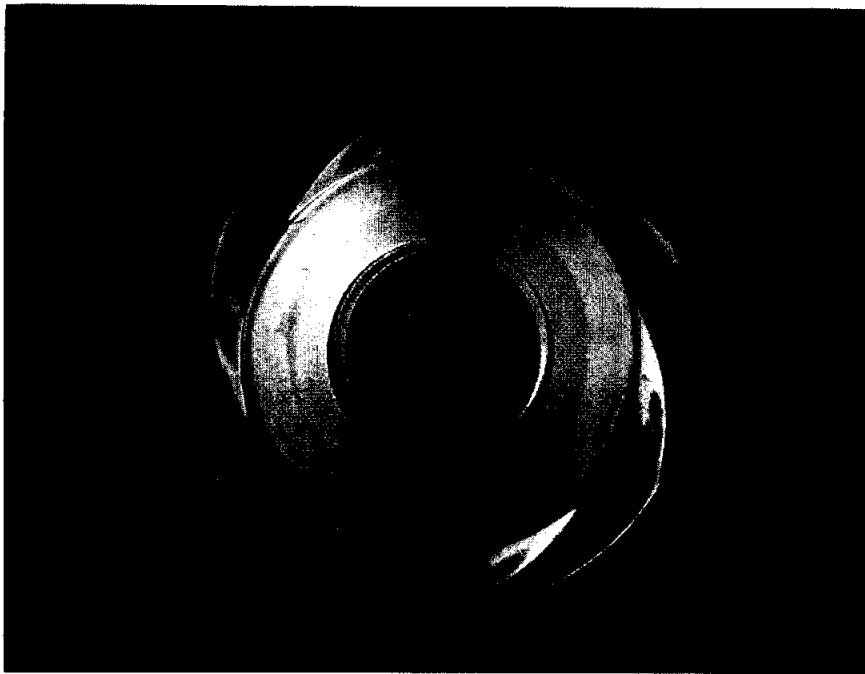
There was noticeable wear to all exposed areas of the suction nozzle and some wear to the inside of the brass bearing (Part No. 12-40) in which the end of the shaft rotates (Photo No. 13).

Photo No. 13 *Suction nozzle after muddy water test -- Unit "A". Note worn areas.*

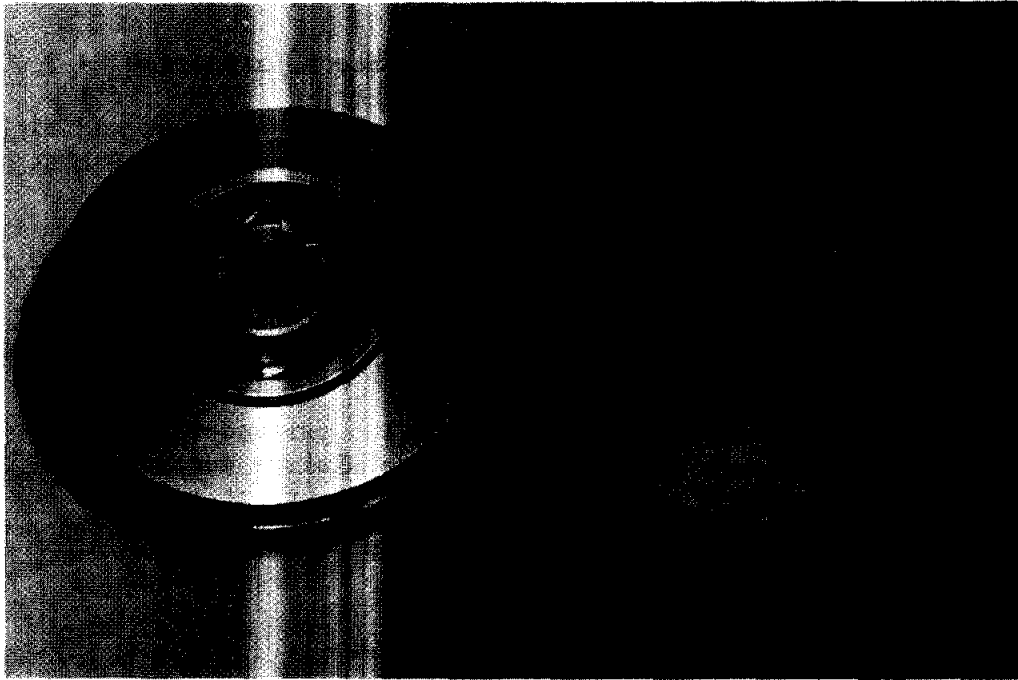
All sharp edges on the vanes of impeller Nos. 1 and 2 were smoothed and rounded. On impeller No. 2, the outside diameter of the shaft collar had decreased .025 inches. The muddy water caused a slight amount of wear to the outer rim of each impeller as well as decreasing the outside diameter of each impeller collar (Photo No. 15).

Photo No. 15 Impeller #1 -- Unit "B" (left), no visible wear after endurance test. Unit "A" (right), showing wear resulting from muddy water test.

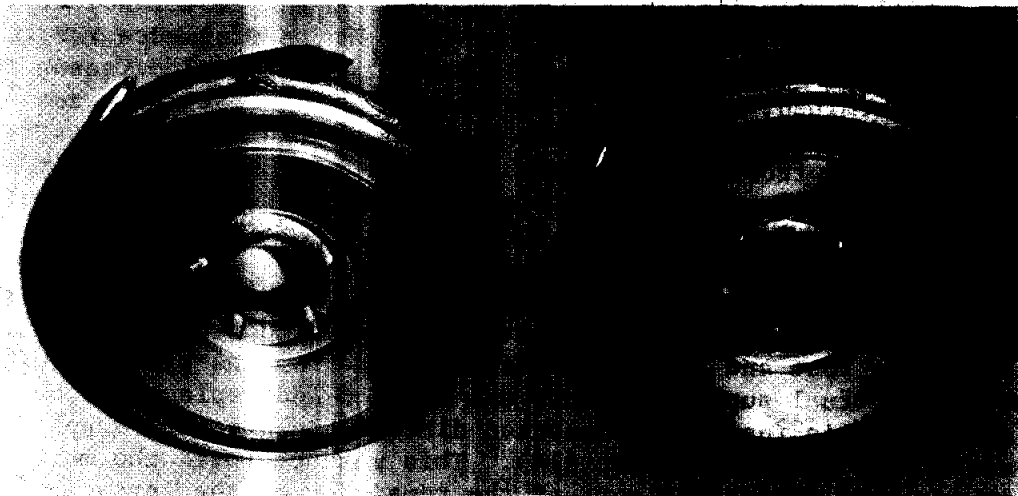
Slight wear was evident on both inner and outer distributor vanes as well as on the inside face. There was a considerable decrease in the thickness of the distributor collar. The inside diameter had increased by .020 inches and the outside diameter by .022 inches (Photo No. 16).

Photo No. 16 Distributor -- Unit "B" (left), no visible points of wear after endurance test. Unit "A" (right), wear after muddy water test.

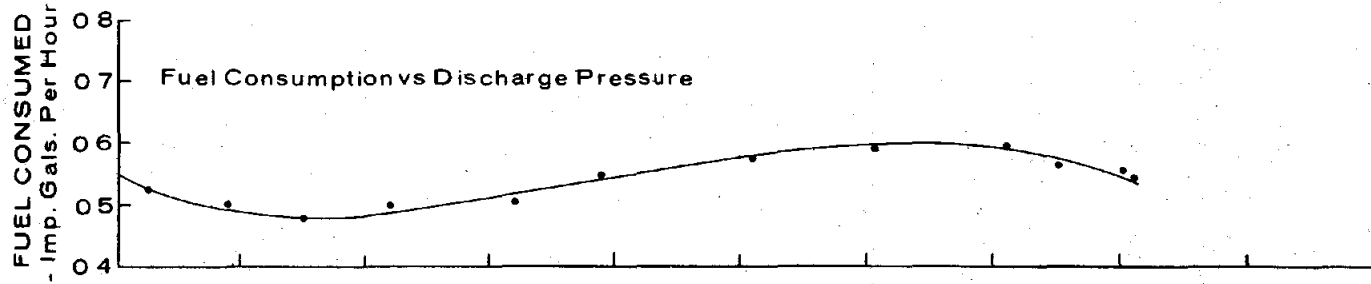
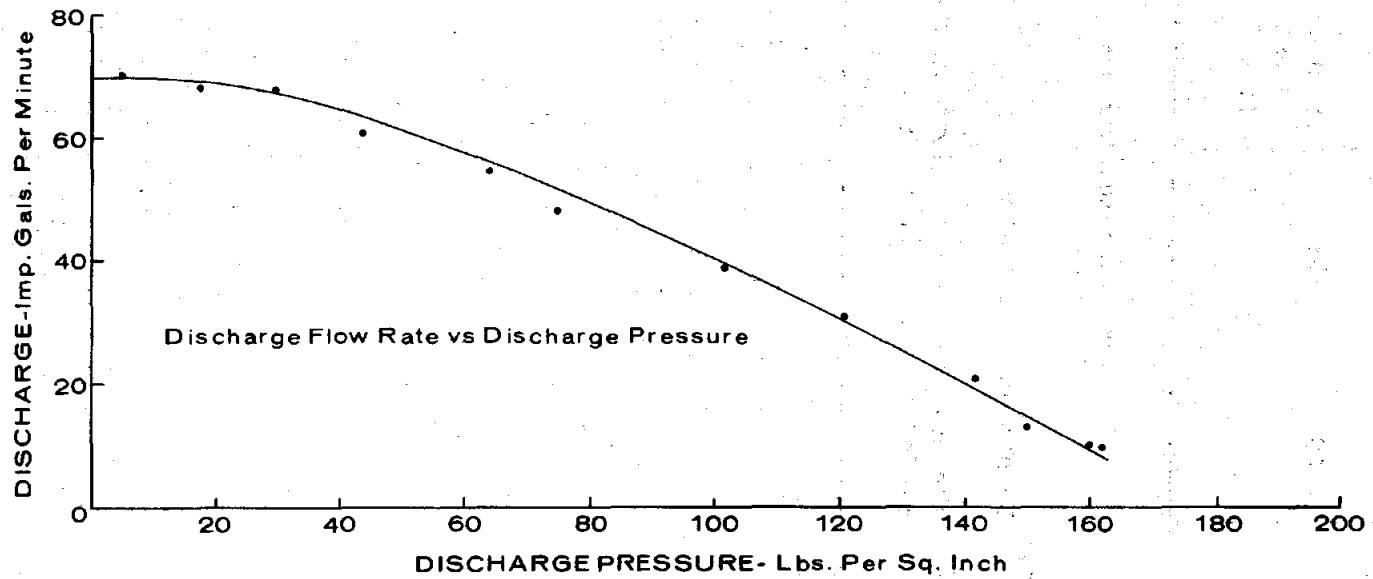
Figure No.1

The Unit produced a maximum discharge flow rate of 70 Imp. gpm between 0-13 psi. As the discharge pressure was increased beyond 13 psi, the discharge flow rate decreased in an approximate linear relationship until shut-off pressure of 178 psi was reached.

The results showed that there was a general increase in fuel consumption for discharge pressures up to 130 psi and then a slight decrease. The rate of fuel consumption ranged from 0.48 - 0.59 Imp. gallons per hour. Performance curves are given in Fig. No. 1.

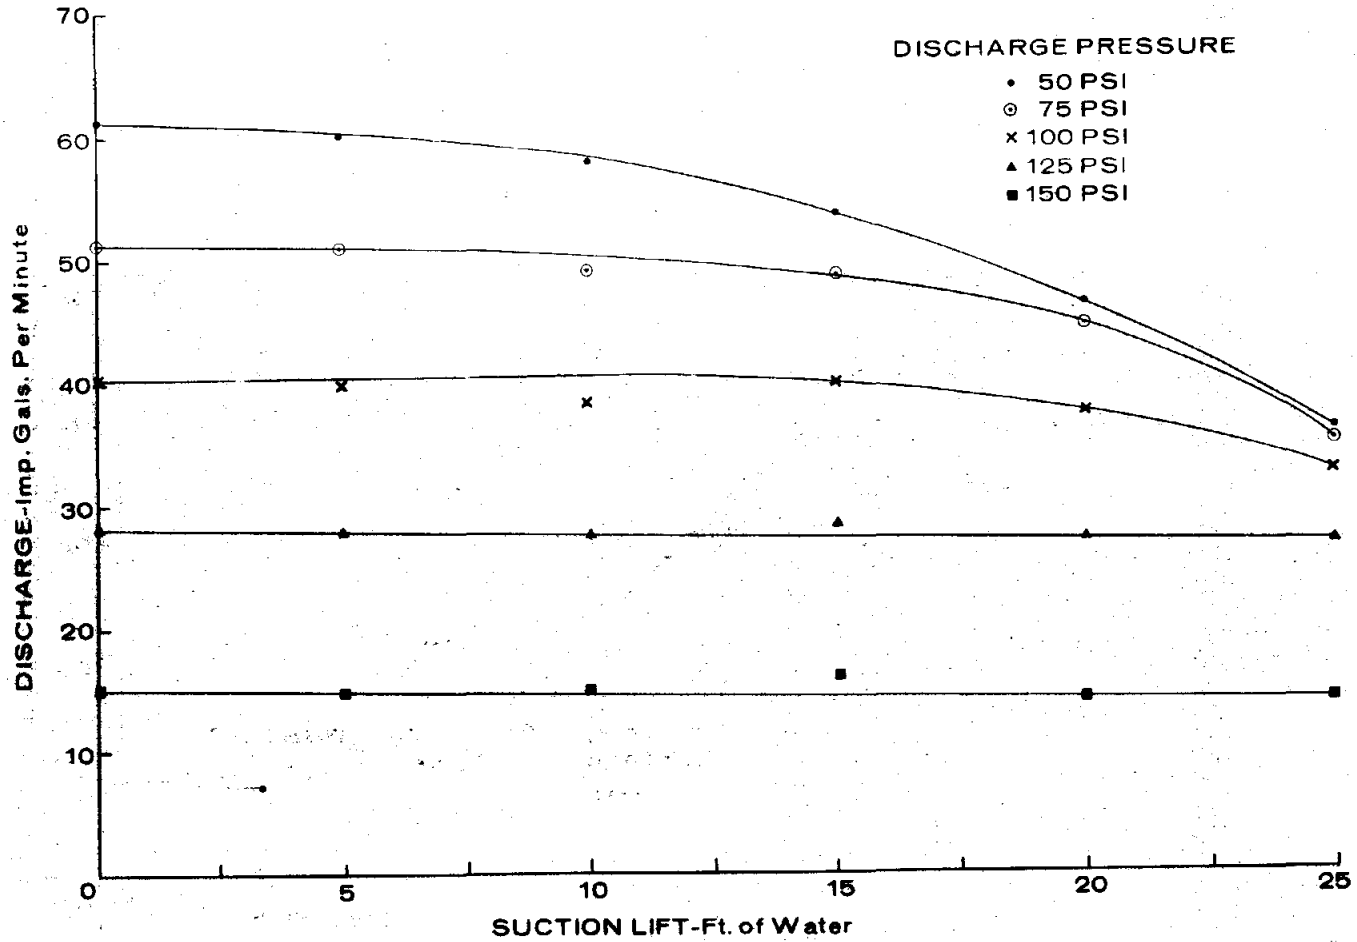
Figure No.2

The results showed that there was little loss in discharge flow rate for pressures of 50, 75 and 100 psi below a suction lift of 15 feet and that there was a negligible loss in discharge flow rate for discharge pressures of 125 and 150 psi at all levels. The results are plotted in Fig. No. 2.

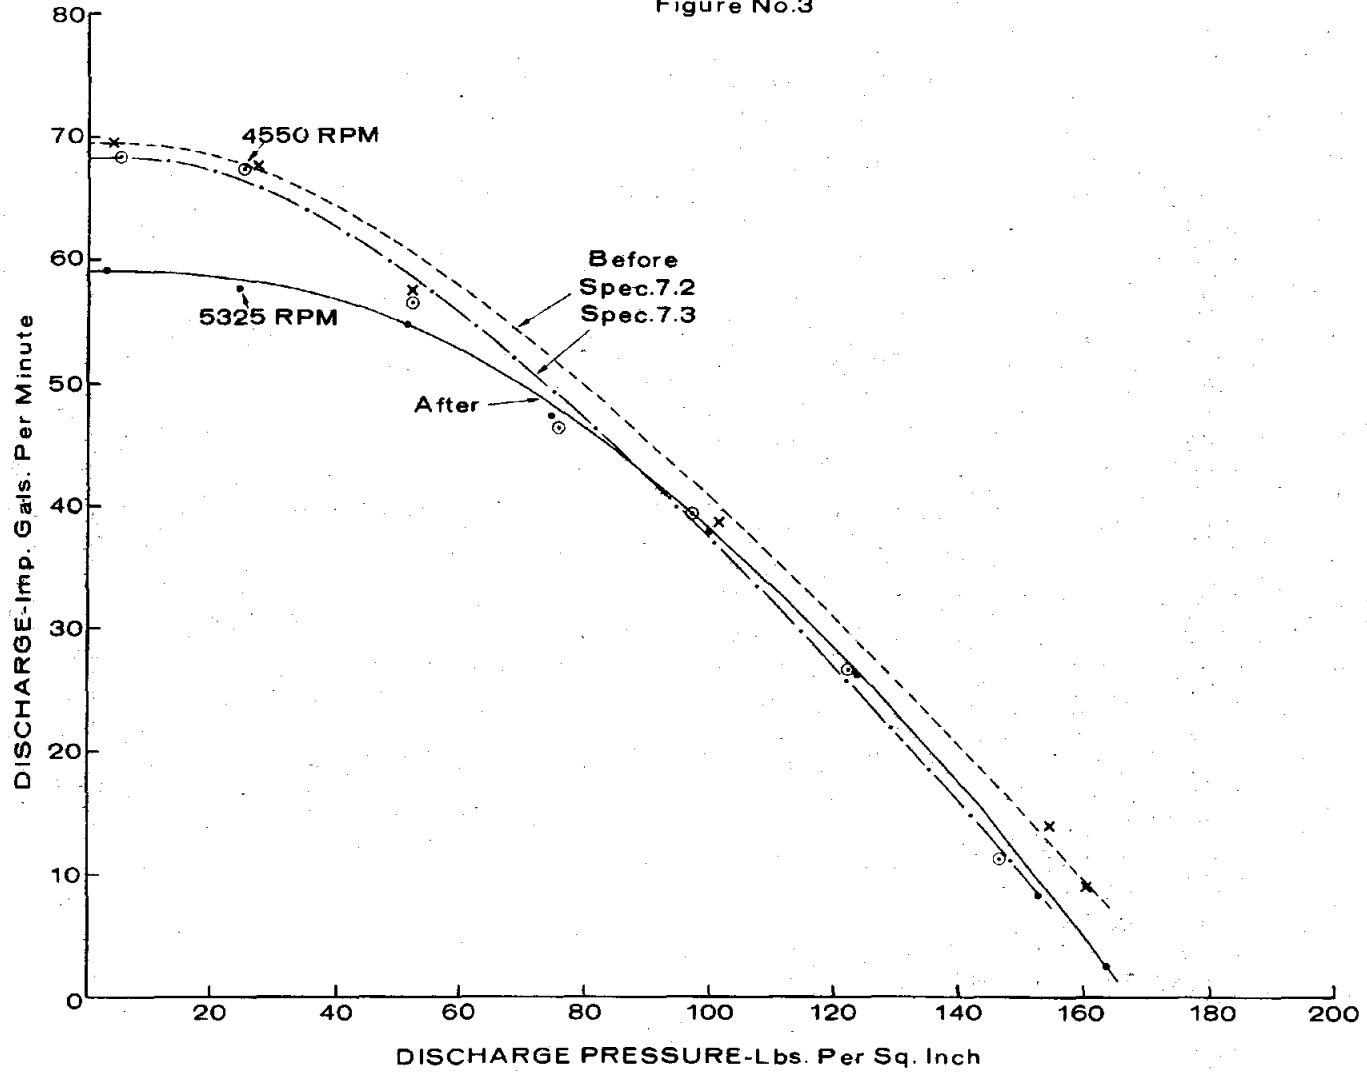
Figure No.3

Discharge flow rates obtained at a 5-ft. suction lift during Test 7.2 were greater than those recorded before the muddy water test in Test 7.3. Results are separately plotted for both Test 7.2 and 7.3 since engine fluctuations throughout Test 7.3 may have lessened the efficiency of the pump to a degree where its operation may not have been representative of actual pump performance. The fluctuations were caused by bubbles entering the carburetor from the fuel line. (p. 16) The unit operated satisfactorily throughout the 5-ft. suction lift test performed after the muddy water test.

A loss in discharge flow rate after the muddy water test of approximately 10 Imp. gpm was recorded at free flow. However, a comparison of discharge flow rates for both before and after the muddy water test showed no substantial difference in flow rate above a discharge pressure of 70 psi. The results are plotted in Fig. No. 3.
