FILE REPORT NOR-Y-21

J.P. SUSUT and R.A. BLAUDEL (1972)

EXAMINATION OF A DAMAGED FOREST AREA NEAR THE BLUE RIDGE
GAS PROCESSING PLANT, ALBERTA.

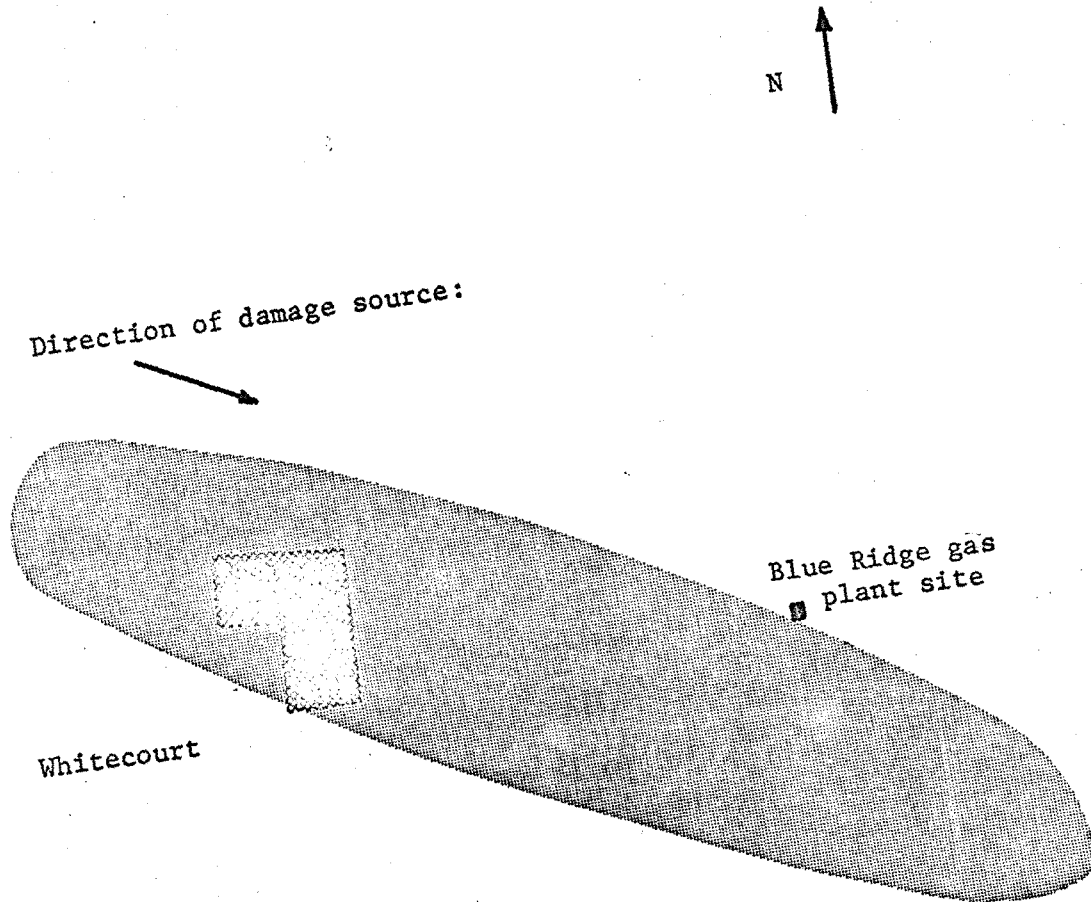
Diagram #1.

Regarding hail, the district forester verified that a particularly severe hail storm, containing large hailstones, had passed through the Whitecourt townsite from a northwesterly direction in August of 1971. The evidence observed in the forest and presented above on: 1) the damage symptoms 2) the directional nature of the damage and 3) the time of damage occurrence; correlates with this hailstorm. The directionality of the damage further demonstrates that the Blue Ridge gas plant did not emmit air pollutants responsible for the damage, because the plant is located on the north eastern edge of the damaged forest area and the source of the damage originated from the north west (see diagram #1 on next page).

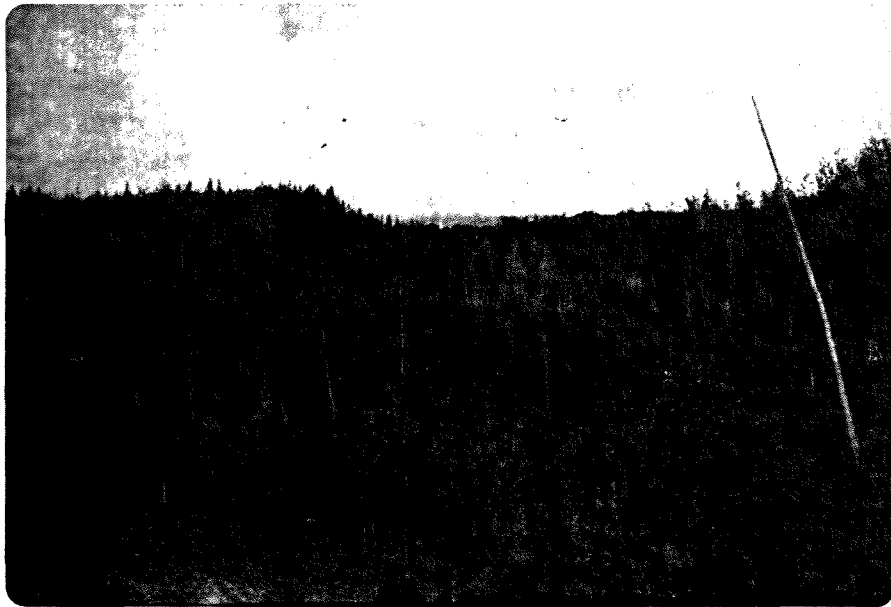
The broadleaf trees in the damaged area displayed badly lesioned dead branches that were completely defoliated and showed no evidences of bearing leaves this summer, while the branches that remained alive were foliated with normal healthy leaves (photo #2 and 3). The conifers retained both the live and dead needles of last year's foliage. None of the needles produced this year were damaged. These facts establish that the damage occurred in 1971 after completion of the conifer needle fushing (usually mid July).

#2. The perimeter of the damaged area - note the light flagging of the lodgepole pine, and the green foliage of the broad leaf trees (aspen and black poplar).

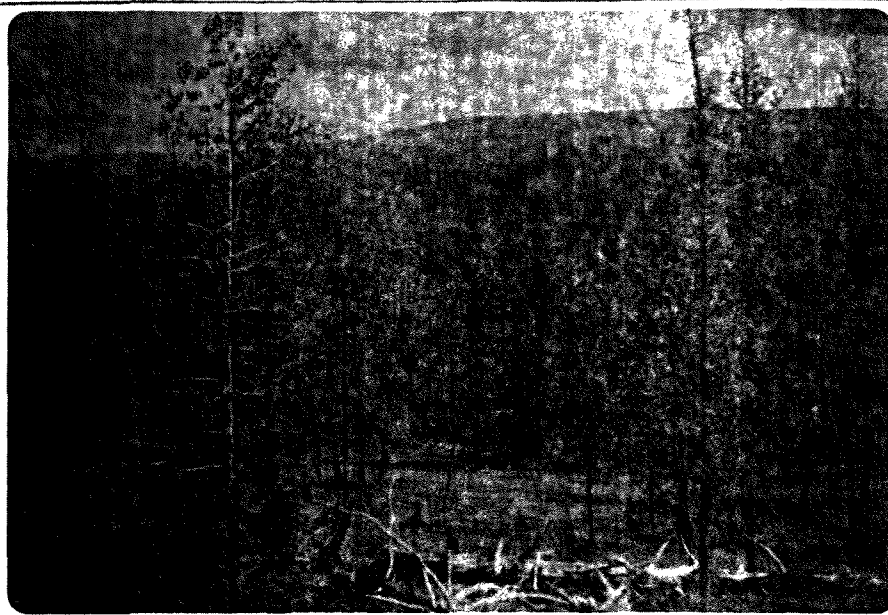
#3

#3. The severely damaged trees inside the affected area - note the green foliage on the live aspen in the foreground.

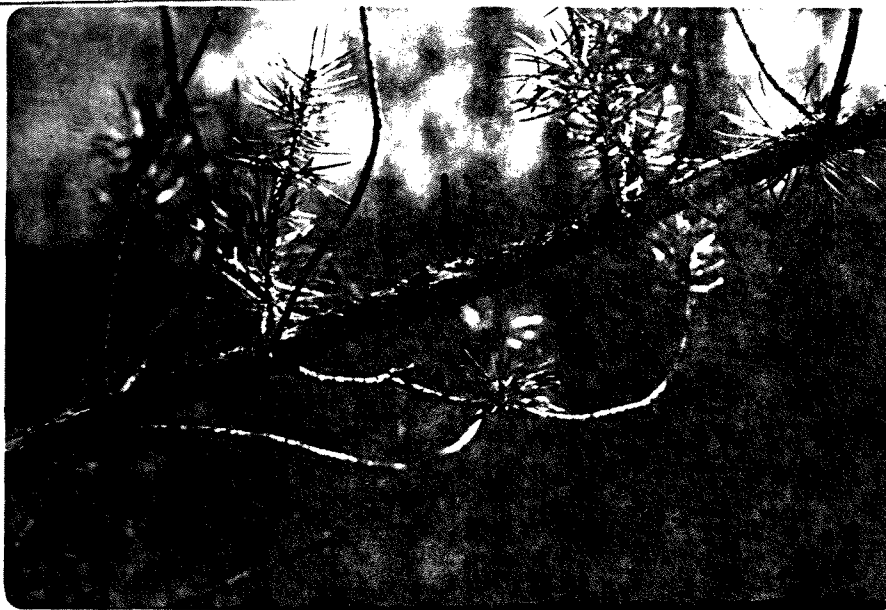
#4

However, lesions typical of those caused by hailstones, were common on the branches (photo #4) and the main stems (photo #5) of the tree species throughout the damaged area. In the most heavily damaged forest area, bark lesions were extremely numerous and resulted in the flagging of all branches on most of the trees (photo #6). Scattered cases of tree mortality also occurred in this area.

#4. Typical hailstone lesions (note arrows) found to be common on tree branches in the damaged area.

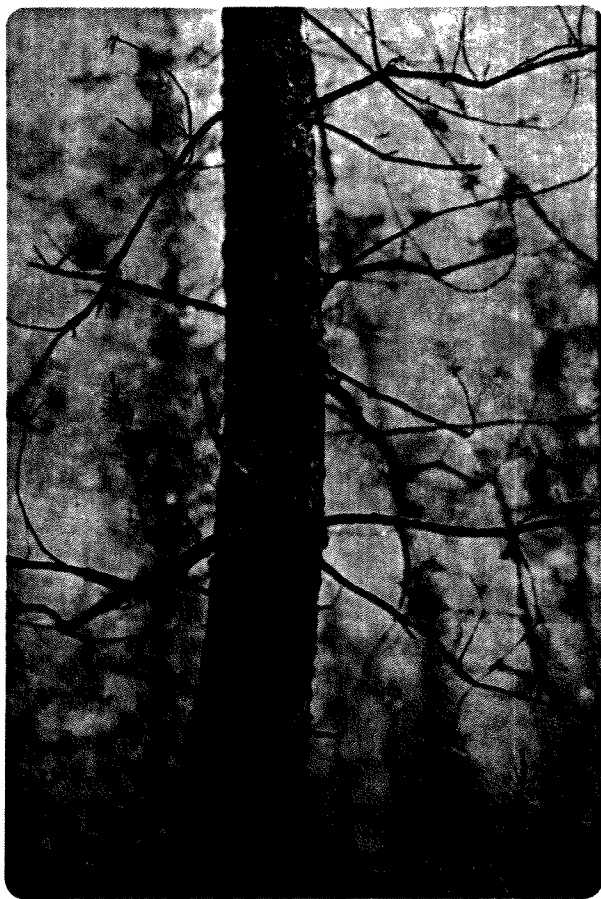
#5

#5. Typical hailstone lesions common on the main stems of the damaged trees.

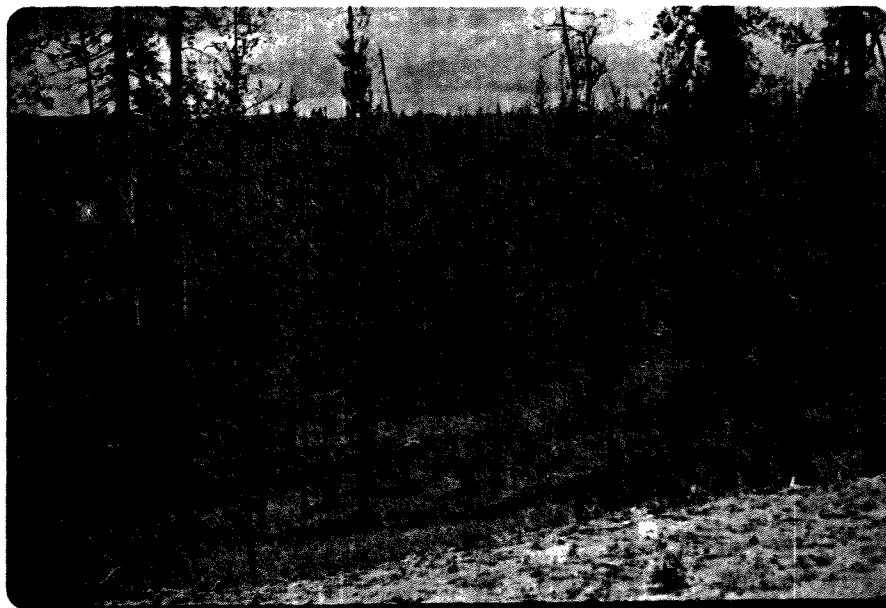
#6

#6. The damaged area contained heavily flagged trees, a few which were dead.

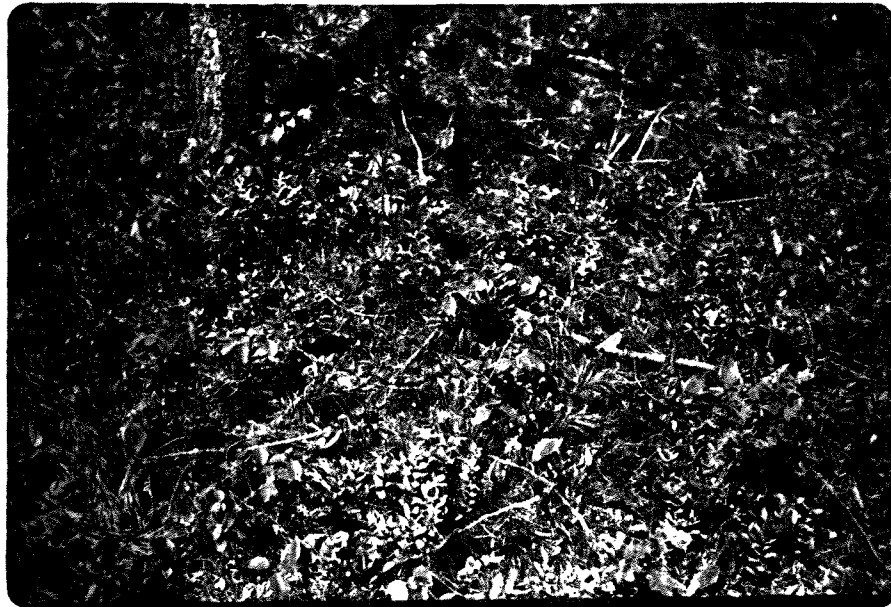
#7

A build up of needles and broken branches was found beneath the canopies of the damaged trees, which indicated mechanical stripping, also typical of severe hail damage (photo #7).

#7. Broken branches and needles such as shown above were commonly found beneath the damaged conifers.

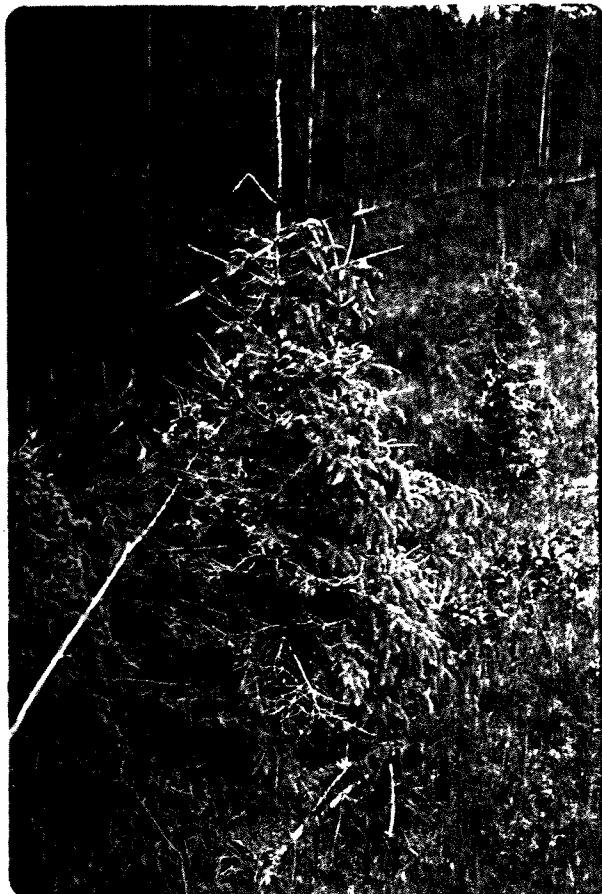
#8

In some cases trees growing closely together were physically protected from the damaging agent and displayed no lesions or other damages. It was observed that the foliar damage, was always severest on the northwestern side of the trees (photo #8), indicating that the damaging agent had come from that direction.

#8. The severely damaged "northwest" side of some spruce trees in the area. The severest damage always occurred on the northwest side of the trees.
