FOREST INSECT AND DISEASE SURVEY
PEST REPORT ON SPECIAL PROJECTS
QUEEN CHARLOTTE ISLANDS

FIDS Report 96-7

FOREST INSECT AND DISEASE SURVEY
PEST REPORT ON SPECIAL PROJECTS
QUEEN CHARLOTTE ISLANDS
1995

Prepared for:
South Moresby Forest Replacement Account (SMFRA)

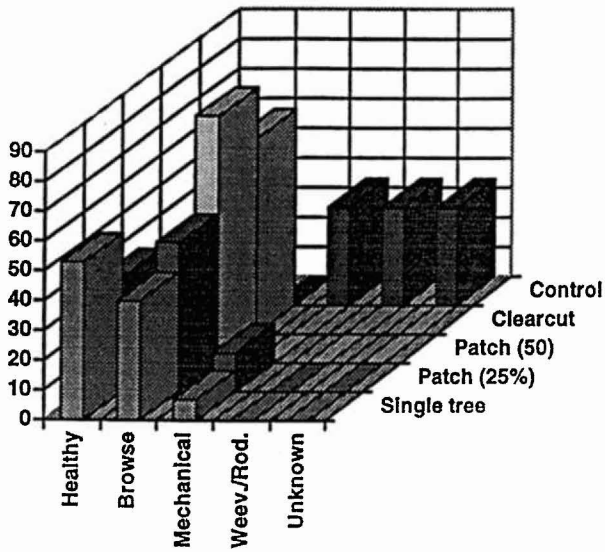
Fig. 1 Spruce

As part of the long term plan, spruce and cedar seedlings were planted at predetermined locations and densities. A total of 118 seedlings were found in the plots of which one was dead the first year, probably due to planting problems. In 1995, of 41 spruce seedlings, 37% were healthy while 52% were affected by deer browse (see Fig. 1). Browse was also the major problem in the unprotected cedar seedlings, with 66% of 38 seedlings (Fig. 3) affected and only 3% healthy. The use of protective collars on cedar reduced deer browse to only 18% of 39 seedlings while 23% remained healthy (Fig. 2).

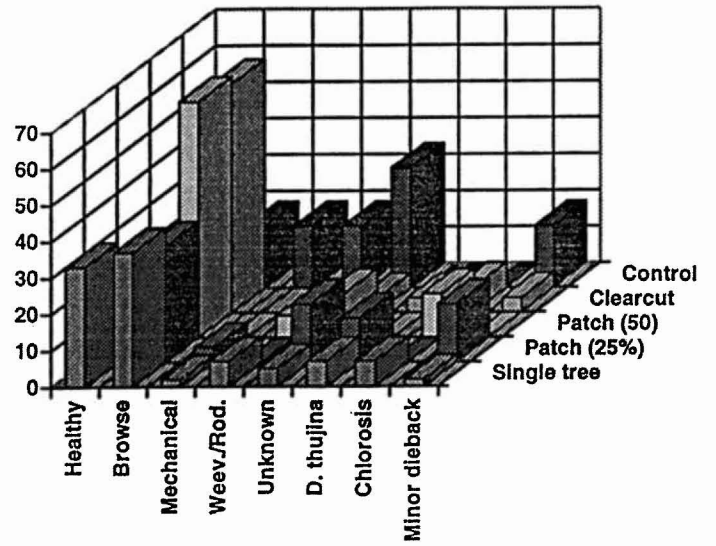
Fig. 4 All seedlings

Overall only 21% of seedlings were healthy and 16% were dead in 1995 (two years after planting). While browse was the most serious problem, affecting 45% of seedlings (Fig. 4), cedar leaf blight infected 6% of seedlings, bark stripping by a root collar weevil or rodents killed 4% of seedlings, 6% of seedlings were chlorotic, minor dieback was found in 6% of seedlings, mechanical damage affected 3% of seedlings while 9% of seedlings were damaged or killed by unknown agents.

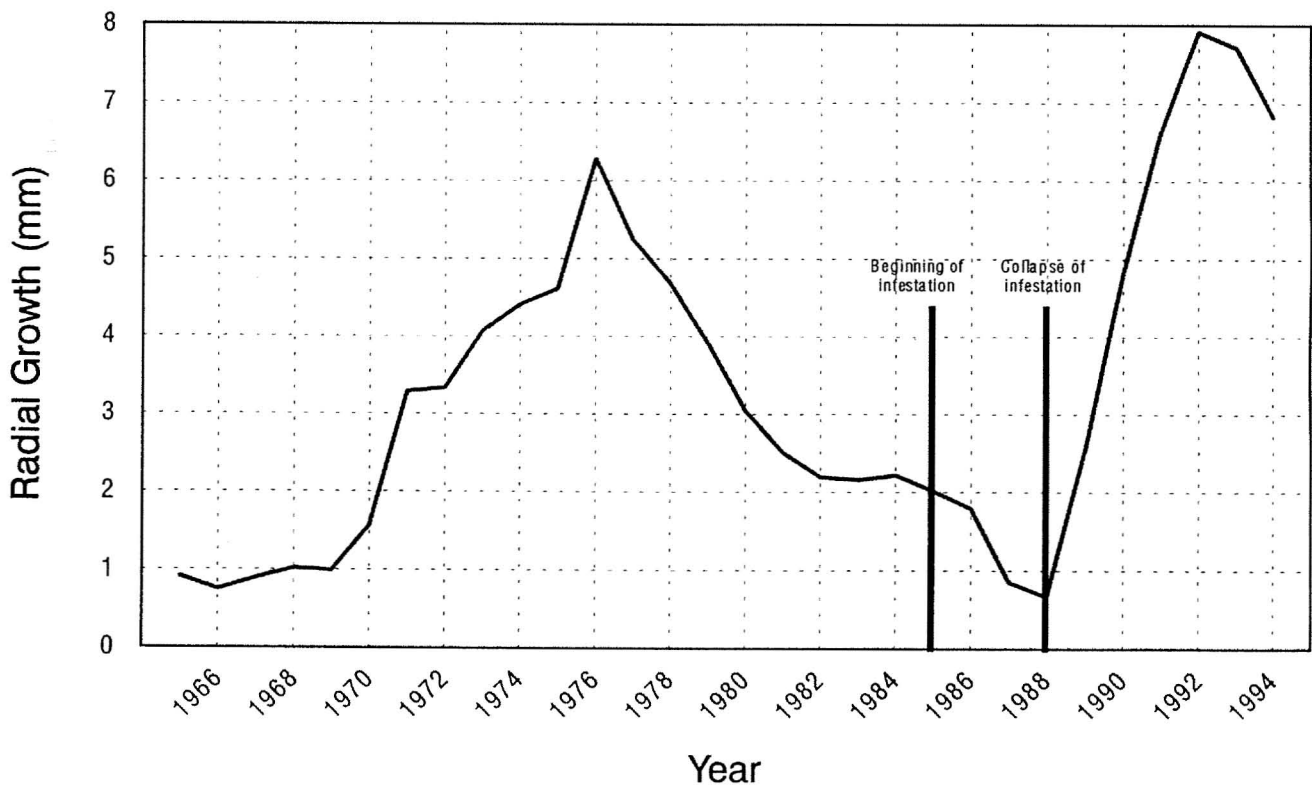
Figure Radial increment of western hemlock in the Honna R. plot (#4), defoliated by western blackheaded budworm. Q.C.I., 1995.

An assessment of the 10 cores showed a dramatic reduction in radial increment during the outbreak period (see graph). Increment averaged only .67 mm in 1988, one year after the most severe recorded defoliation. This average is 363% less than the annual average of 2.42 mm for the 5 year period prior to the onset of the outbreak. Recovery was already evident in 1989 with a growth rate of 2.53 mm, although part of this dramatic recovery was doubtless associated with the spacing in 1988.

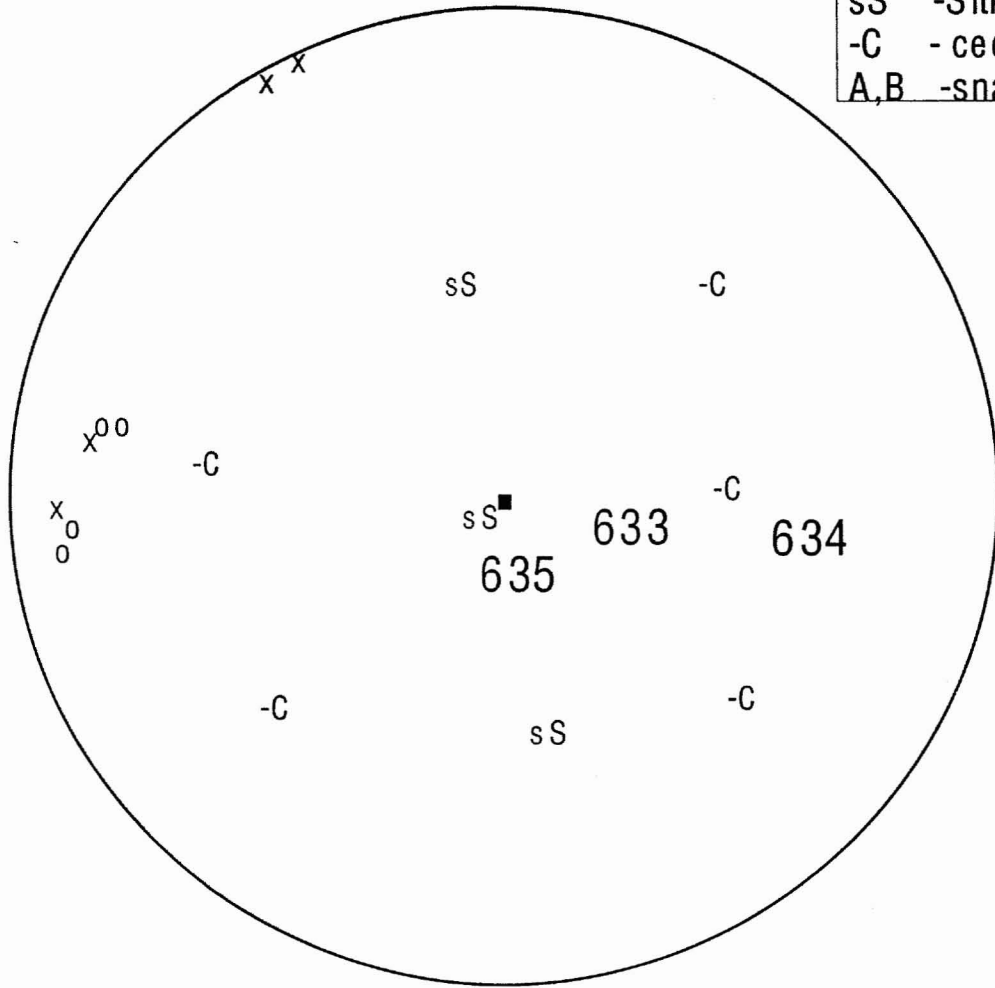
Plot 1 (R.P. - 180)

Original tree no.	New tree no.	Species	DBH	Status
1	633	wH	43	healthy, scar
2	634	wH	18	sweep, felled
3	635	wH	24	sweep, logged
xx		wH		majority under slash

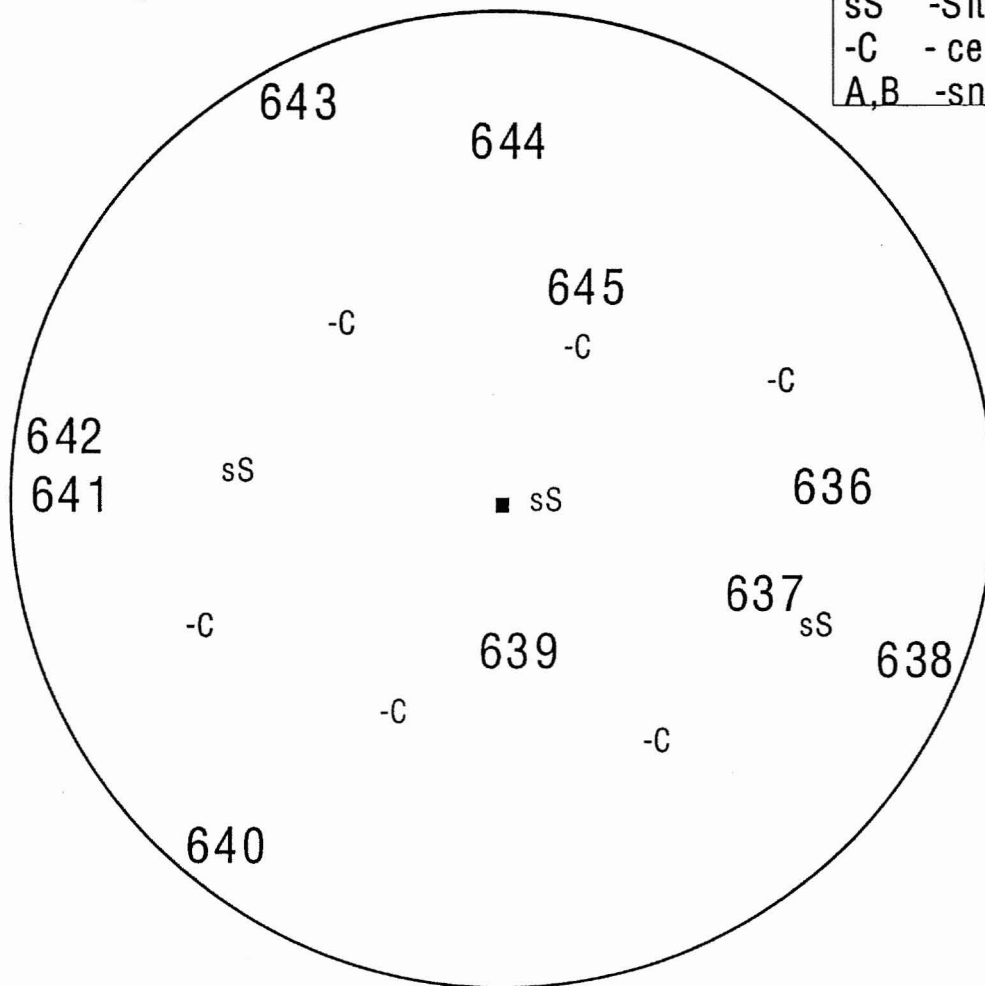
Plot 2 (R.P. - 188)

Original tree no.	New tree no.	Species	DBH	Status
1	636	wH	27	lean
2	637	wH	29	lean, logged
3	638	wH	25	logged
4	639	wH	35	
5	640	wH	34	logged
6	641	wH	12	
7	642	wH	12	healthy, dead standing
8	643	wH	32	logged
9	644	wH	41	logged
10	645	wH	28

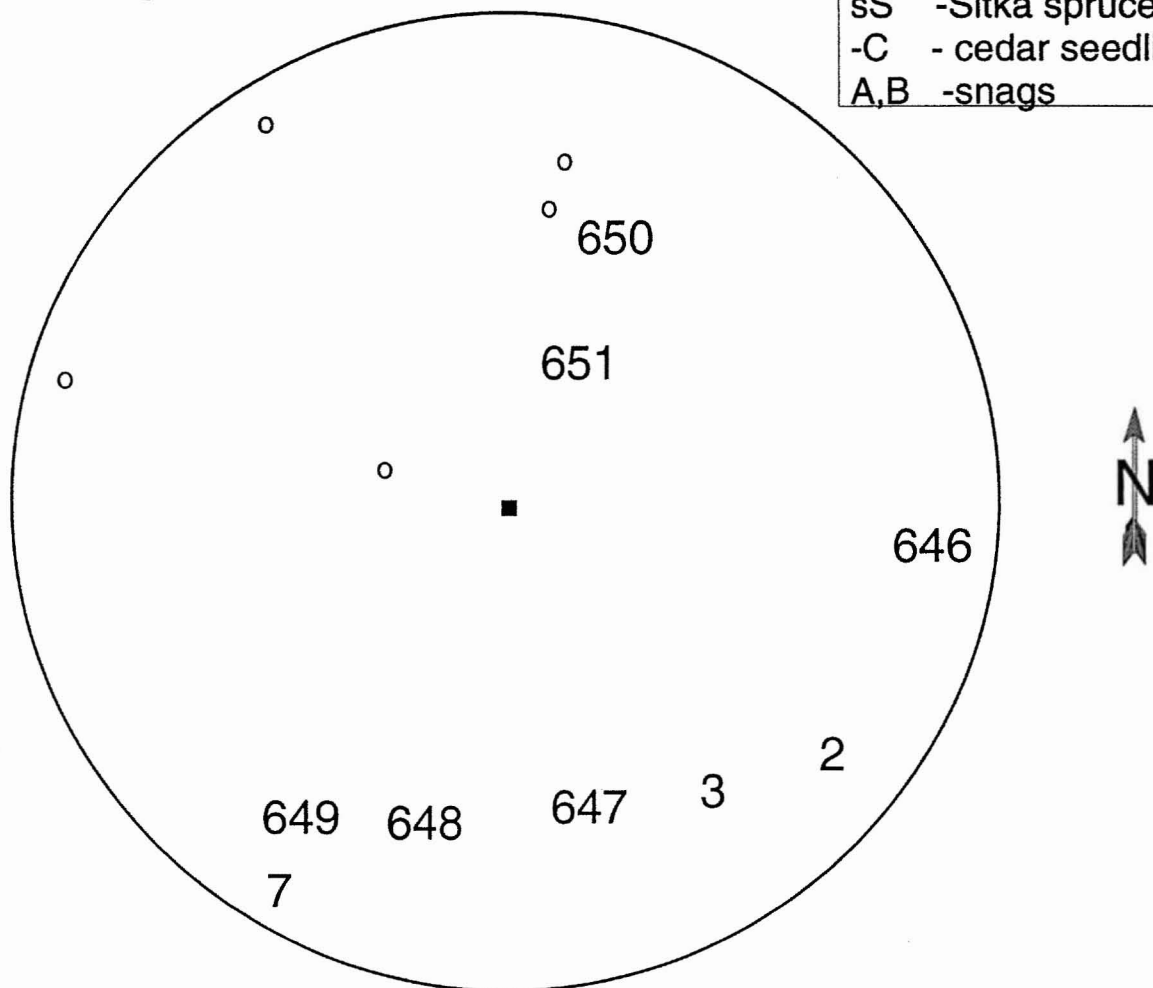
Plot 3 (trail)

Original tree no.	New tree no.	Species	DBH	Status
1	646	wrC	96	fork, logged
2		wH	12	mistletoe (1), felled, not found
3		wH	9	felled, not found
4	647	wH	9	felled
5	648	wrC	143	dead top, logged
6	649	wH	7	sweep, felled
7		wH	11	felled, not found
8	650	wH	95	mistletoe suspect, logged
9	651	wH	11	mistletoe (1), felled
xx		wH		destroyed, under slash

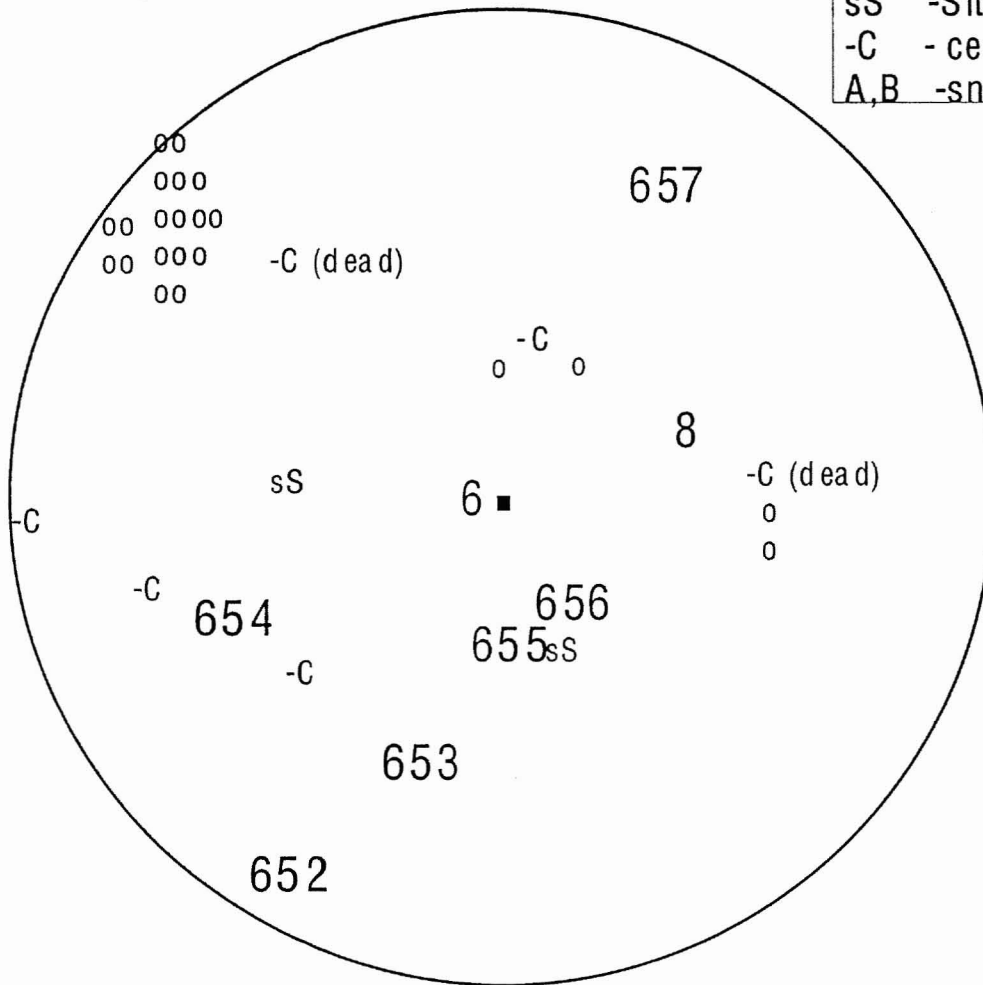
Plot 4 (R.P. -113)

Original tree no.	New tree no.	Species	DBH	Status
1	652	wH	48	mistletoe (3)
2	653	wH	14	mistletoe (1)
3	654	wH	11	lean, mistletoe (2)
4	655	wH	13	mistletoe (2), felled
5	656	wH	15	mistletoe (2), felled
6		wH	11	mistl. (1), felled, not fnd
7	657	wrC	70	brk. top, logged
8		wH	6	mistl. (1), felled, not fnd
xx		wH		destroyed, heavy slash

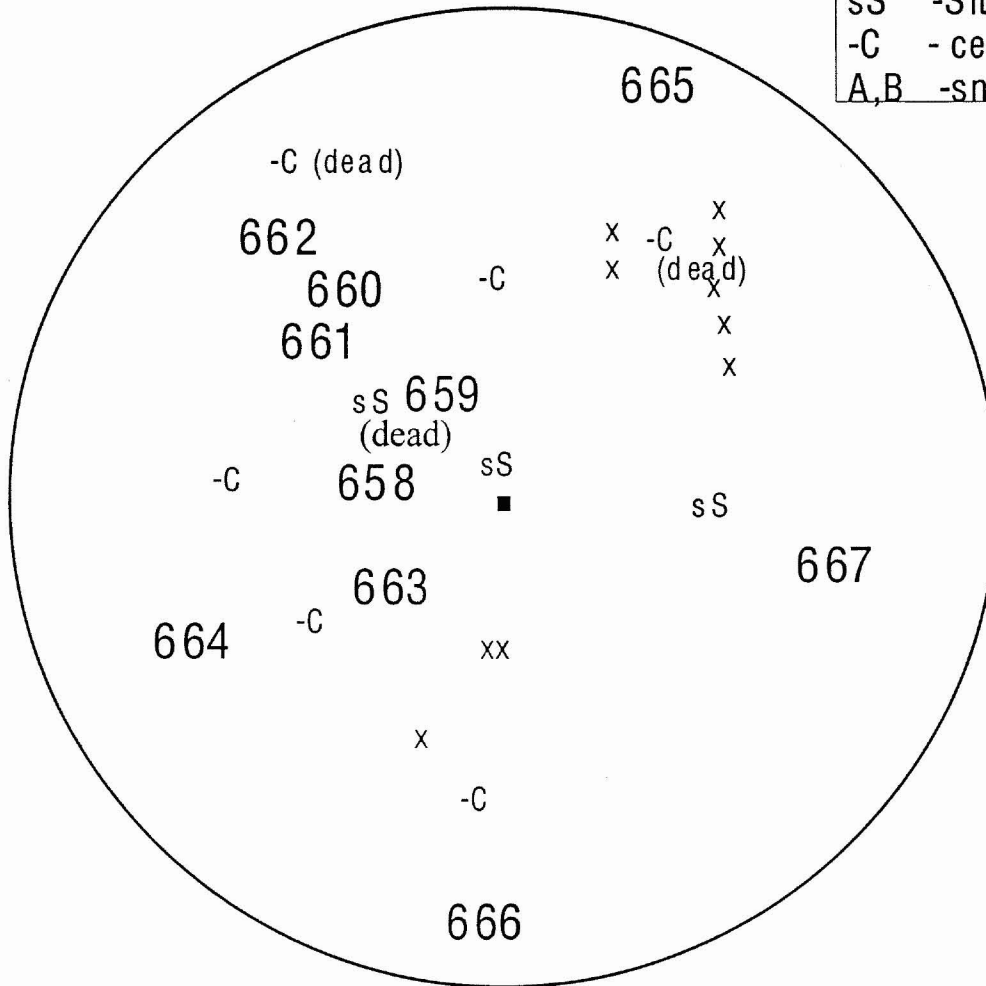
Plot 5 (R.P. - 104)

Original tree no.	New tree no.	Species	DBH	Status
1	658	wH	8	mistletoe (1)
2	659	wH	20	mistletoe (3)
3	660	wH	45	mistletoe (3)
4	661	wH	42	mistletoe (3)
5	662	wH	54	mistletoe (3), rec. dead
6	663	wH	77	mistletoe (2)
7	664	wH	15	healthy, scar
8	665	wH	26	mistletoe (1)
9	666	wH	120	mistletoe (3), sapsuck.
10	667	wH	16	mistletoe (1)
xx		wH

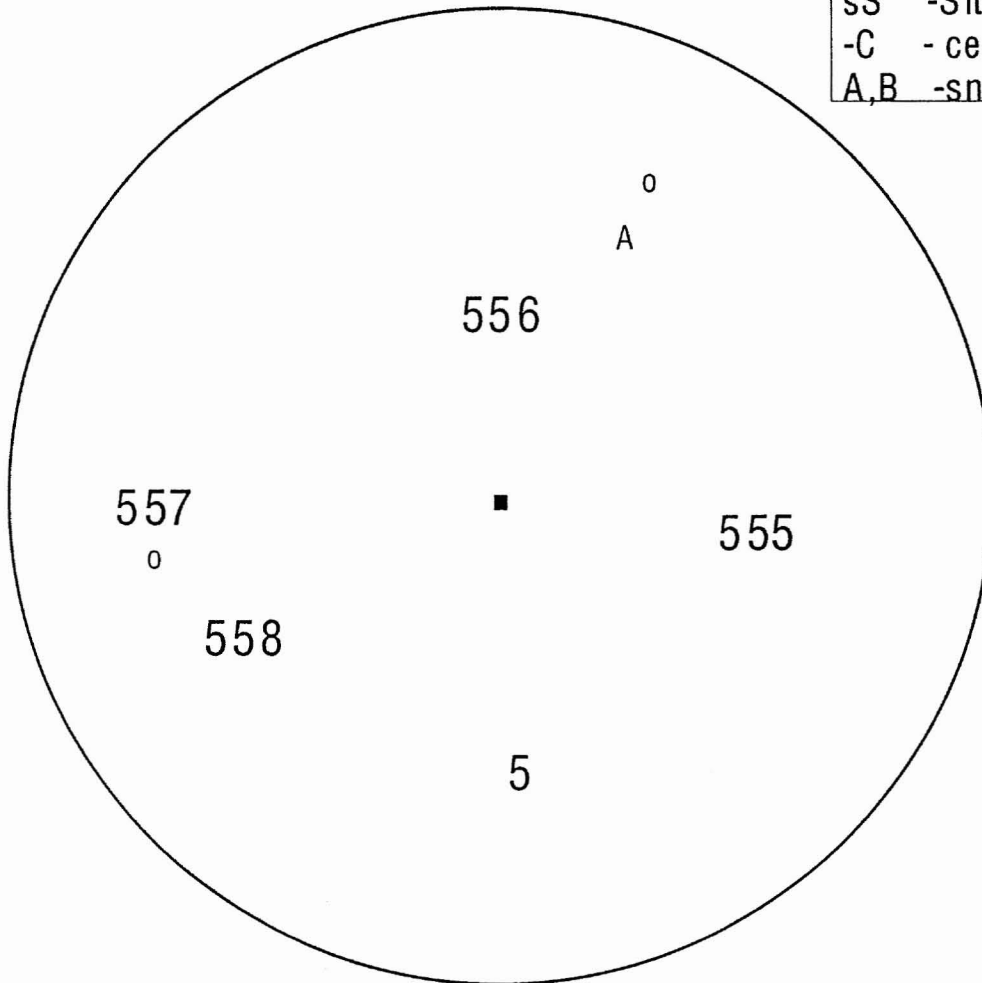
Plot 6 (trail)

Original tree no.	New tree no.	Species	DBH	Status
1	555	wH	96	mistletoe (1), windt.
2	556	wH	15	mistletoe (1), windt.
3	557	wH	49	mistletoe (1), windt.
4	558	wH	48	mistletoe (1), windt.
5		wH	17	buried under slash
A				snag, knocked down
xx		wH		under slash, not found

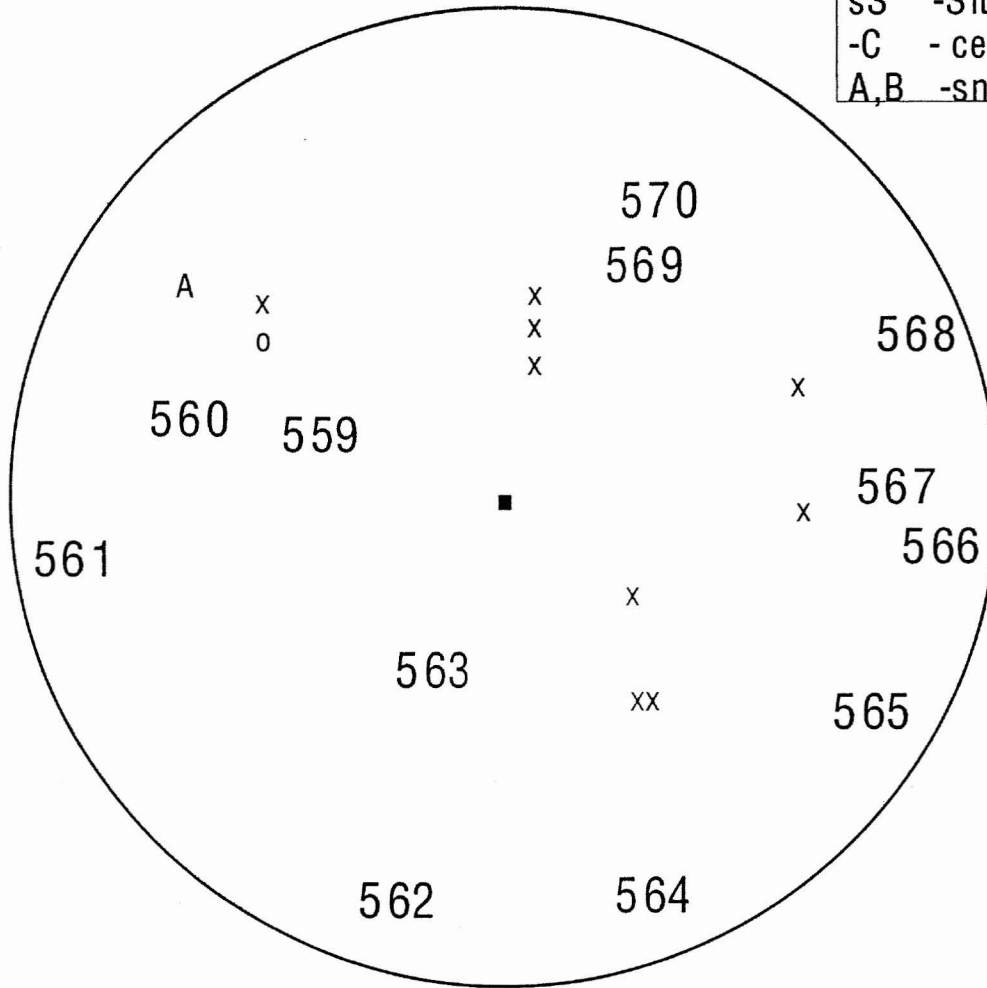
Plot 7 (trail - 0+314)

Original tree no.	New tree no.	Species	DBH	Status
1	559	wH	27	mistletoe (3)
2	560	wH	16	mistletoe (1)
3	561	wH	14	mistletoe (1)
4	563	wH	12	healthy
5	562	wH	16	healthy
6	564	wH	11	healthy
7	565	wH	11	healthy
8	566	wH	12	mistletoe (1), fork
9	567	wH	23	mistletoe (2)
10	568	wH	13	mistletoe (1)
11	569	wH	14	mistletoe (2)
12	570	wH	20	mistletoe (2)
xxx		wH

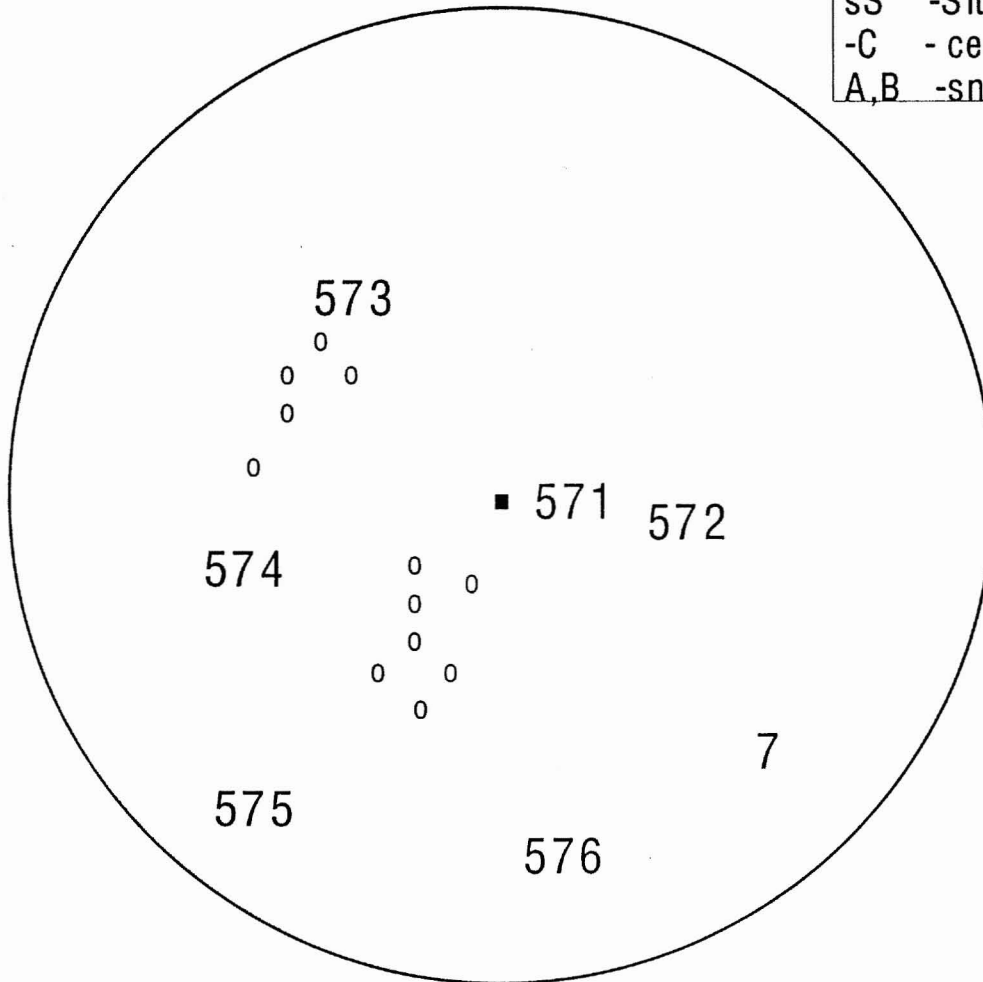
Plot 8 (R.P. - 74)

Original tree no.	New tree no.	Species	DBH	Status
1	571	wH	41	lean, logged
2	572	wH	120	dead top, logged
3	573	wH	20	logged
4	574	wH	37	lean, logged
5	575	wH	38	logged
6	576	wH	31	fork, logged
7		wH	14	crook, felled
xx		wH		destroyed, heavy slash

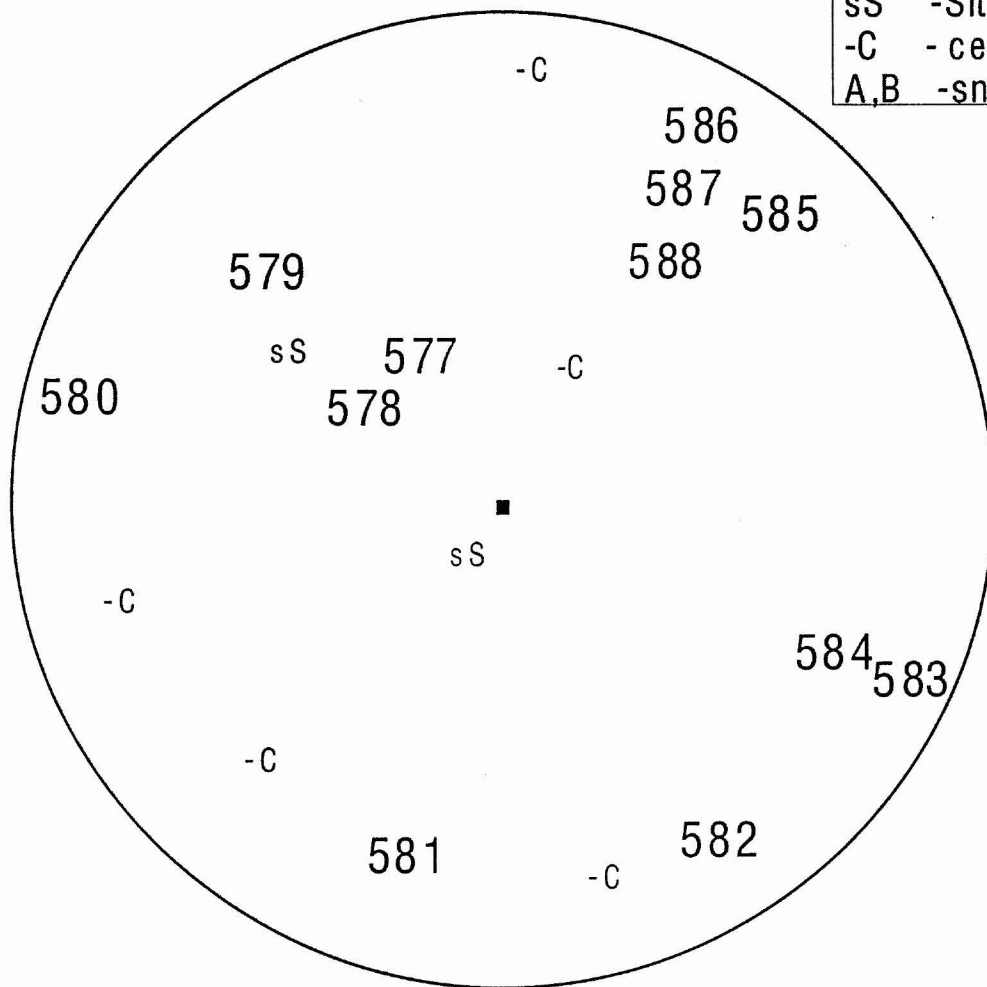
Plot 10 (R.P. - 48)

Original tree no.	New tree no.	Species	DBH	Status
1	577	wH	60	logged
2	578	wH	17	crook, felled
3	579	wrC	9	felled
4	580	wH	13	felled
5	581	wH	13	lean, felled
6	582	wH	34	logged
7	583	wH	17	lean/sweep, felled
8	584	wH	62	lean, logged
9	585	wH	30	logged
10	586	wH	13	crook, felled
11	587	wH	14	felled
12	588	wH	12	felled

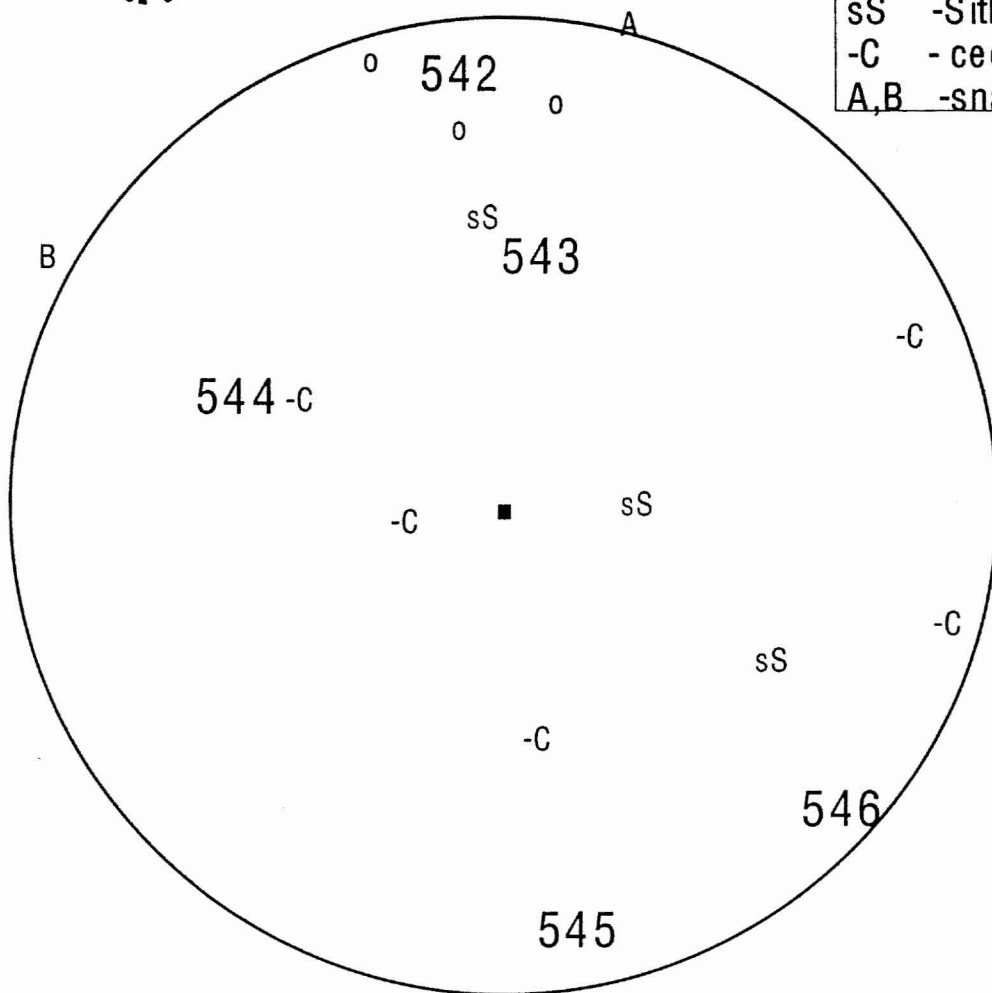
Plot 11 (R.P. - 213)

Original tree no.	New tree no.	Species	DBH	Status
1	542	wH	61	
2	543	wH	14	felled
3	544	wH	27	logged
4	545	wH	69	healthy, dead (beetle?)
5	546	sS	130	f. pini, fork
A, B				snags felled
xx		wH		most destroyed, slash

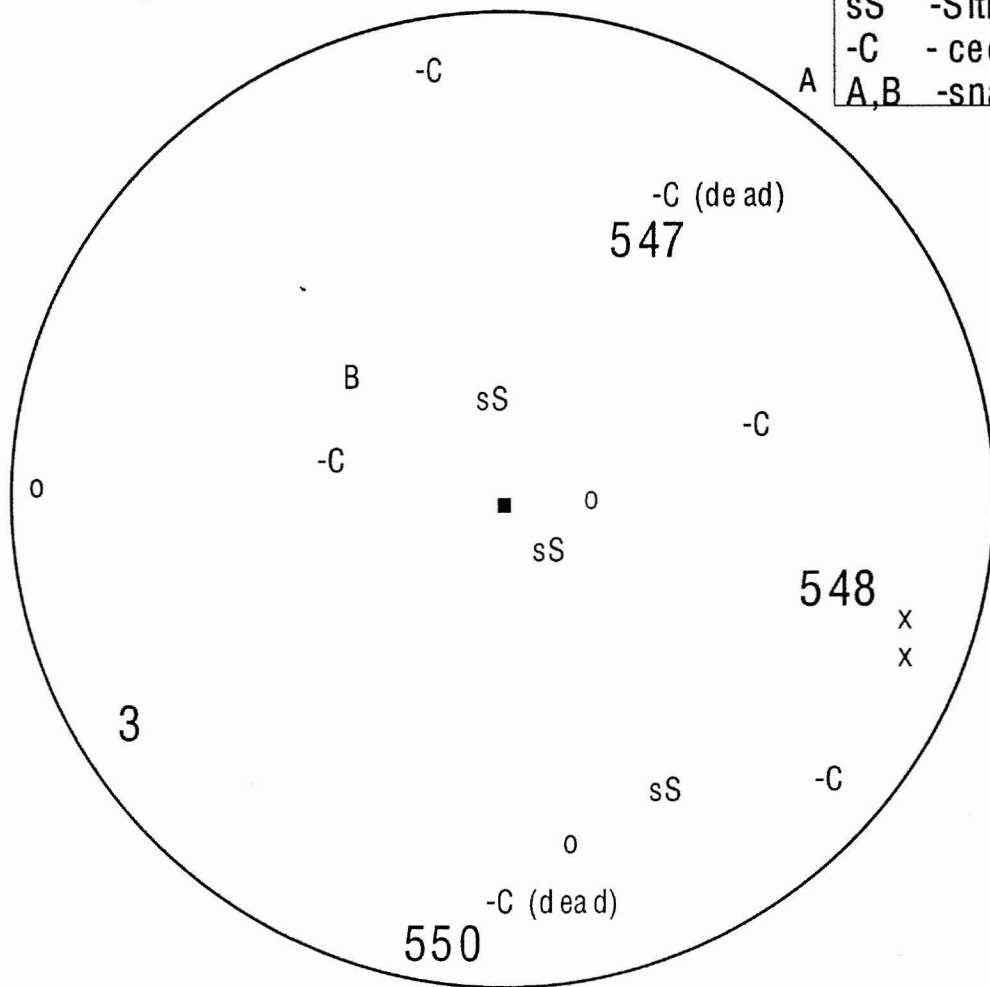
Plot 12 (R.P. - 230)

Original tree no.	New tree no.	Species	DBH	Status
1	547	wH	56	
2	548	wH	49	sapsucker
3		wH	13	crook, felled, not found
4	550	wH	70	sapsucker, conks
A,B				felled
xx		wH		about half lost, slash

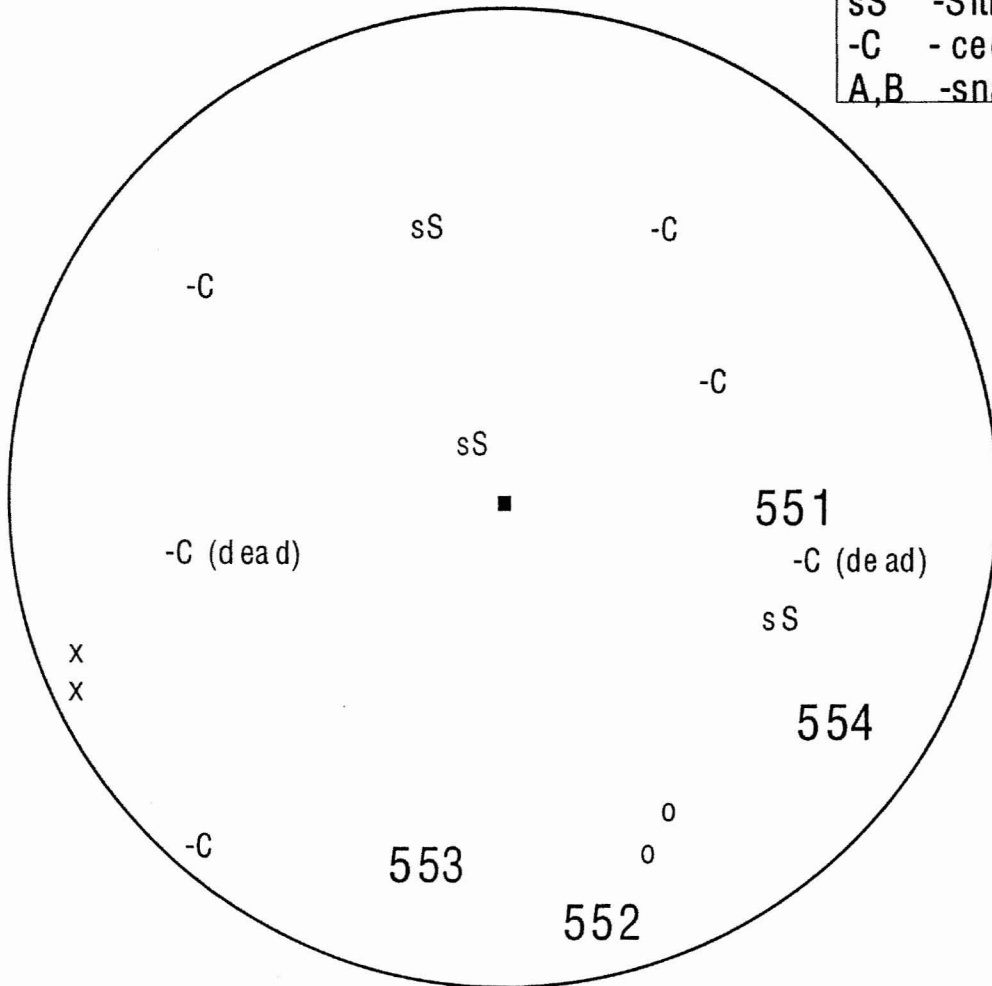
Plot 13 (R.P. - 249)

Original tree no.	New tree no.	Species	DBH	Status
1	551	wH	46	
2	552	wH	37	
3	553	wH	23	brk. top
4	554	wH	34	snag, f. pinicola, felled
xx		wH		about half lost, slash

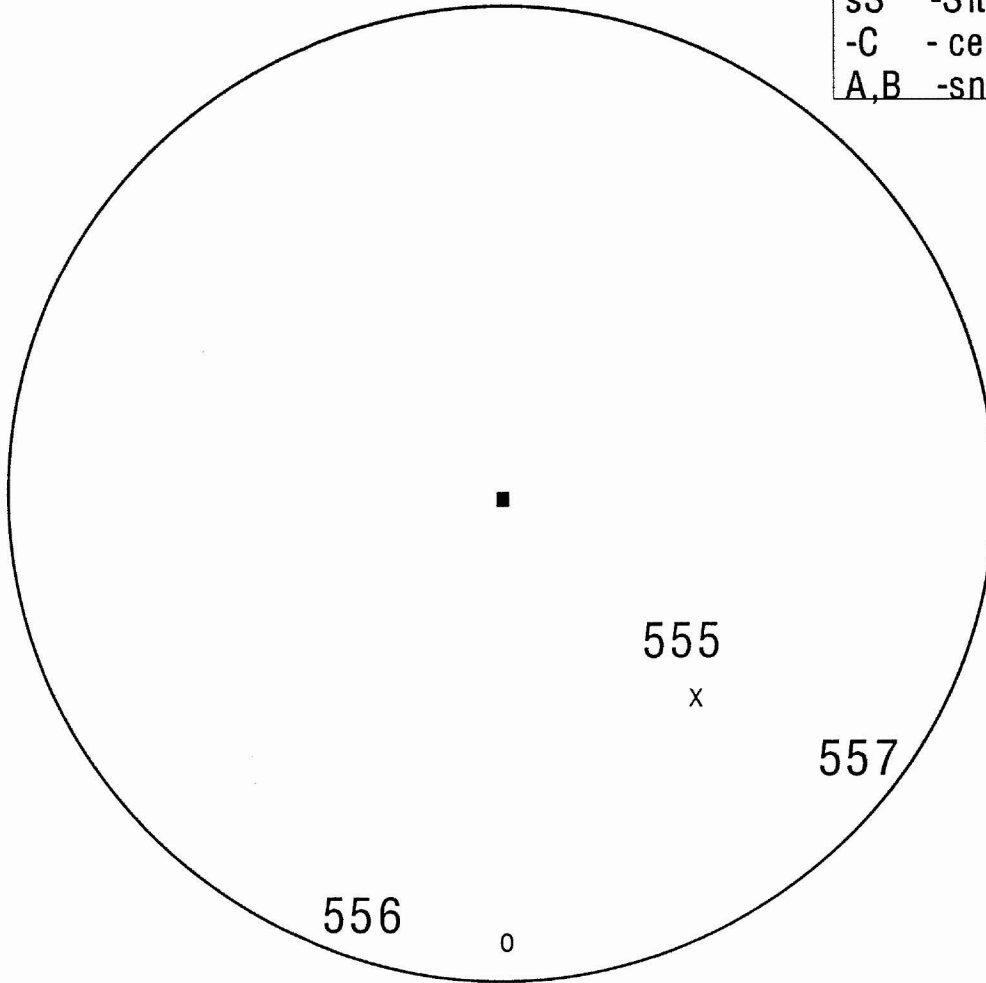
Plot 14 (trail - 1529)

Original tree no.	New tree no.	Species	DBH	Status
1	555	wH	19	
2	556	sS	87	dead branches
3	557	wH	39	
xx		wH		1 of 2 missing

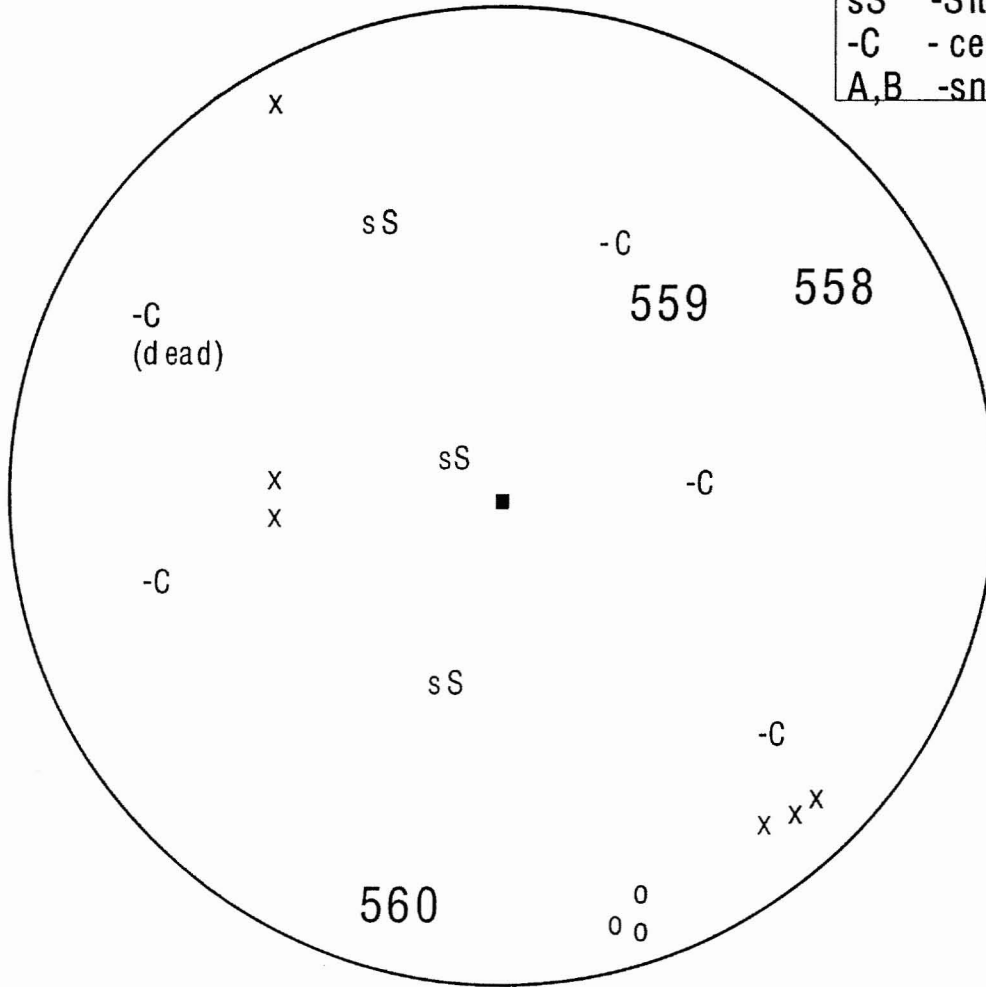
Plot 15 (R.P. - 181)

Original tree no.	New tree no.	Species	DBH	Status
1	558	wH	16	crook
2	559	wH	21	fork/sweep
3	560	wH	35	healthy, sap sucker
xx		wH		some under slash

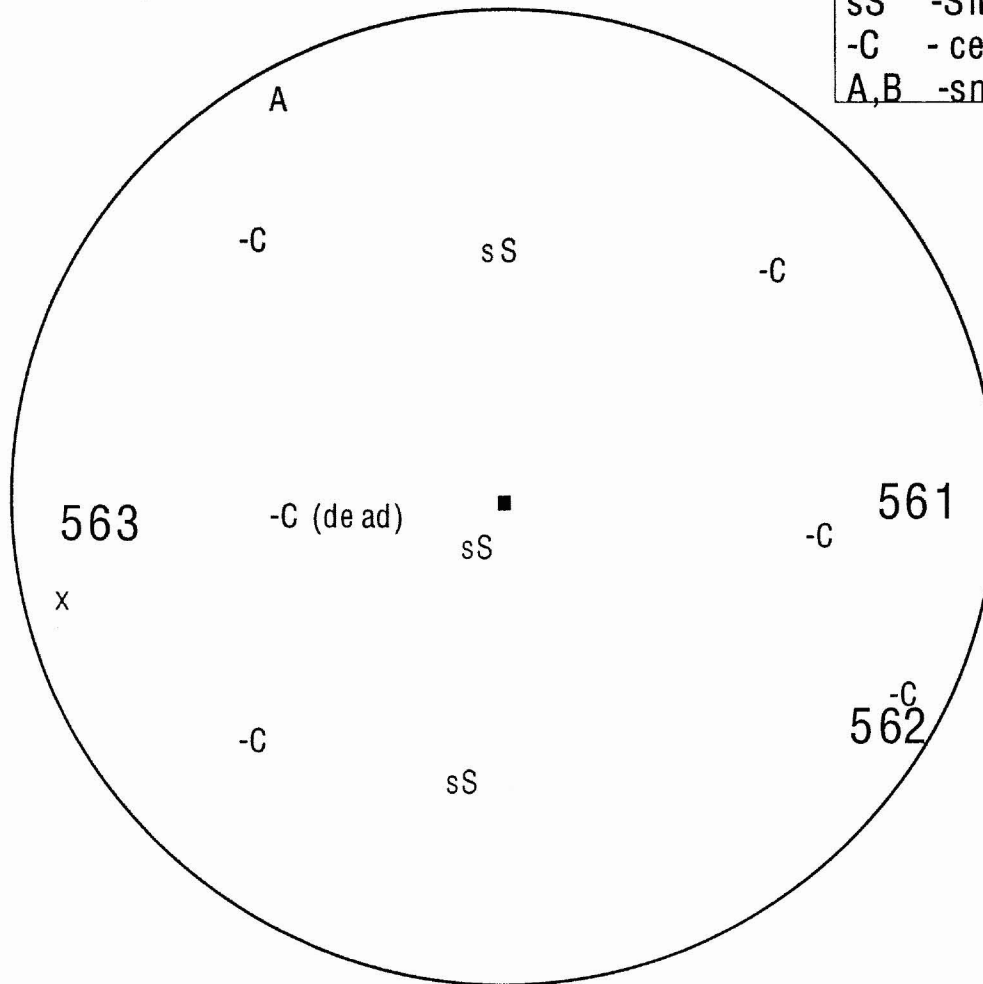
Plot 16 (R.P. - 134)

Original tree no.	New tree no.	Species	DBH	Status
1	561	wH	59	crook/scar, logged
2	562	wH	65	sweep, logged
3	563	wH	34	brk. top, logged
xx		wH

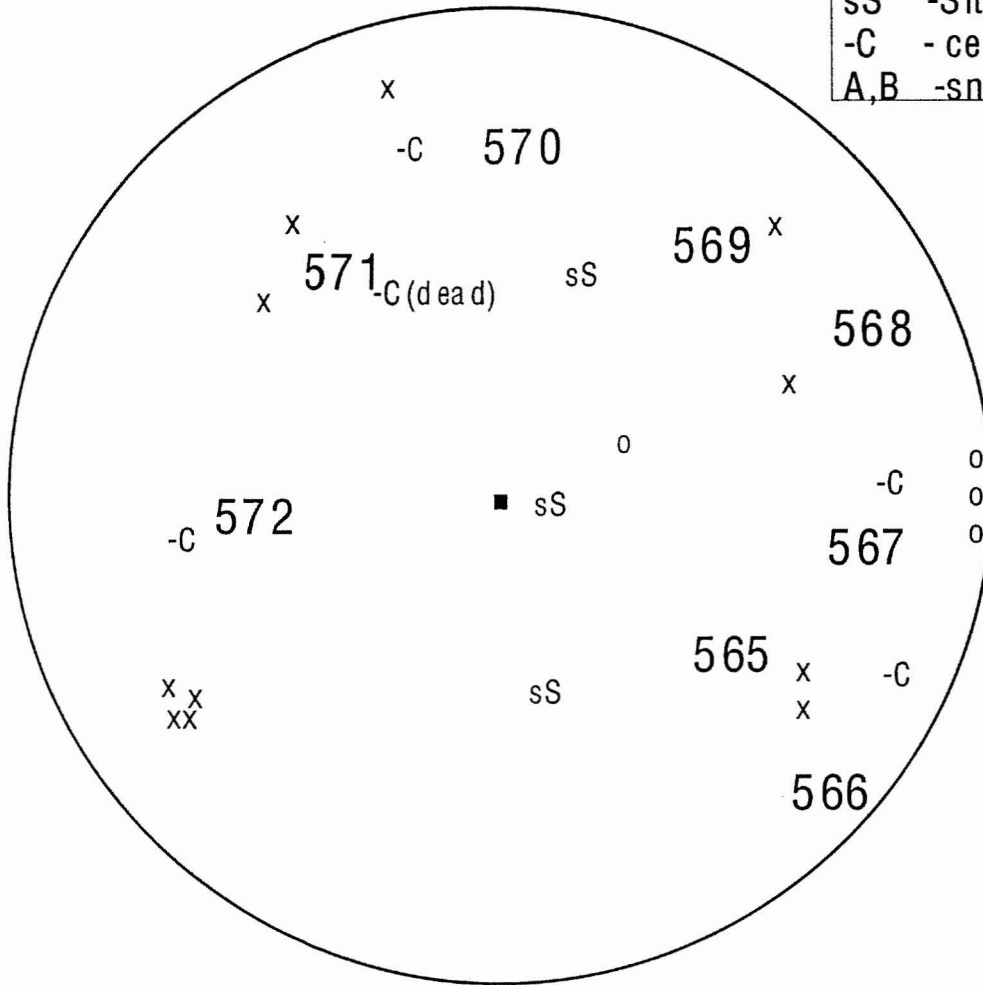
Plot 18 (R.P. - 85)

Original tree no.	New tree no.	Species	DBH	Status
1	565	sS	73	logged
2	566	wH	23	crook, logged
3	567	wH	33	logged
4	568	sS	63	logged
5	569	wH	47	brk. top, logged
6	570	sS	84	
7	571	sS	85	
8	572	wH	58	sweep, sapsucker
xx		wH		about half lost, slash

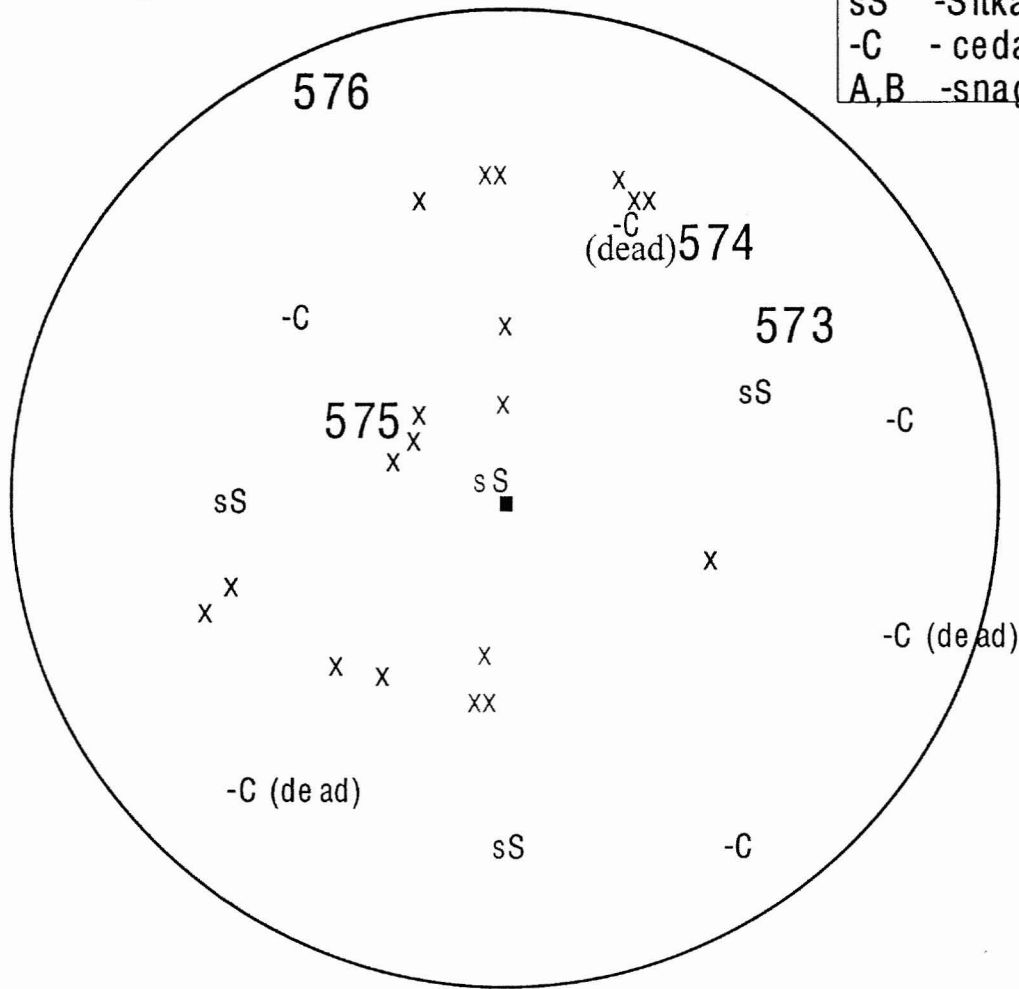
Plot 19 - (R.P. - 89)

Original tree no.	New tree no.	Species	DBH	Status
1	573	wH	43	dead top, logged
2	574	wH	38	brk. top, logged
3	575	wH	77	logged
4	576	wH	42	frost crack, logged
xx		wH		most intact, drought stressed
