Voyageur air cushion vehicle trials on the Mackenzie Delta: Environmental effects two years later

Information Report NOR-X-146

December 1976

northern forest research centre
edmonton, alberta

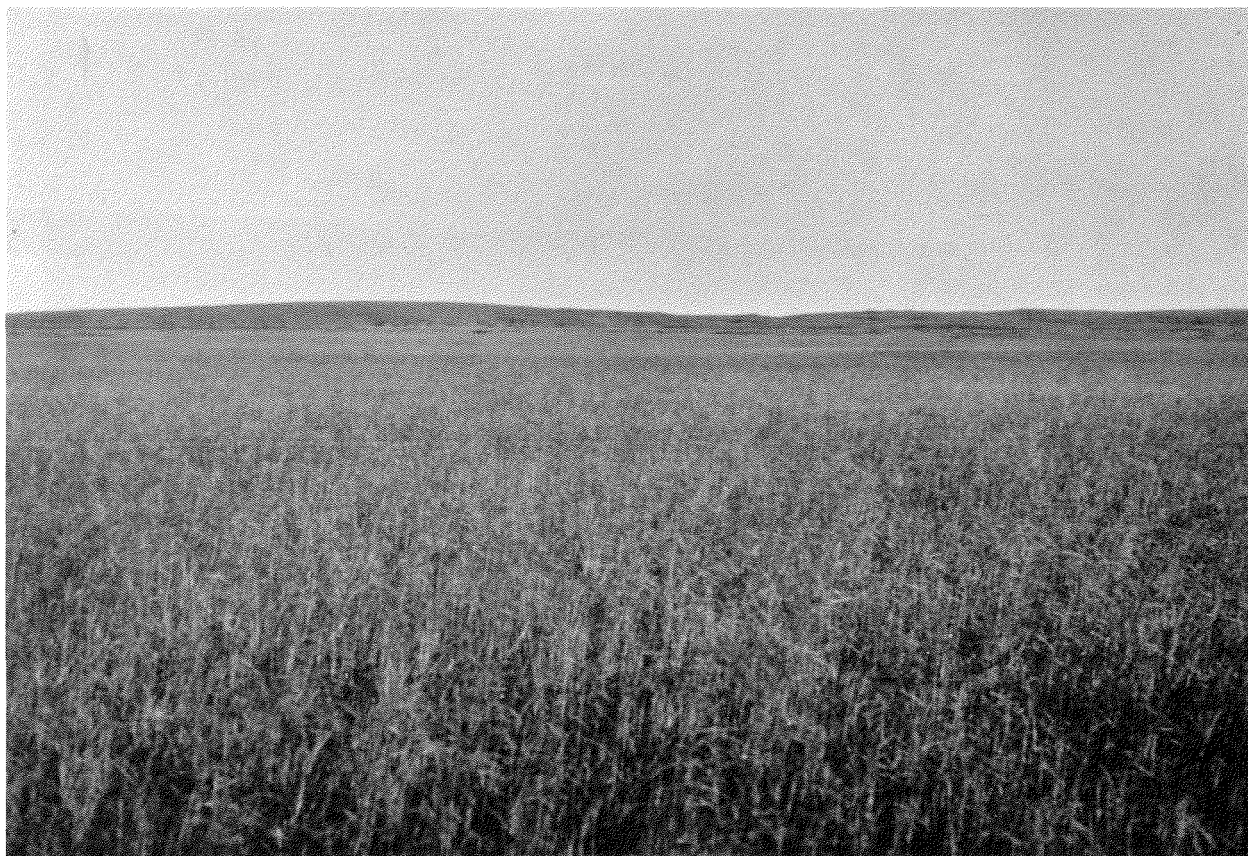
Figure 3. Ground view of the disturbed sample plot on the lowland tundra.

Trial Course 9 on which the disturbed PSP is located had been subjected to 20 passes by the ACV. This course was still visible from the air (Fig. 2), but it was not discernible on the ground (Fig. 3). A close inspection of the ground showed that many old *Carex* blades were lying flat and aligned in the same direction. This was probably caused by the blast of air issued from the ACV. The height of culms (flowering stems) of living *Carex aquatilis* was the same on both the control and disturbed plots (Table 2).

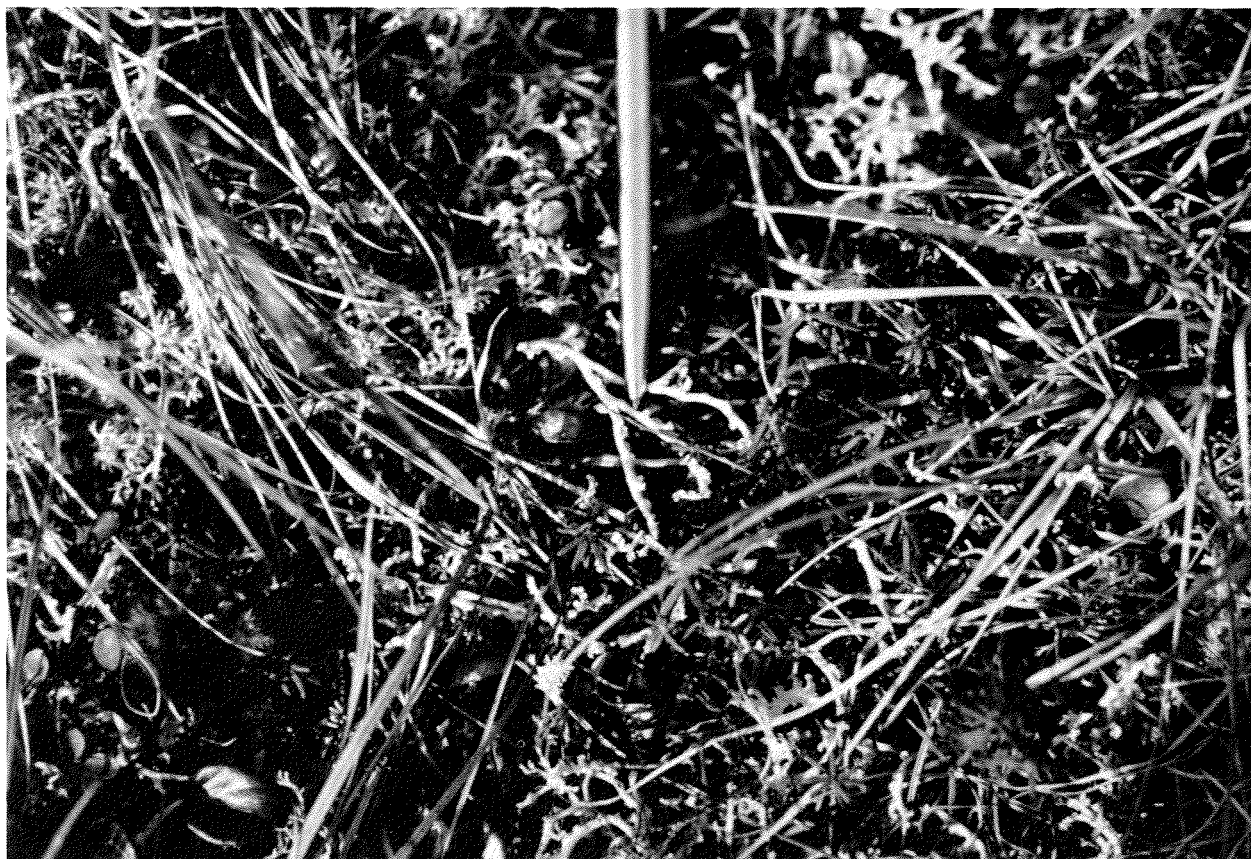
Figure 5. Detached and redistributed *Cetraria cucullata* thallus at tip of pen.

The trial courses were well visible from the air (Fig. 4). On the ground, signs of disturbed vegetation were everywhere. The most common evidence was the occurrence of displaced lichens, mainly *Cetraria cucullata* thalli (Fig. 5). A check of five small (10 cm x 10 cm) random plots showed that about 10 percent of the thalli on the disturbed plot was displaced. These thalli did not differ in appearance from the undisturbed ones, but many had landed upside down or in small pools of water, so their viability was questionable. Broken, displaced alder and willow shrubs were further evidence of damage. Alders appeared to be more susceptible to breakage than willows. Most breakage occurred near the root collar, resulting in a split main stem (Fig. 6). Small clumps of dense *Dicranum* (cf. *fuscens*) cushions were torn up and displaced. Some *Carex* tussocks were also split and uprooted, and the uprooted portions were dead (Fig. 7).

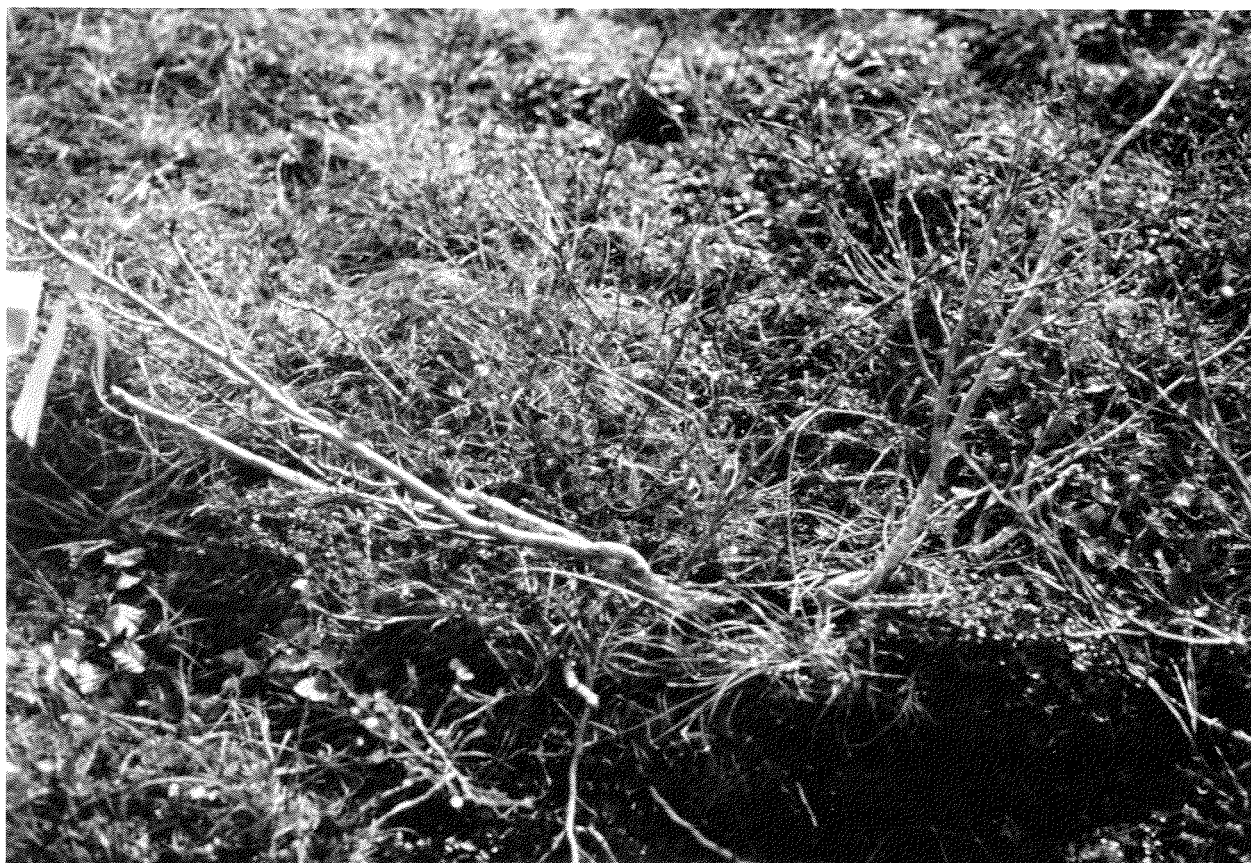
Figure 7. Disturbed upland tundra vegetation. Note torn and dead *Carex* at the tip of tape and displaced lichen below the tape near the 13-in. mark. The tape case is resting against a chunk of uprooted *Dicranum*.

Photos appearing on pages 16 and 17 were inadvertently interchanged. The photo on page 17 is Figure 6, and the one on page 16 is Figure 7.

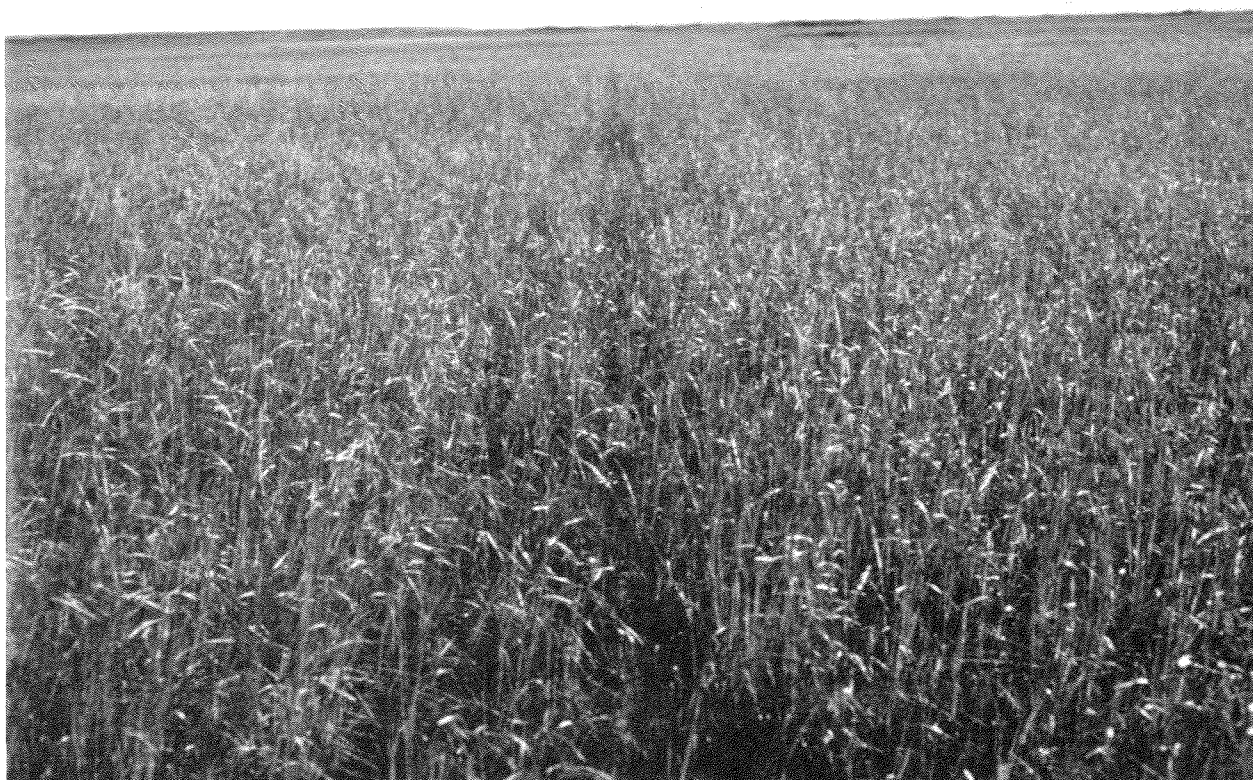
Figure 11. Linear depression in the vegetation on a seismic line.

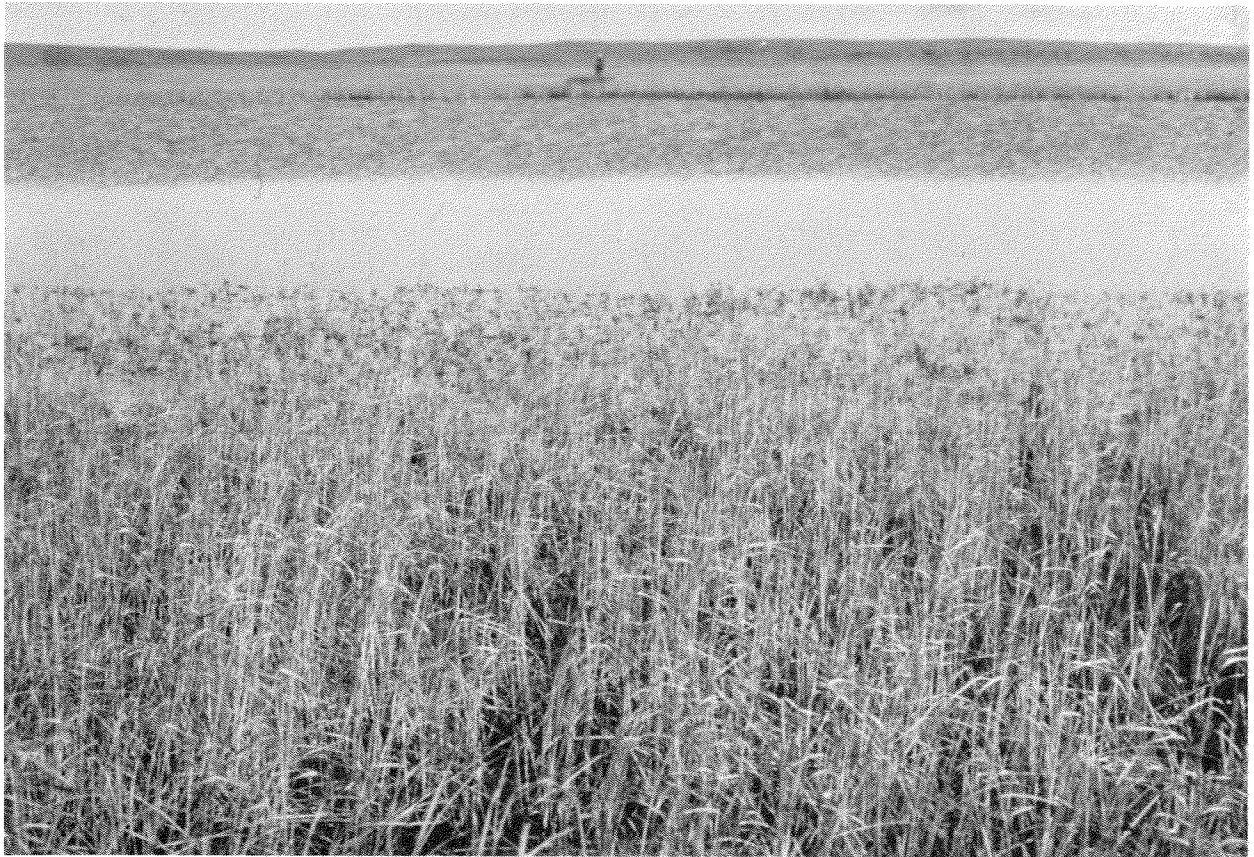
Figure 12. Land-water interface on Trial Course 9.

Trial Courses 6, 8, and 9 had been traversed by the Voyageur 20 times each at various speeds (Table 1). Trial Course 10 had been traversed only once at high speed. The disturbed permanent sample plot is located on Trial Course 9. Trial Courses 6, 9, and 10 were visible from the air, but Course 8 was not discernible (Fig. 2). All trial courses were walked to detect any signs of disturbance, but, as in the case of the PSPs, none were found. Shrubs and grasses were examined enroute; the only noticeable effect was a tendency for the old, dead sedge blades to be aligned parallel to the trial course. By contrast, an older seismic line crossing Trial Course 10 showed a readily discernible linear groove in the vegetative mat of living and dead vegetation (Fig. 11). There was no difference in active layer thickness between the disturbed seismic line and the nearby area. Inspection of the aquatic sites and land-water interface sites, located on Trial Course 9, revealed no changes in appearance or in the composition of the vegetation (Fig. 12).

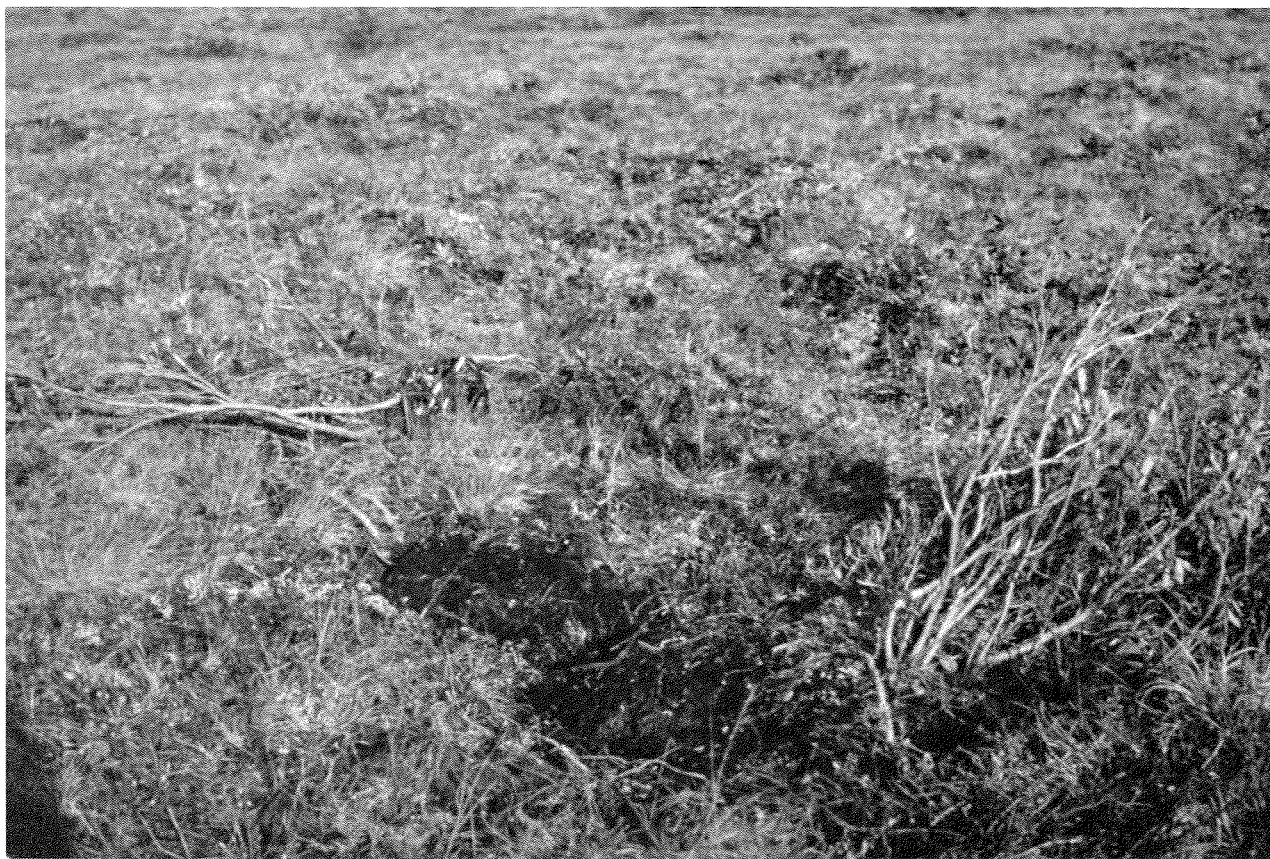
Figure 13. Half of an alder shrub torn out by the ACV, with disrupted ground surface.

Only one instance of terrain damage directly attributable to ACV passage was noted. Half of an alder shrub was torn out of the ground (Fig. 13), resulting in a disrupted organic mat and a slight hollow some 15 cm deep where water had accumulated. No noticeable depression in the permafrost table appeared under the disturbed spot, and all active layer depths were within the
