**SHEAR BEHAVIOUR OF OSB  
WOOD COMPOSITE I-BEAMS  
WITH WEB OPENINGS**

1995

Sammy Wang and J.J. Roger Cheng  
Department of Civil Engineering  
University of Alberta  
Edmonton, Alberta  
T6G 2G7

**A5021-123**

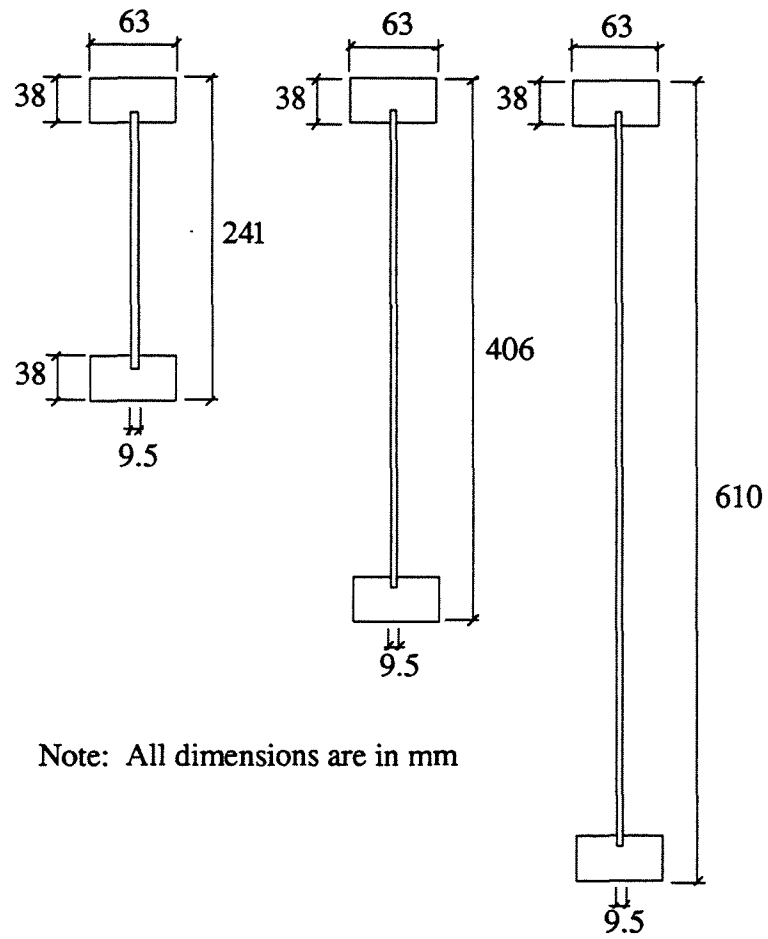
Figure 3.1. Nominal dimensions of OSB I-beam specimens

Note: All dimensions are in mm

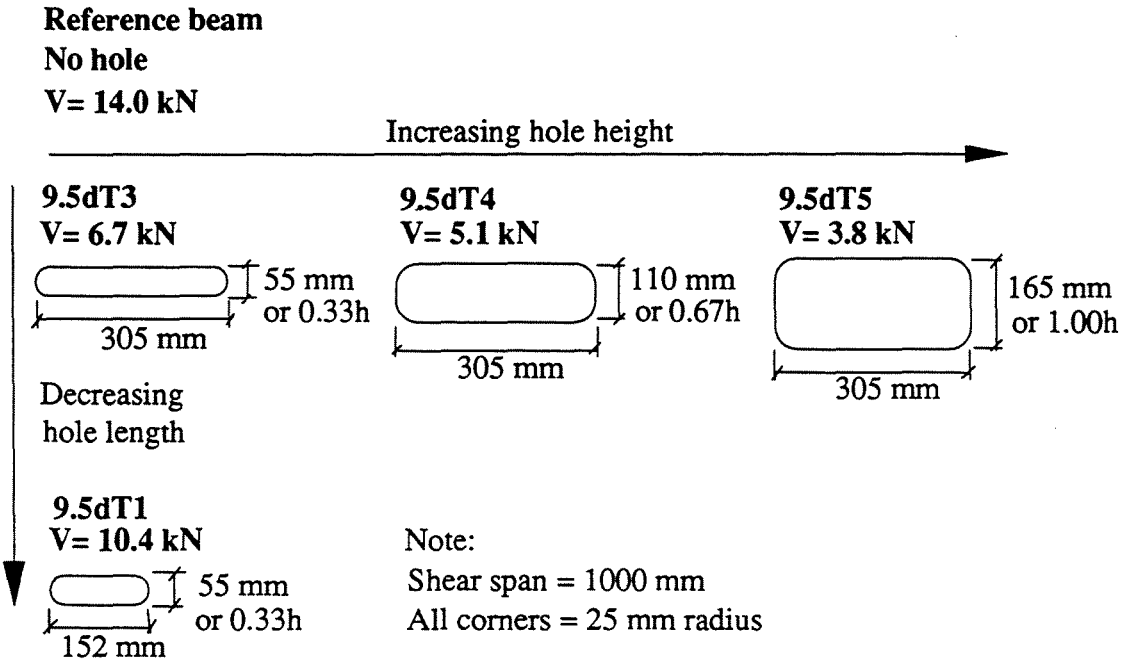
Figure 5.7 Effect of hole size in 241 mm deep beams

Similarly, specimens 9.5dT3, 4 and 5 in Figure 5.7 had the same width dimension of 305 mm, but the hole height varied 55 mm (33% of h), 110 mm (67% of h), and 165 mm (100% of h), respectively. The maximum reduction in shear strength was 73% of the reference beam strength. Specimen 9.5dT1 had a hole 152 mm x 55 mm (33% of h) resulting in a 26% shear strength reduction.

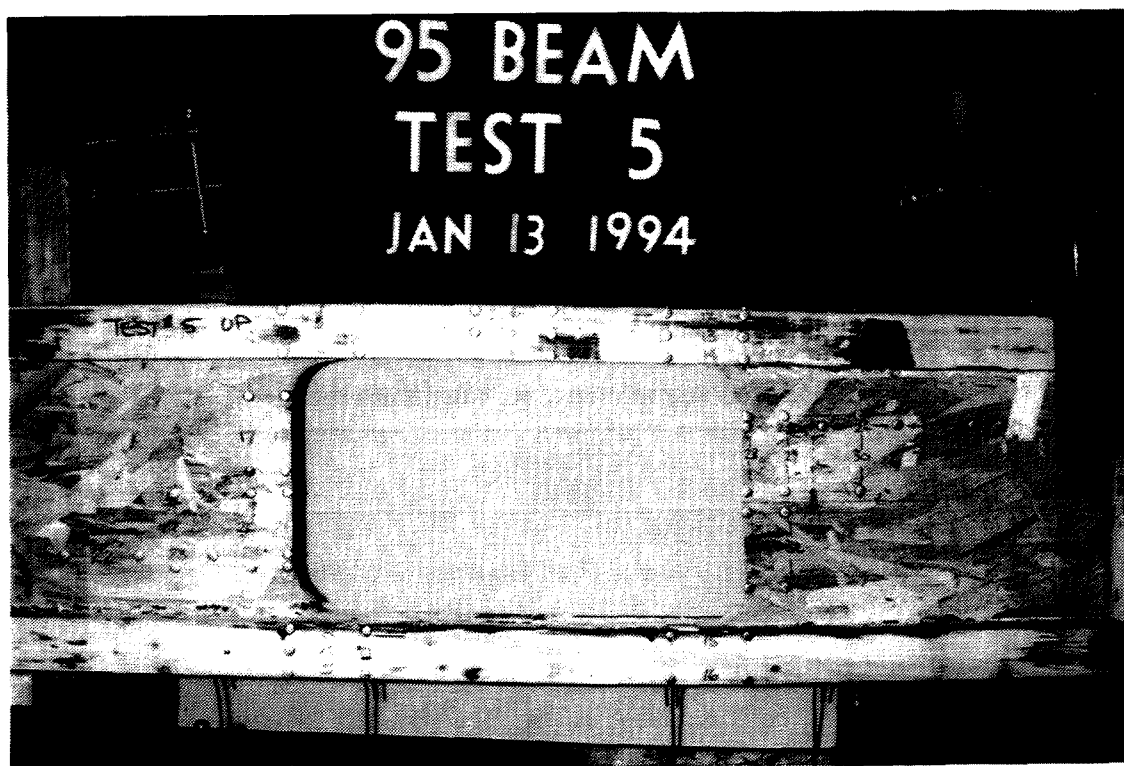
**Figure 5.31. Web/flange connection failure in specimen 9.5dT5**

The tensile forces were easily seen in action at the top right and bottom left "tension corners" of the hole when the height of the hole equaled the full height of the web. Specimens 9.5dT5 and 24dT6 had this hole geometry. As the beam was loaded, the tension corners of the hole developed high tensile strains perpendicular to the flanges of the wood I-beam. The beam deformed to a point where OSB web strands, embedded and glued into the flange lumber, failed in shear next to the web/flange glue line. The web slowly pulled out of the flange as the beam neared its maximum shear strength. Figures 5.1 and 5.3 show how the stiffness of the beam was reduced as the web pulled out of the flange until failure occurred. Figure 5.31 shows the web pulling out of the flange.
