The Alberta Shake Development Program

Final Report

March 14, 1990

**The Lac La Biche
Regional Economic Development Council
Lac La Biche, Alberta**

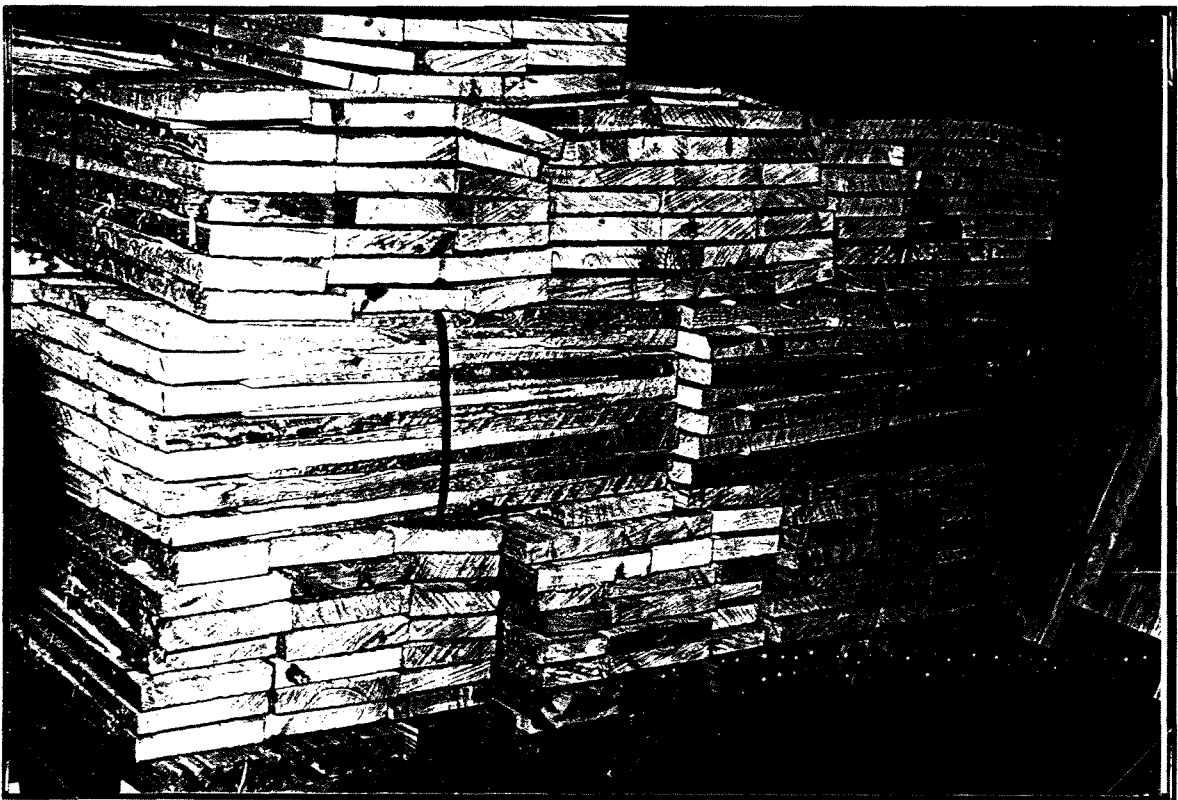
Figure 2. Taper sawn shakes ready for shipment to Texas Forest Products Laboratory.

knots and other visible defects. Cedar and southern pine shakes, on the other hand, are essentially knot-free and every effort is made to minimize the amount of flat grain which normally can cause splits and warpage upon exposure. Figures 1 and 2 show some of the green lumber and shake bundles manufactured for this project.

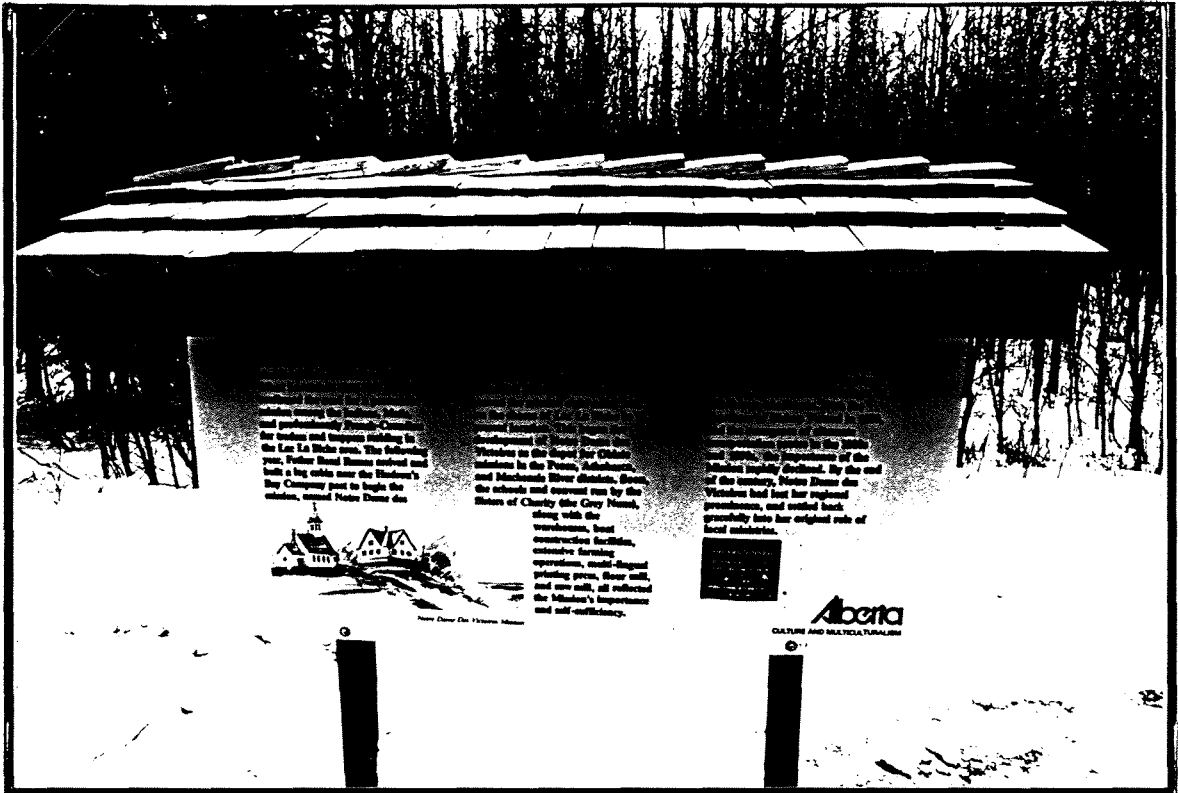
Figure 3. Test roof at Lac La Biche. Untreated jack pine. Installed August 15, 1989.

Figures 3 and 4 illustrate two test roofs installed August 15, 1989 at Lac La Biche, Alberta. One roof is untreated jack pine, the other is jack pine dipped green in Cunapsol. Additional test roofs are scheduled to be installed in 1990.

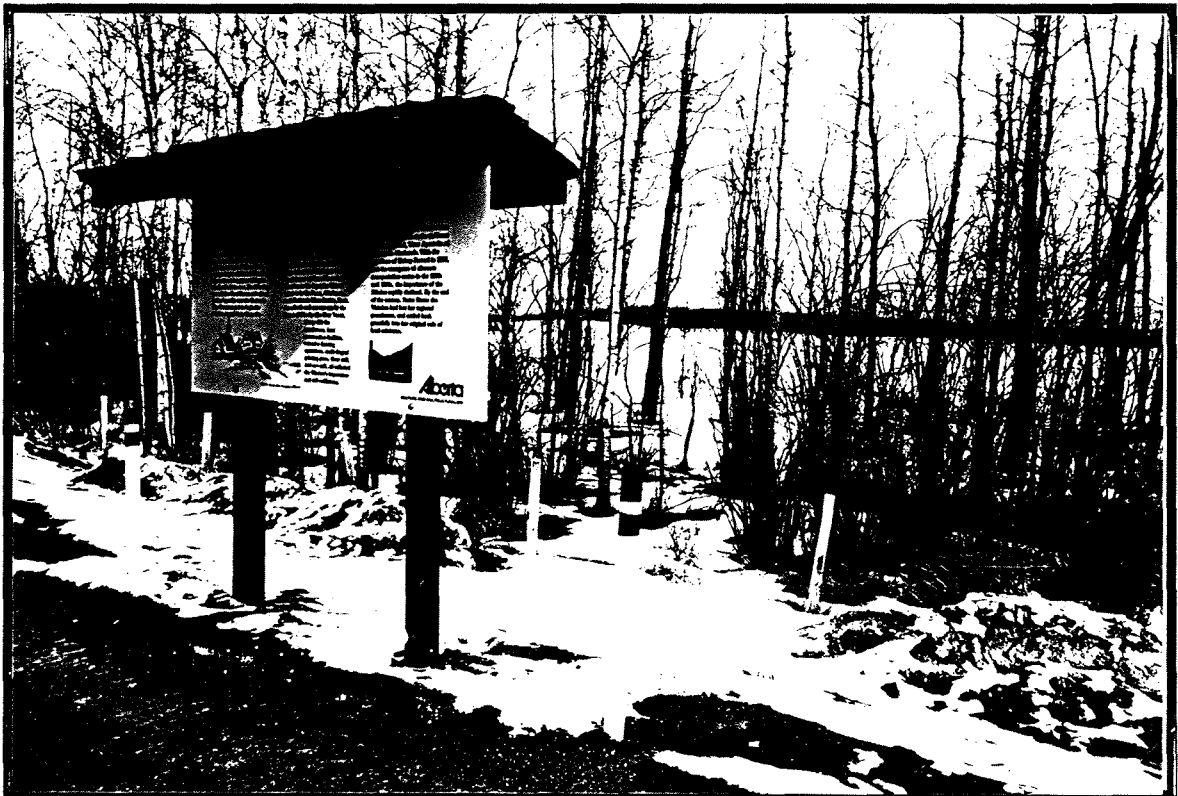
Figure 4. Test roof at Lac La Biche. Jack pine - dipped green, Cunapsol. Installed August 15, 1989.

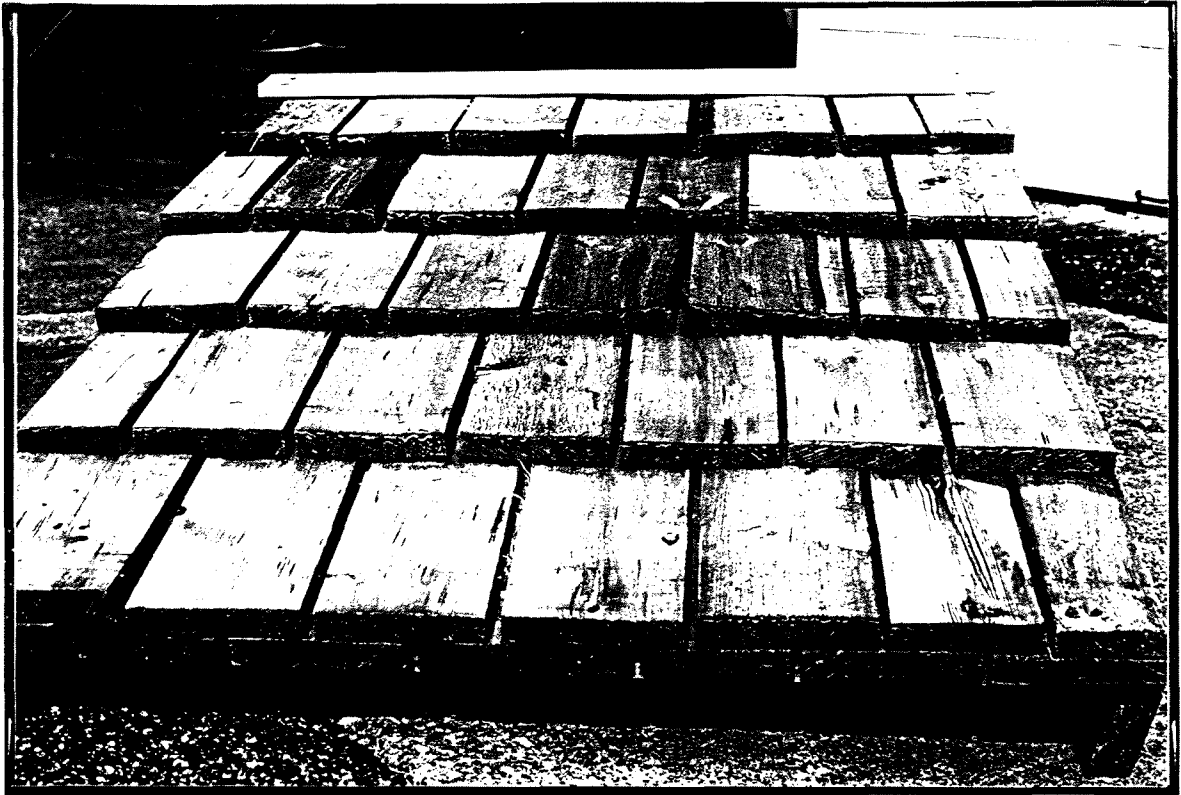
Figure 12. Jack pine - untreated; after 14-week rain test (accelerated weathering).

The leaching effect of the 14-week rain test is equivalent to approximately 800 inches of rainfall. Results from field studies in Texas with dip treated southern pine shakes (in Cunapsol) show no mold, mildew or decay after 5 years. These results are impressive considering the decay potential in East Texas. Untreated southern pine shakes will normally last only 2 to 3 years before being destroyed by decay fungi.

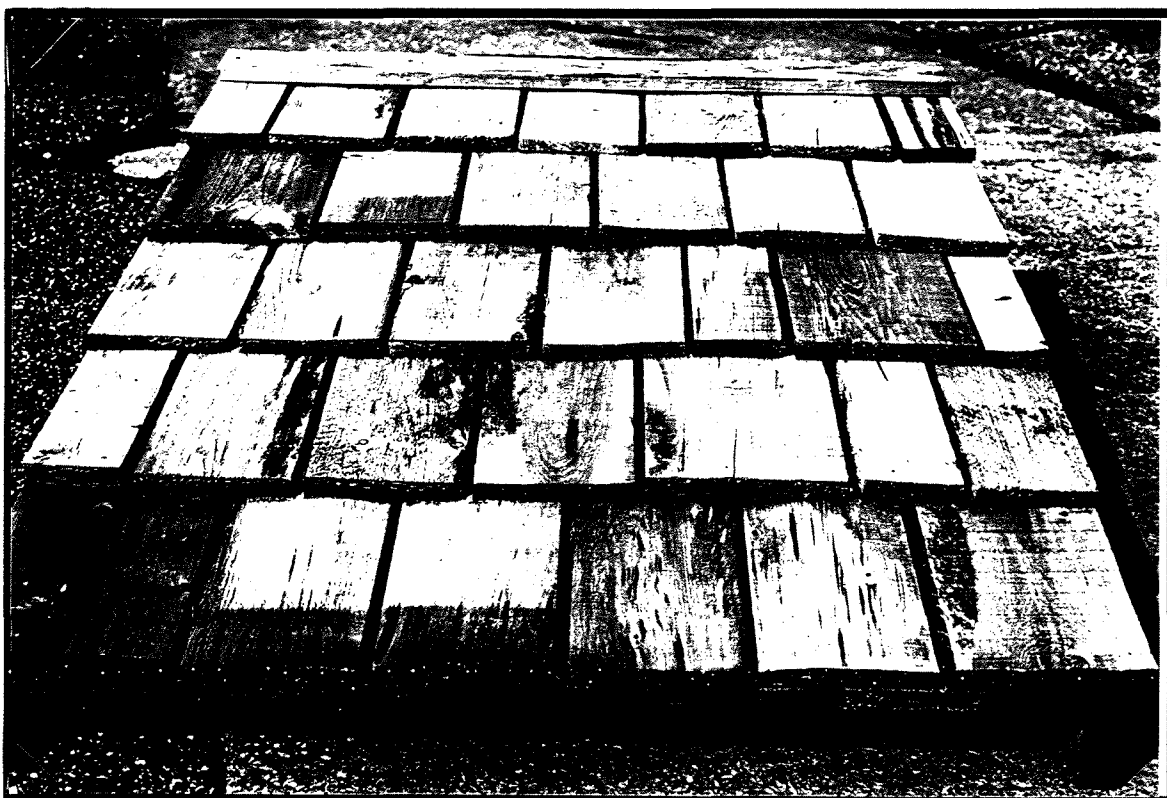
Figure 14. Jack pine - dipped dry, Cunapsol; after 14-week rain test (accelerated weathering).

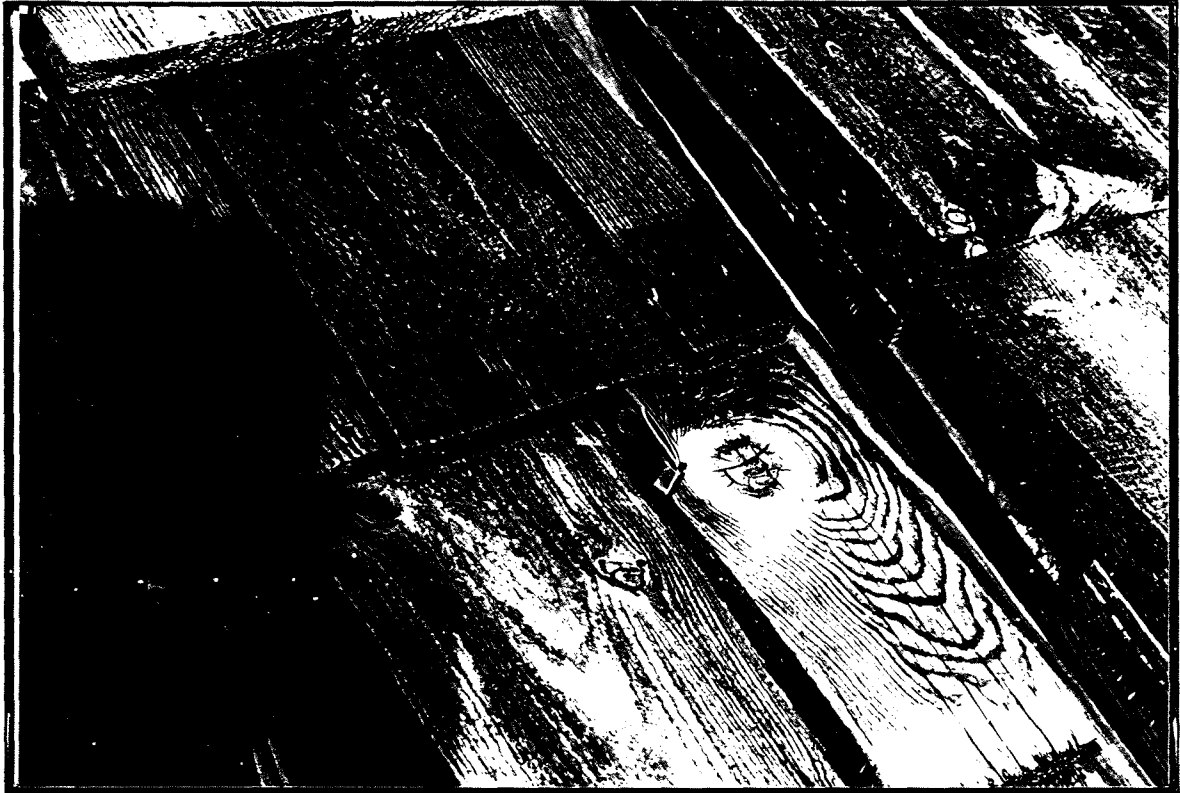
Figure 18. Lodgepole pine - dipped dry, Cunapsol; after 14-week rain test (accelerated weathering). Note major split in flat sawn portion of shake.

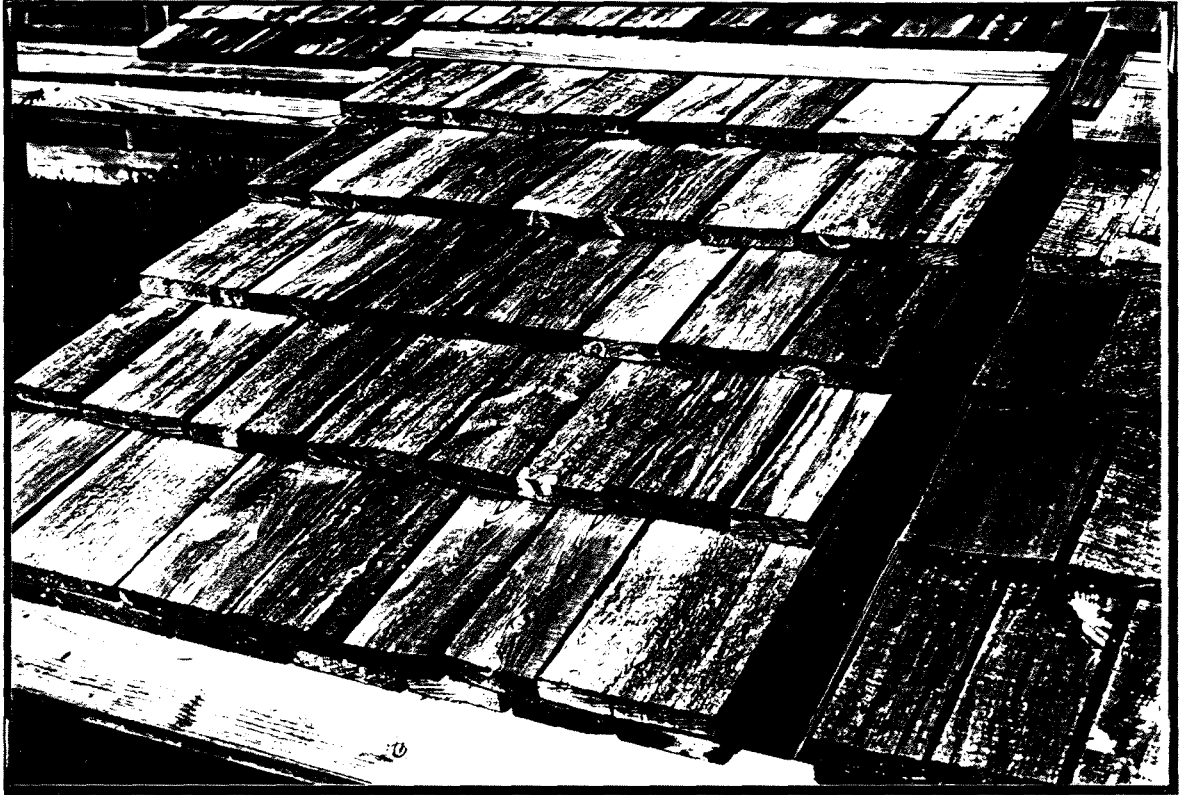
**Figure 23. Jack pine - untreated. Field exposure test, Hudson, Texas.
Installed 7/29/89. Photographed and inspected 2/26/90.**

Figures 23 to 47 illustrate the field exposure trials at Hudson, Texas. These photographs were taken February 26, 1990, approximately 7 months after the shakes were installed. Clearly, this relatively short period of outdoor exposure was more severe than the 14-week rain test. Furthermore, the Texas climate is much harsher than the western Canadian climate (much more heat, rainfall, humidity, decay, insects, fungi, etc.). Outdoor exposure in east Texas is a real "acid test" - if shakes can hold up under these conditions, then they should perform satisfactorily anywhere. It should be remembered that these test decks are constructed from ungraded shakes which are known to contain a variety of defects. The field exposure trials should help to determine the relative significance of different defects, and will help determine quality standards which should be followed.

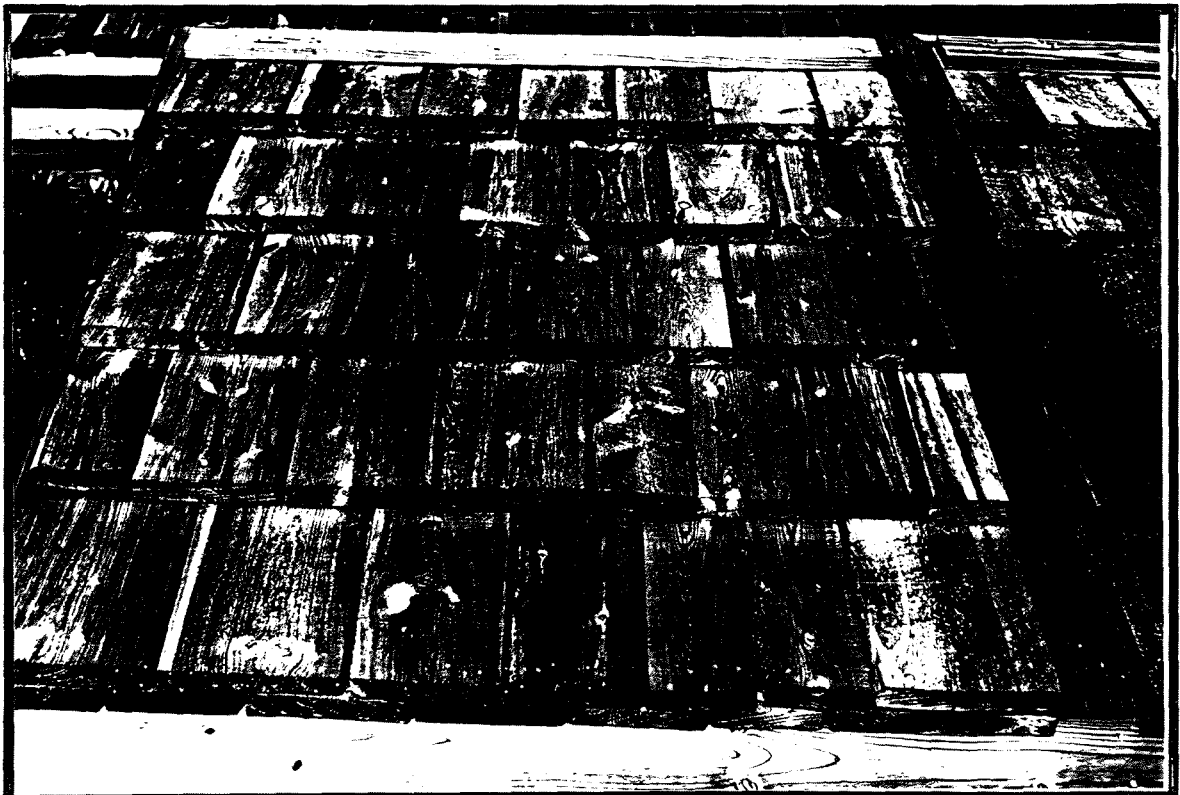
**Figure 24. Jack pine - untreated. Field exposure test, Hudson, Texas.
Installed 7/29/89. Photographed and inspected 2/26/90.**

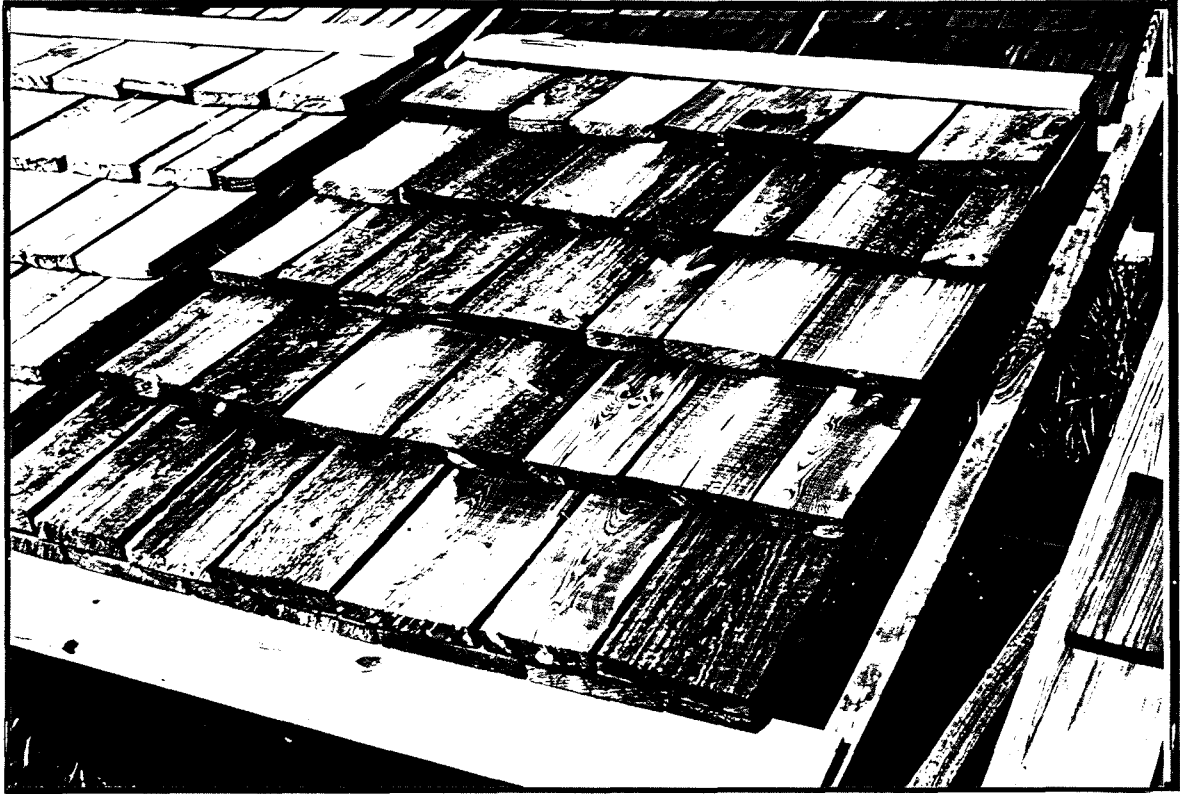
**Figure 29. Jack pine - dipped green, Cunapsol. Field exposure test, Hudson, Texas.
Installed 7/29/89. Photographed and inspected 2/26/90.**

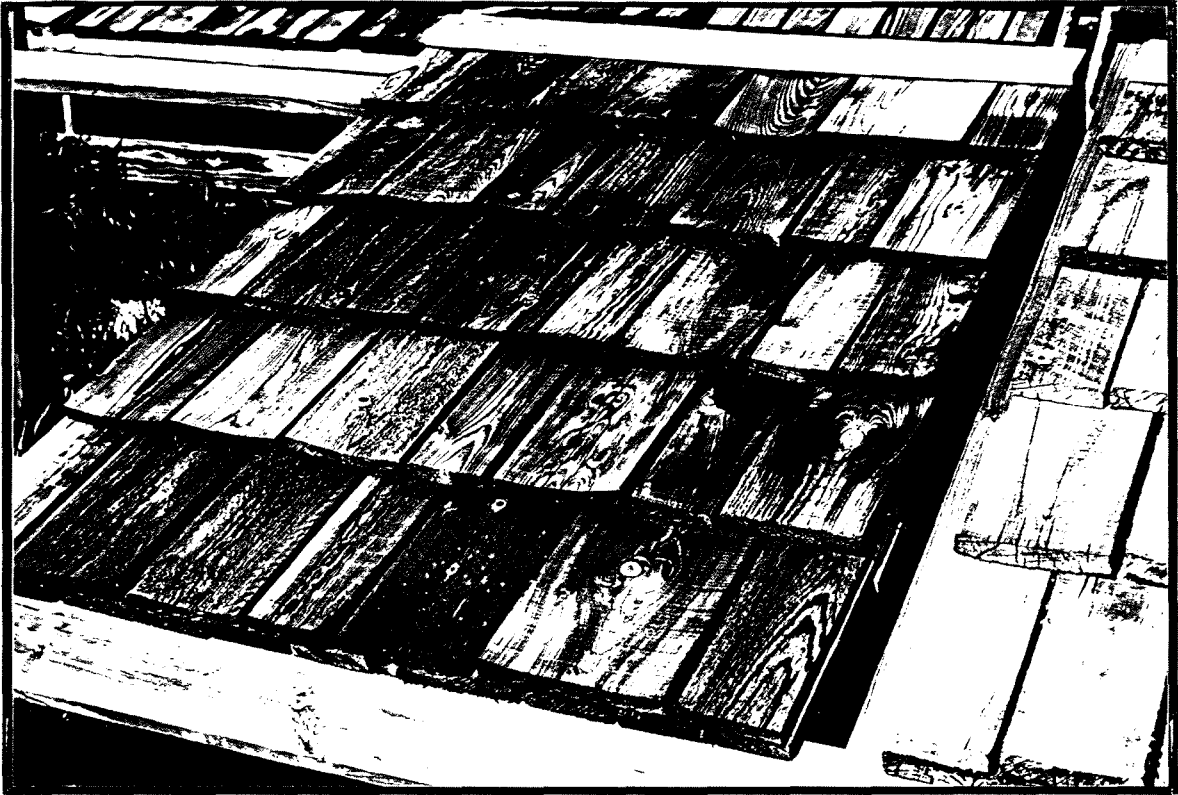
Figure 31. Lodgepole pine - dipped green, Cunapsol. Field exposure test, Hudson, Texas. Installed 7/29/89. Photographed and inspected 2/26/90.

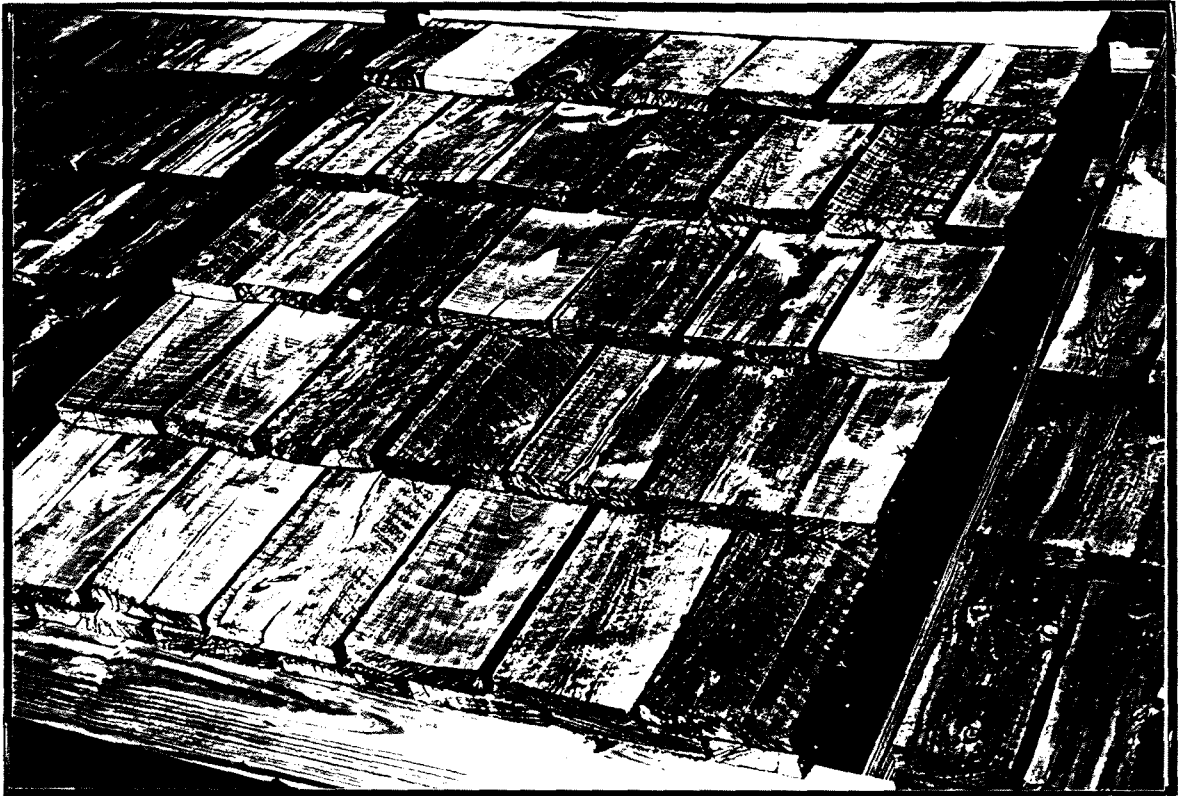
**Figure 33. Aspen - dipped green, Cunapsol. Field exposure test, Hudson, Texas.
Installed 7/29/89. Photographed and inspected 2/26/90.**

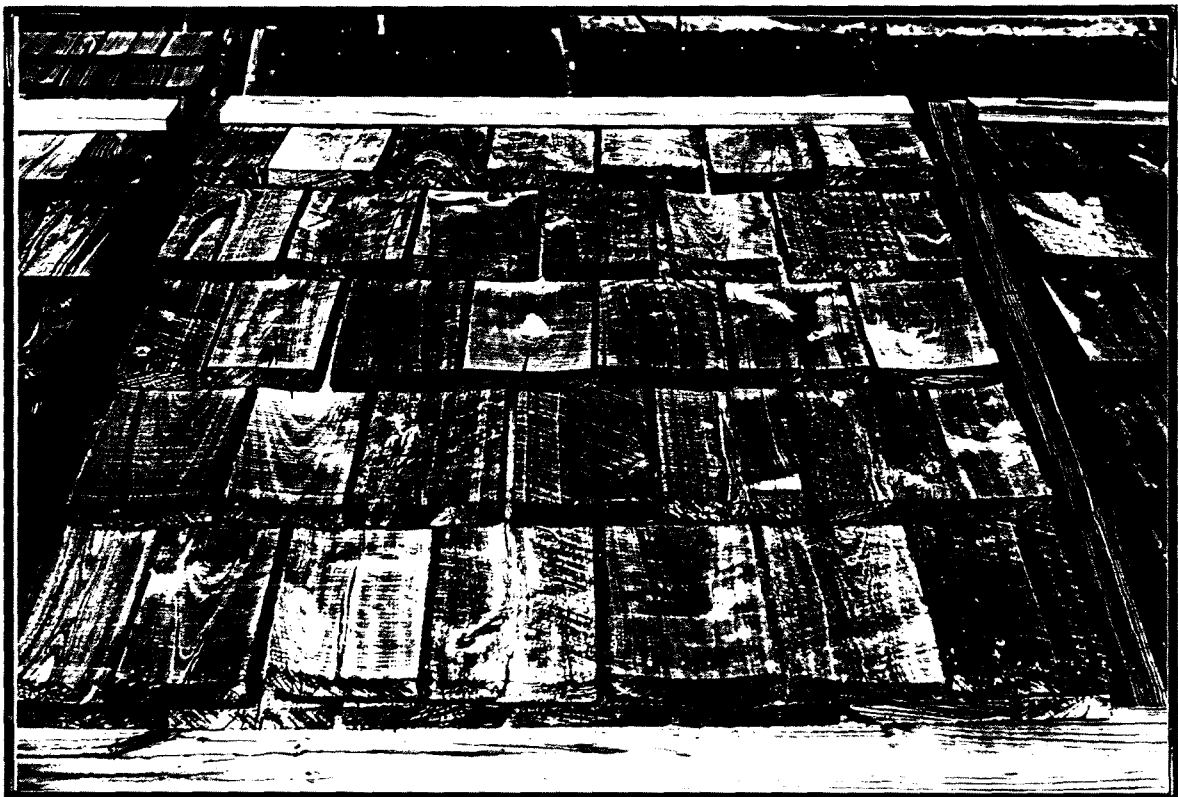
**Figure 34. Aspen - dipped green, Cunapsol. Field exposure test, Hudson, Texas.
Installed 7/29/89. Photographed and inspected 2/26/90.**

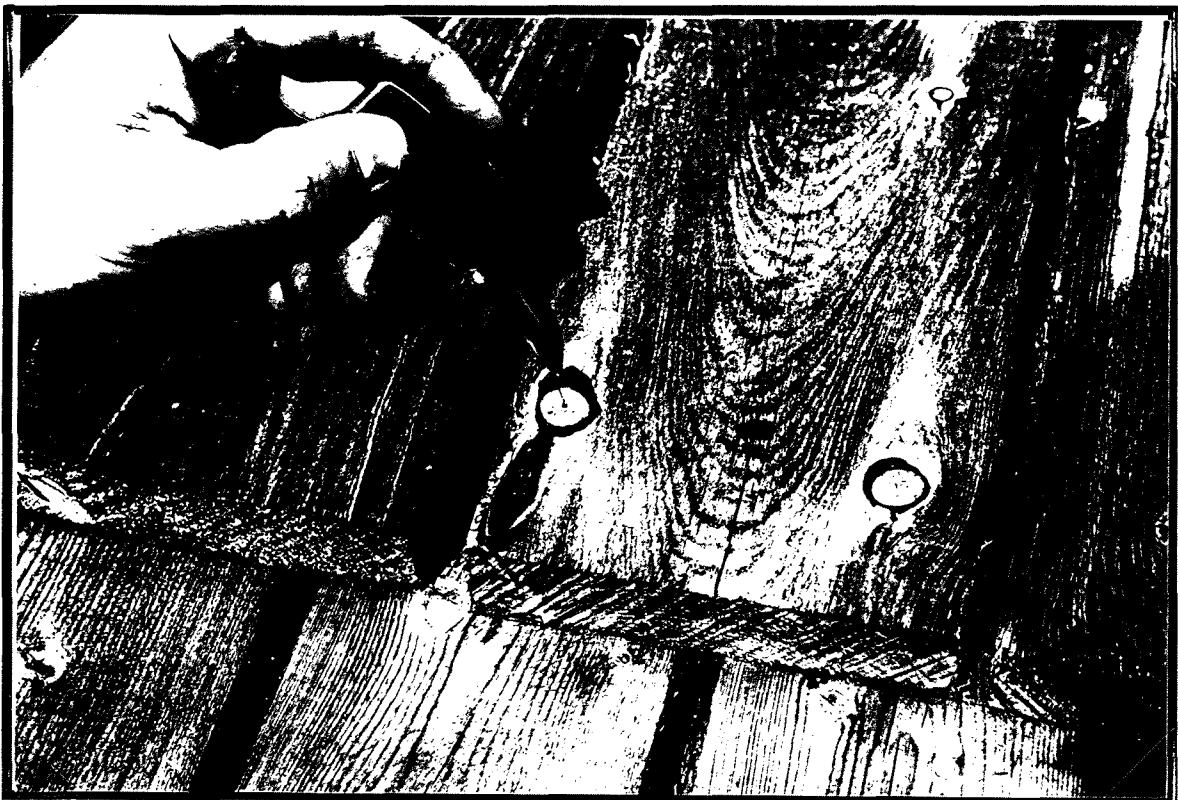
Figure 44. Black ring knot (loose). Jack pine - untreated. Field exposure test, Hudson, Texas. Installed 7/29/89. Photographed and inspected 2/26/90.

- The Cunapsol treated aspen shakes are not performing well. Based on what we've seen to date, we do not recommend use of Cunapsol treated aspen as a roofing shake.
- The jack pine shakes are performing the best, followed by lodgepole pine, and then aspen.
- Jack pine and lodgepole pine should perform very well as roofing shakes provided that quality is maintained and defects are reduced.
- The quality of shake used in the testing (both accelerated weathering and field exposure) for this study is not adequate for a premium roofing shake. The main defects encountered in this study are:
 - flat sawn shakes
 - black ring, and otherwise loose, knots
 - pith portions.

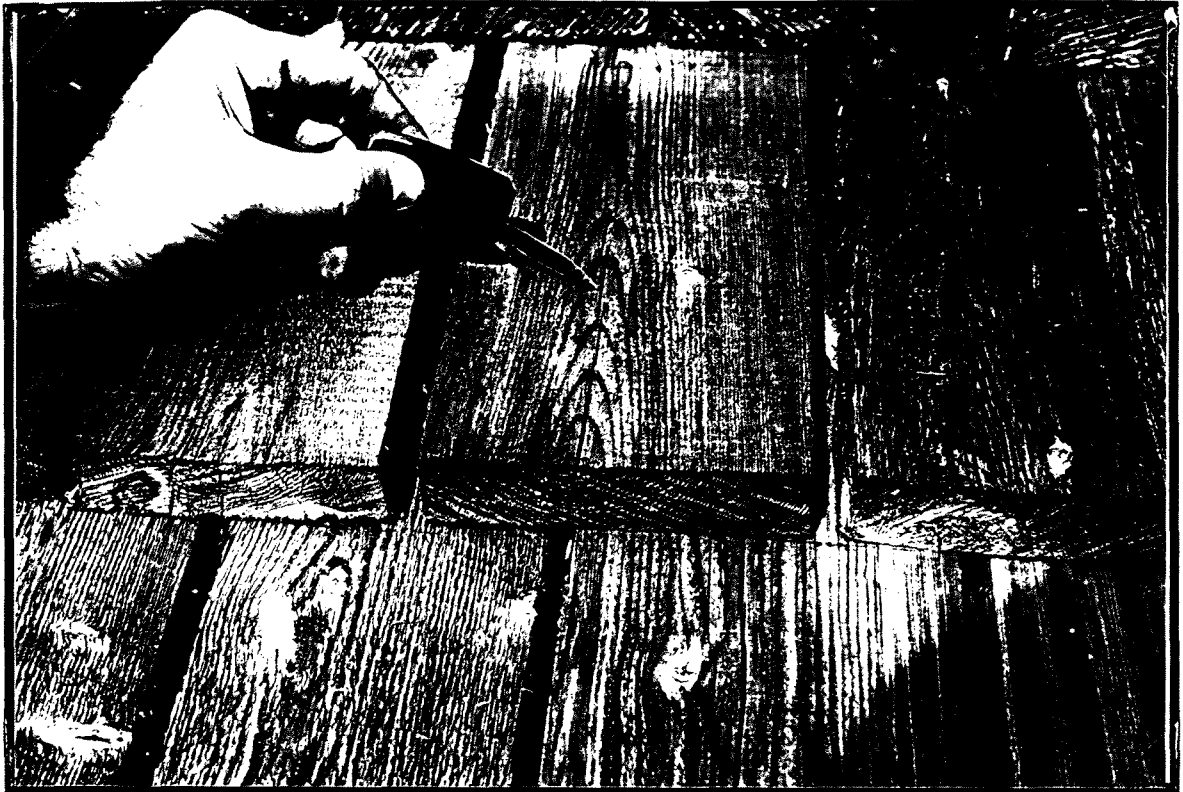
Figure 45. Minor split, flat sawn; Jack pine - untreated; Field exposure test, Hudson, Texas; Installed 7/29/89; Photographed and inspected 2/26/90
