A PROCEDURE TO EVALUATE GROUND DISTRIBUTION PATTERNS FOR WATER DROPPING AIRCRAFT

by
Brian S. Hodgson

**FOREST FIRE RESEARCH INSTITUTE
OTTAWA, ONTARIO
INFORMATION REPORT FF-X-9**

**FORESTRY BRANCH
DECEMBER, 1967**

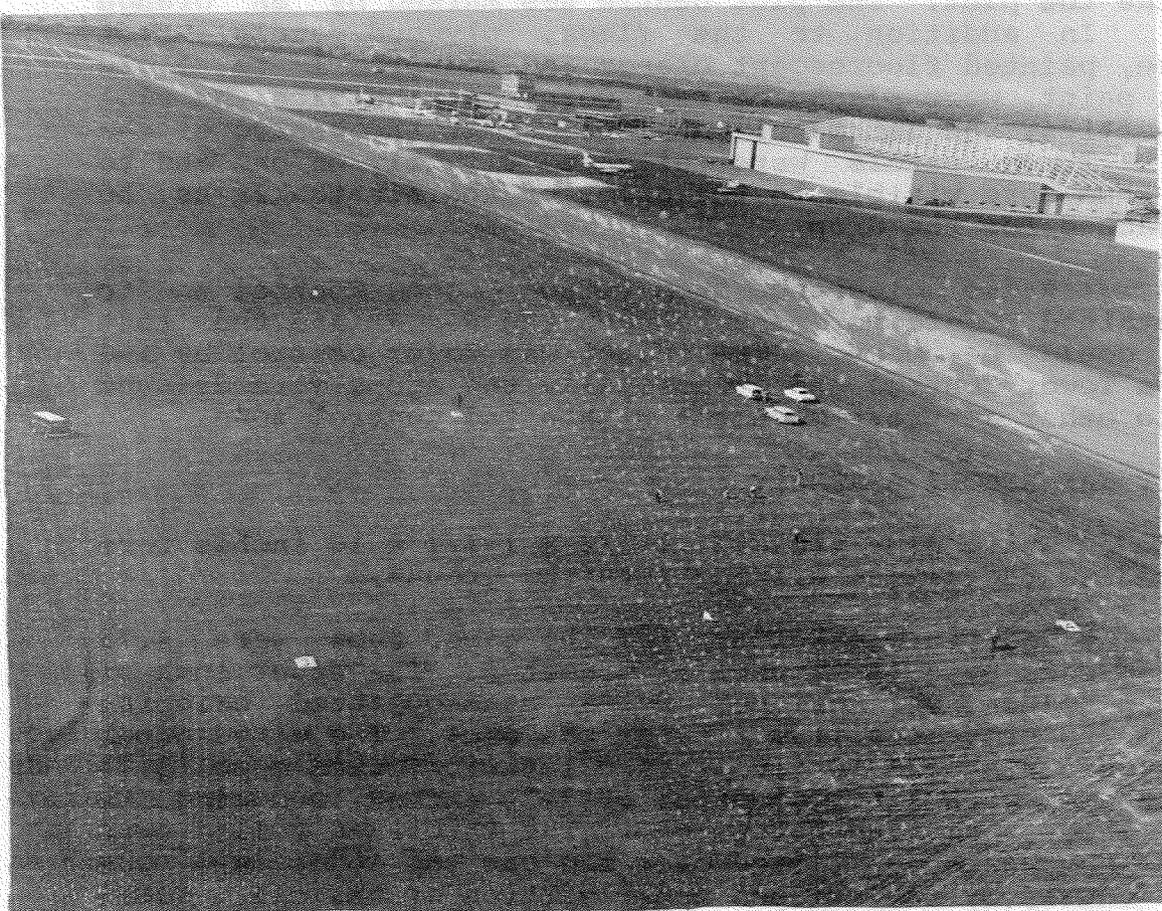
Figure 1. Aerial view of test drop site at Uplands Airport. Note the panel markers and flags.

A plot grid was established at Uplands Airport, Ottawa, in an area between the main runway 25 and taxiway E (Echo) at the junction of taxiway D (Delta). This site gave ready access to the National Aeronautical Establishment hangar via taxiway D.

Overall slope of the ground was downward SW to NE, with a slight crossfall and with considerable rolling unevenness across the width and length of the plot. Initial grid layout was 480 feet long by 172.5 feet wide covering an area of 81,840 square feet. Later, a further increase of the grid dimensions was made to give approximate gross overall dimensions of 570 by 202 feet with actual coverage area of 113,737.5 square feet.

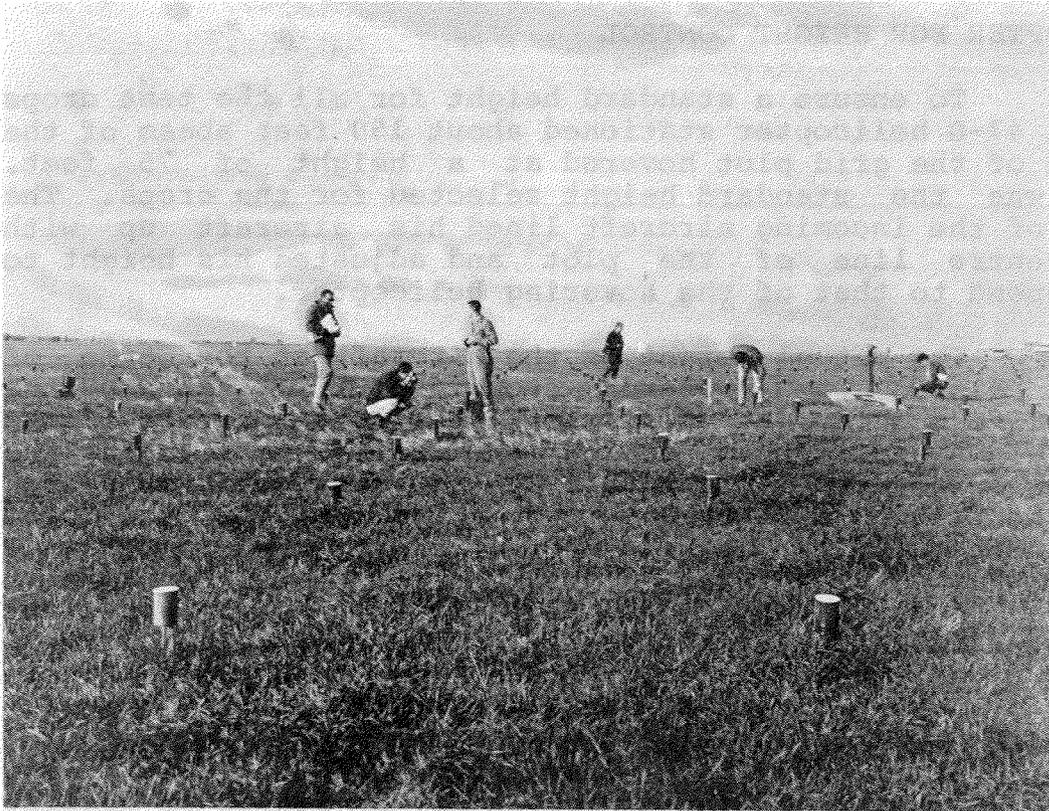
Figure 2. Ground view of the test site.

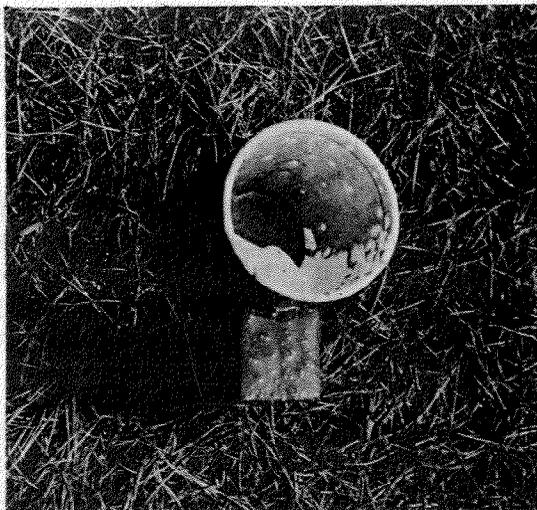
Figure 3. Collecting cup after drop from TBM Avenger with Phoschek retardant.

After each test drop, any of the waxed cups showing evidence of containing water, in liquid or droplet form, were capped with plastic lids that fitted the cups. Care in putting these caps on is important, otherwise spillage or evaporation can take place. The best method of capping found was to place the lid over the cup at one point and then run the palm of the hand around the cup edge pressing down at the same time. Once capped, the cup was pushed up from the underside away from the firm hold of the crimped edge of the can, so that it could easily be picked up by the collectors without damaging the closed cup.

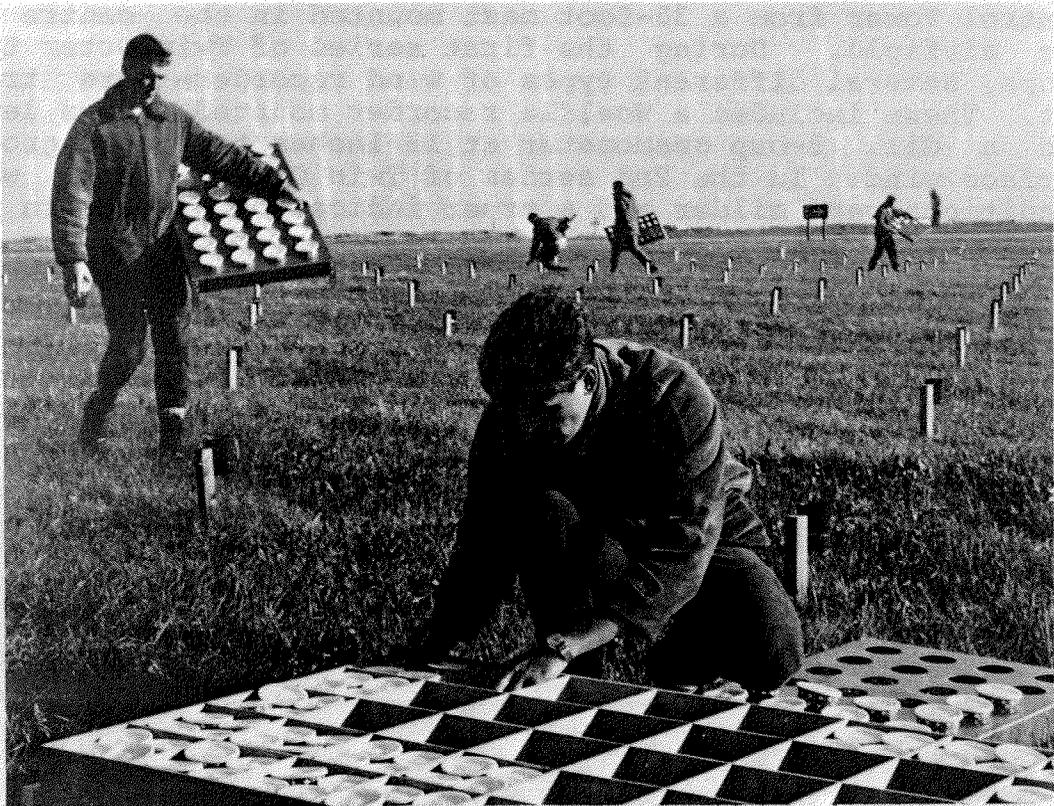
Figure 4. Collecting tray and carrying box.

Capped cups were brought from the drop area in 32-cup capacity aluminium carriers. At the central collecting point these cups were transferred into a 320-cup capacity plywood framed box. This box was sectioned into 40 compartments, each holding 8 cups in 2 layers of 4 each.

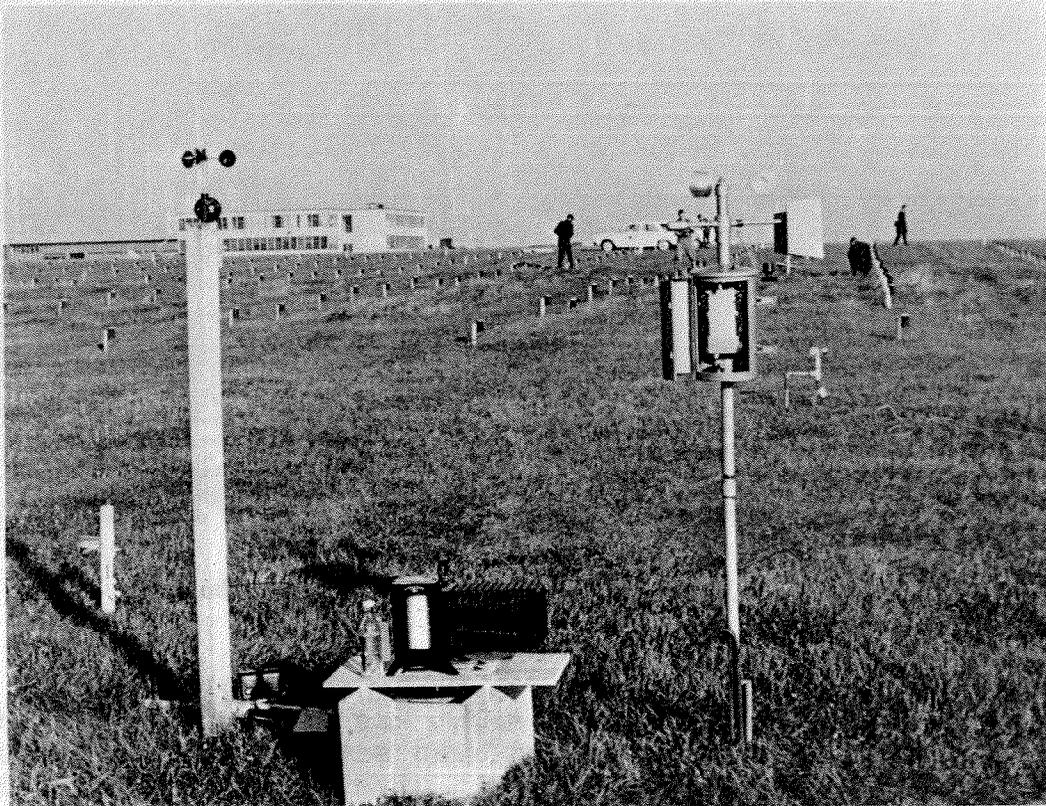
Figure 5. Wind recorders used during Twin Otter tests.

The 'on site' wind was measured by a 3-cup Casella anemometer mounted 6 feet above the ground adjacent to the drop area. The indicated wind noted on the final ground distribution charts is the wind as measured by the Uplands Control Tower from a 30-foot mast mounted in the centre of the airfield. During the first series of Twin Otter test drops, several different types of wind recorders were tried out. These included a Woelfle recorder mounted at eye level and a Gill 3-cup anemometer at 18 inches to record ground surface wind. In the 2nd series of Twin Otter drops, wind conditions were milder and a truer indication of pattern was obtained.

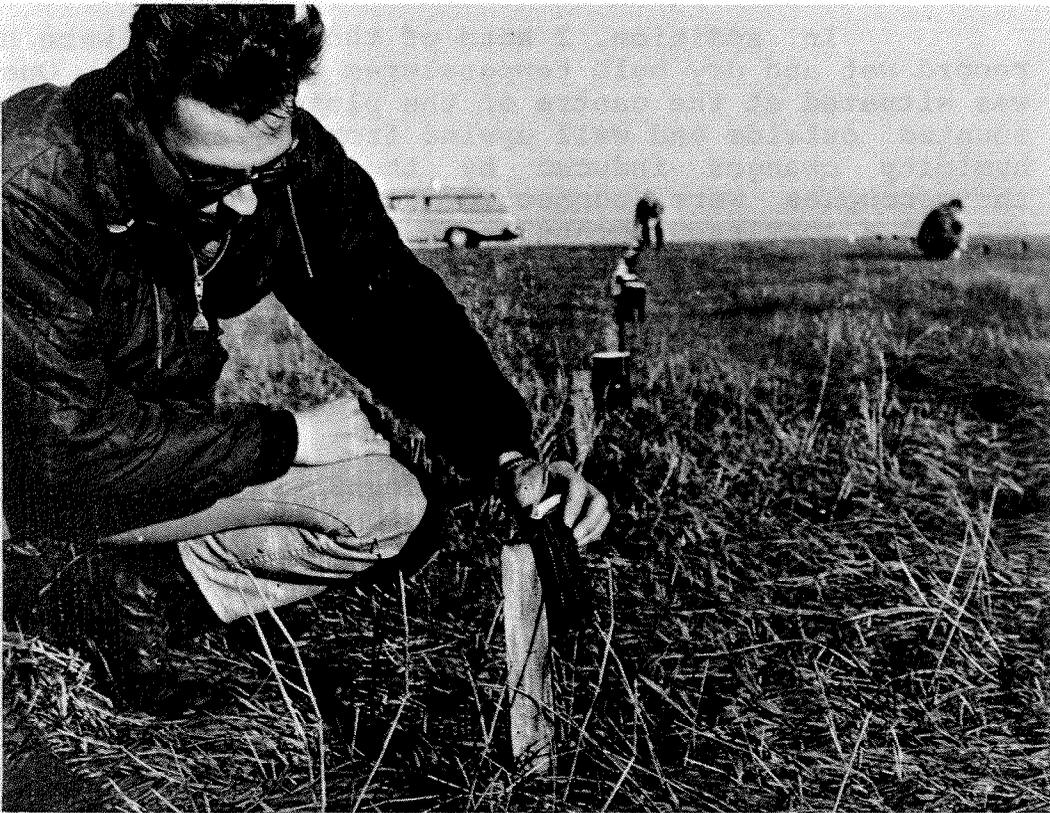
Figure 6. Can flattened by dropped water.

On several occasions cup/can assemblies were flattened during drops where no load disintegration of the water mass had taken place. No aircraft can be singled out as the chief offender -- it occurred with each aircraft type tested.

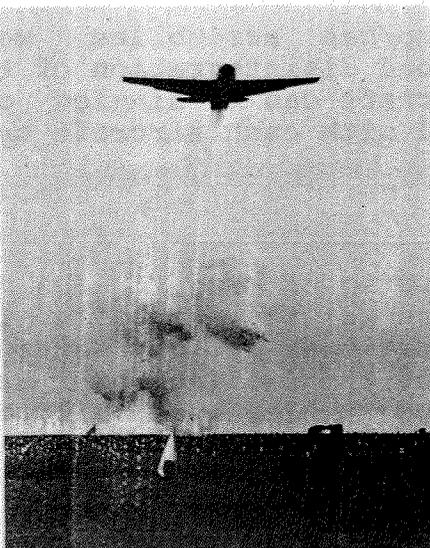
Figure 7. TBM Avenger drop. Note fingering of the water mass.

Load disintegration was observed to be very distinct in some cases, it again was not restricted to any particular aircraft. The photo of the TBM Avenger shows 'fingering' to a very marked degree; the ground distribution pattern for this particular drop is quite splotchy.

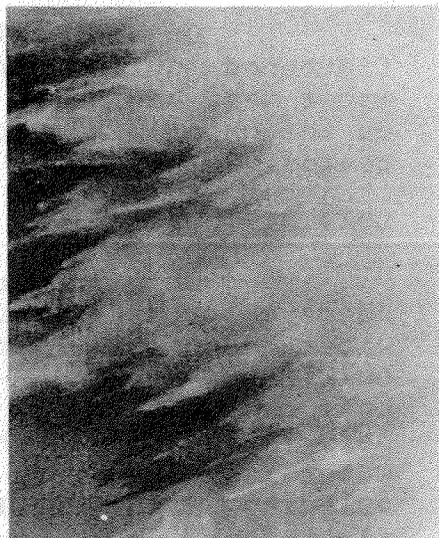
Figure 8. Typical frontal disintegration during Canso drop.

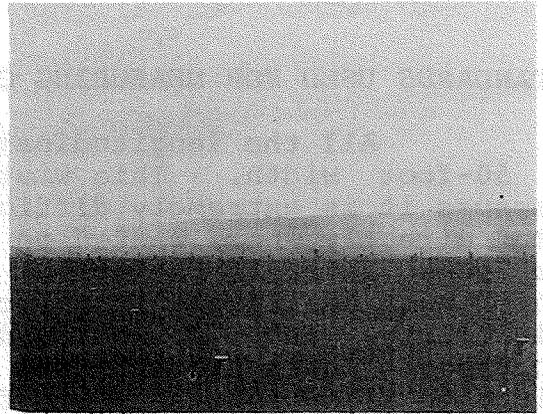
Figure 9.

Generally the water reached the ground in a fine disintegrated form, very much like a heavy rain. Photograph No. 9 shows the water moments after impact in the form of a heavy mist rain.

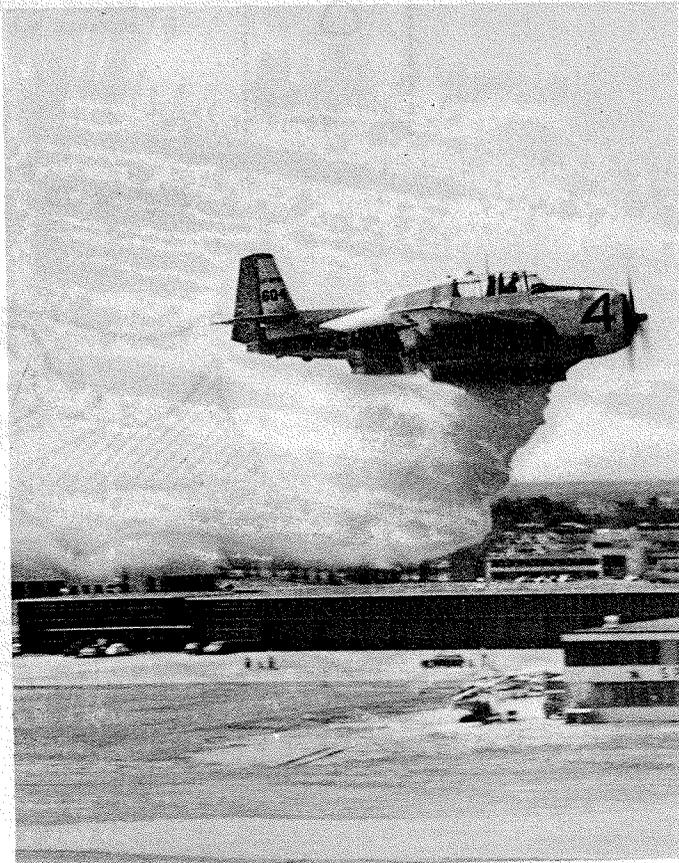
*Figure 12.
500 gallon TBM Avenger.*

Considerable breakup of the water load is shown in the plotted ground distribution. Rather than nice concentric contours there exist many little islands and pockets which, on the basis of the standard method of measurement outlined previously, result in no measurement being taken for the inner contours. It is realized that this gives rise to anomalies but some form of standard measuring technique had to be adopted.

The plot for drop 10 shows several interesting features. Firstly, in spite of the strong headwind there is little or no bunching of the contours and secondly, the fingering nature of the water mass shows up distinctly on the forward contour edge - see Figure 7 of this drop, head view. Several other of the drops show this feature but not to such a marked extent. Percentage recovery has a 15% range.

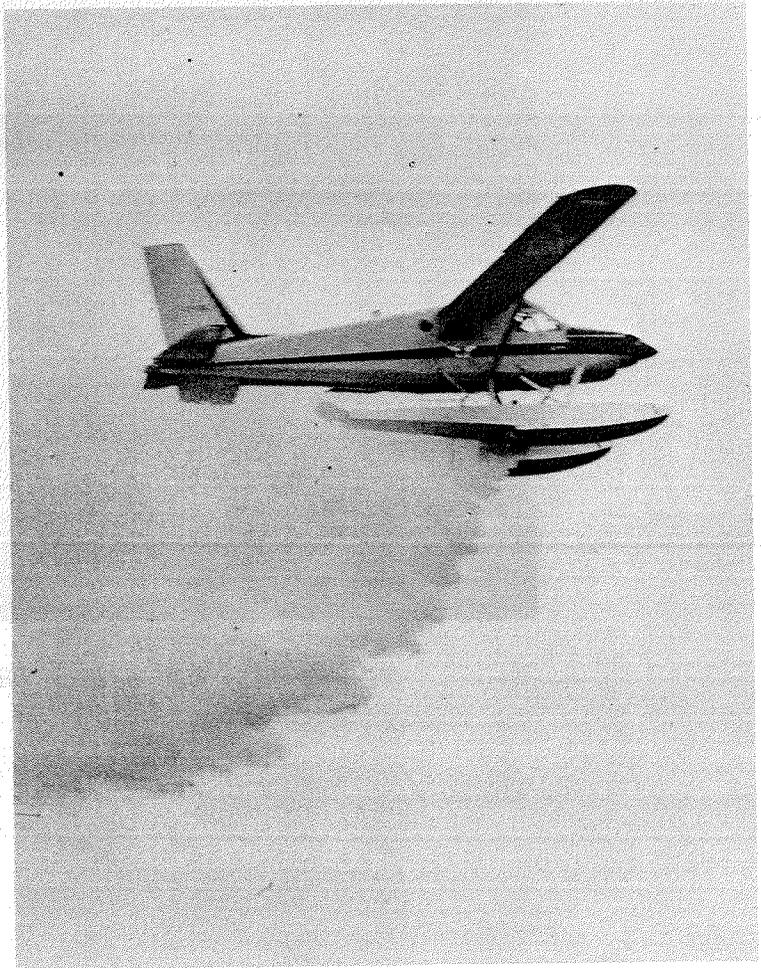
*Figure 13. 140 gallon
DHC-2 Turbo-Beaver.*

The low temperature and high relative humidity conditions under which this set of tests was carried out resulted in very high recovery figures for three of the drops, and increasingly lower recoveries for the remainder. The range of recoveries, 38%, is inexplicable, especially those recovery figures over 100%. The Simpson's rule integration method used for calculation of percentage recoveries may be slightly inaccurate because of the lower number of cups weighed during these drops. It is more likely that the maximum recovery for this aircraft is about 95%.

The inner contours of the distribution patterns show marked breakup into islands. This would suggest great load disintegration of the falling water mass. The fingers reaching the ground first in patches and then the remaining mass of water falling fairly uniformly over the plot thus gives an overall ground distribution pattern containing small pockets of high concentration. Photographs taken at the time of the test drops confirm this degree of load disintegration and a movie film of other drops shows this idea of the mass of water compounding over the 'fingers'.

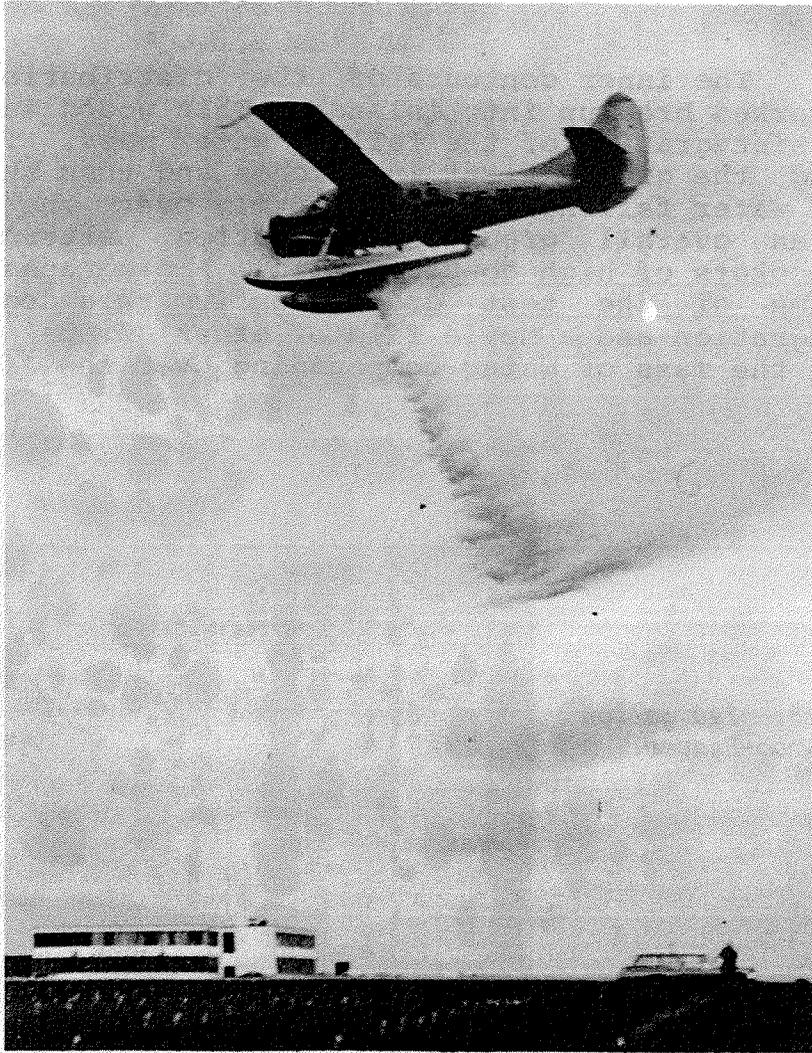
Figure 14. 230 gallon DHC-3 Otter

Similar to the Turbo-Beaver, this aircraft has ground distribution patterns which show considerable breakup into islands at higher concentration levels. This makes measurement of the higher contour lengths almost impossible. Patterns for the Otter are narrower than those of the Turbo-Beaver even though the range of airspeeds is quite comparable.

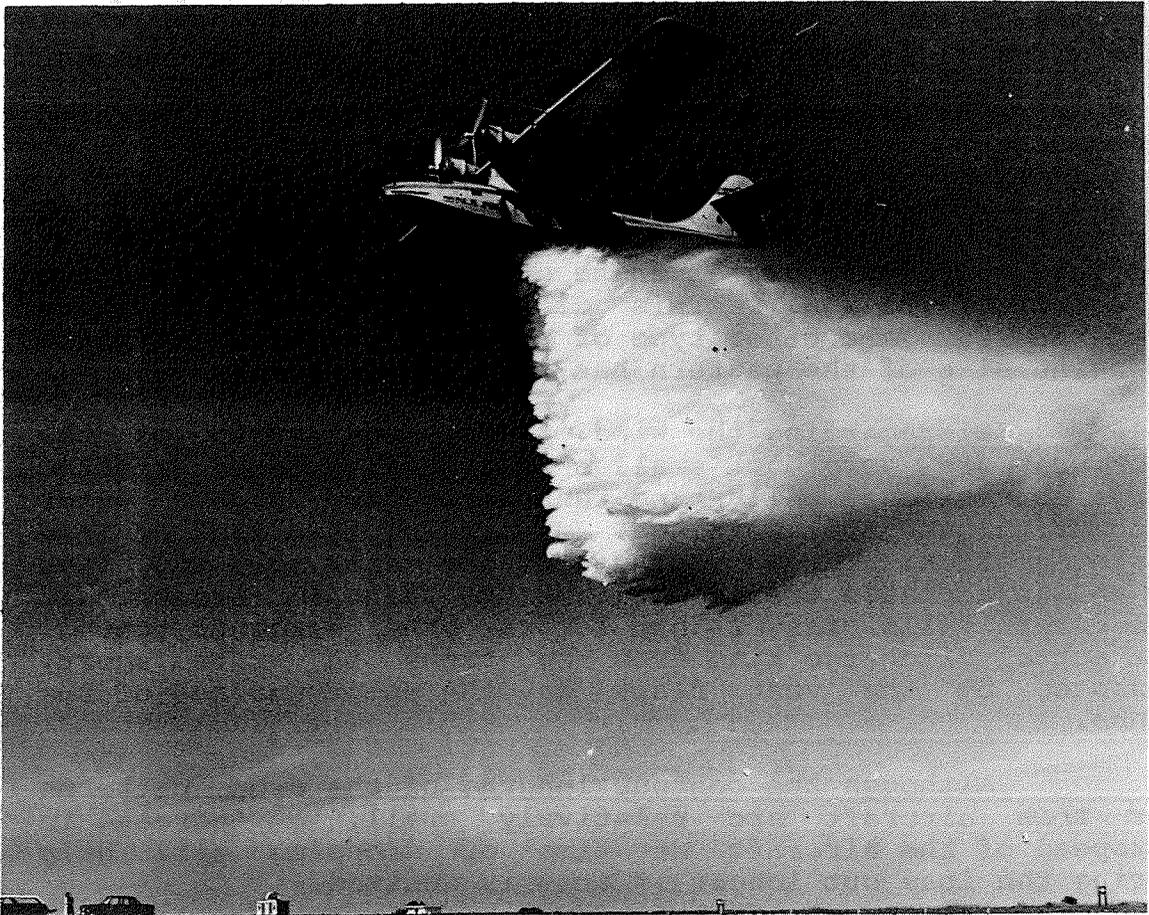
Figure 15. 800 gallon PBY Canso

The ground distribution patterns for this aircraft show that the water from the two separate tanks does not coalesce into one large mass by the time it reaches the ground. The fact that the starboard door opens sooner than the port door results in a lopsided contour for the 0.07 inch and higher concentrations. The right-hand mass of the water appears to roll under slightly at the time of initial contact with the ground, thus adding more water to the left side of the pattern.

This initial contact with the ground by the right mass causes it to break up more than when the following left-hand mass hits the ground; thus the left-hand contours will be more complete.

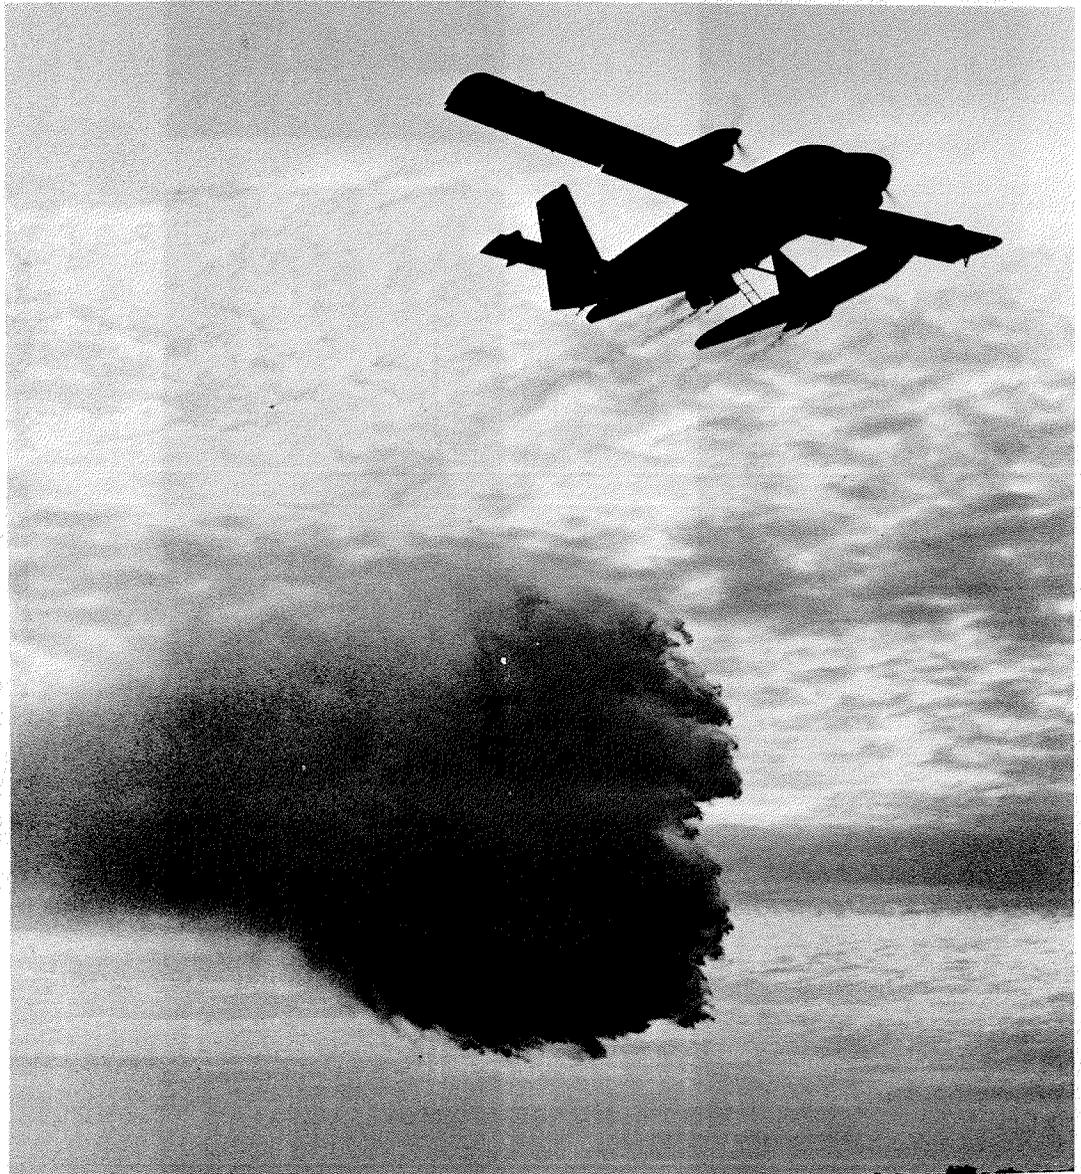
Figure 16. 400 gallon DHC-6 Twin Otter. Note the vent flaps on the upper side of the pontoons, which open at same time as the drop doors.

The design of the float tank system incorporates vent flaps on top of the pontoon that open in conjunction with the drop doors. This gives an extremely quick discharge time for the aircraft, with practically no trail out.

The rounded shape of the water mass is illustrated in photograph No. 16.

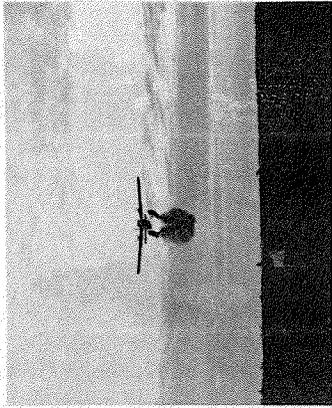
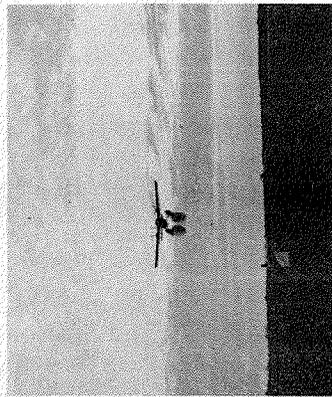
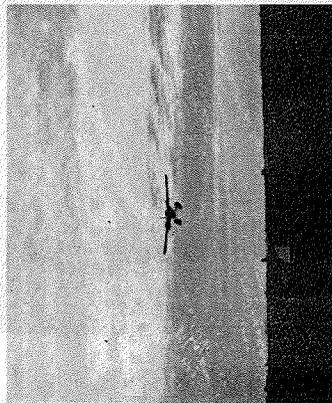
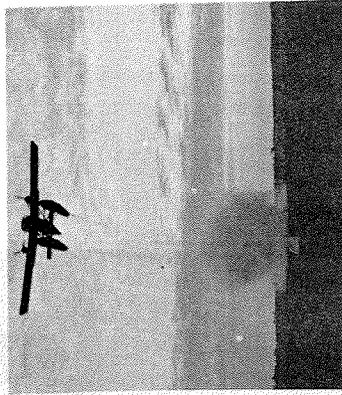
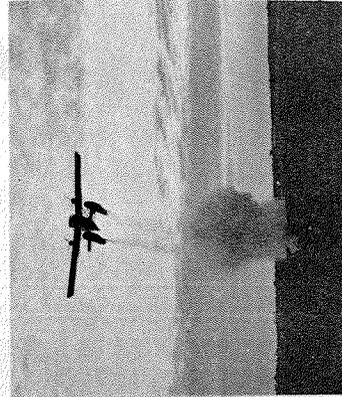
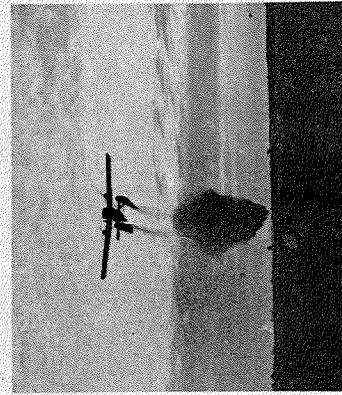
Figure 17. Twin Otter drop, head on view.
Time interval between pictures not constant.

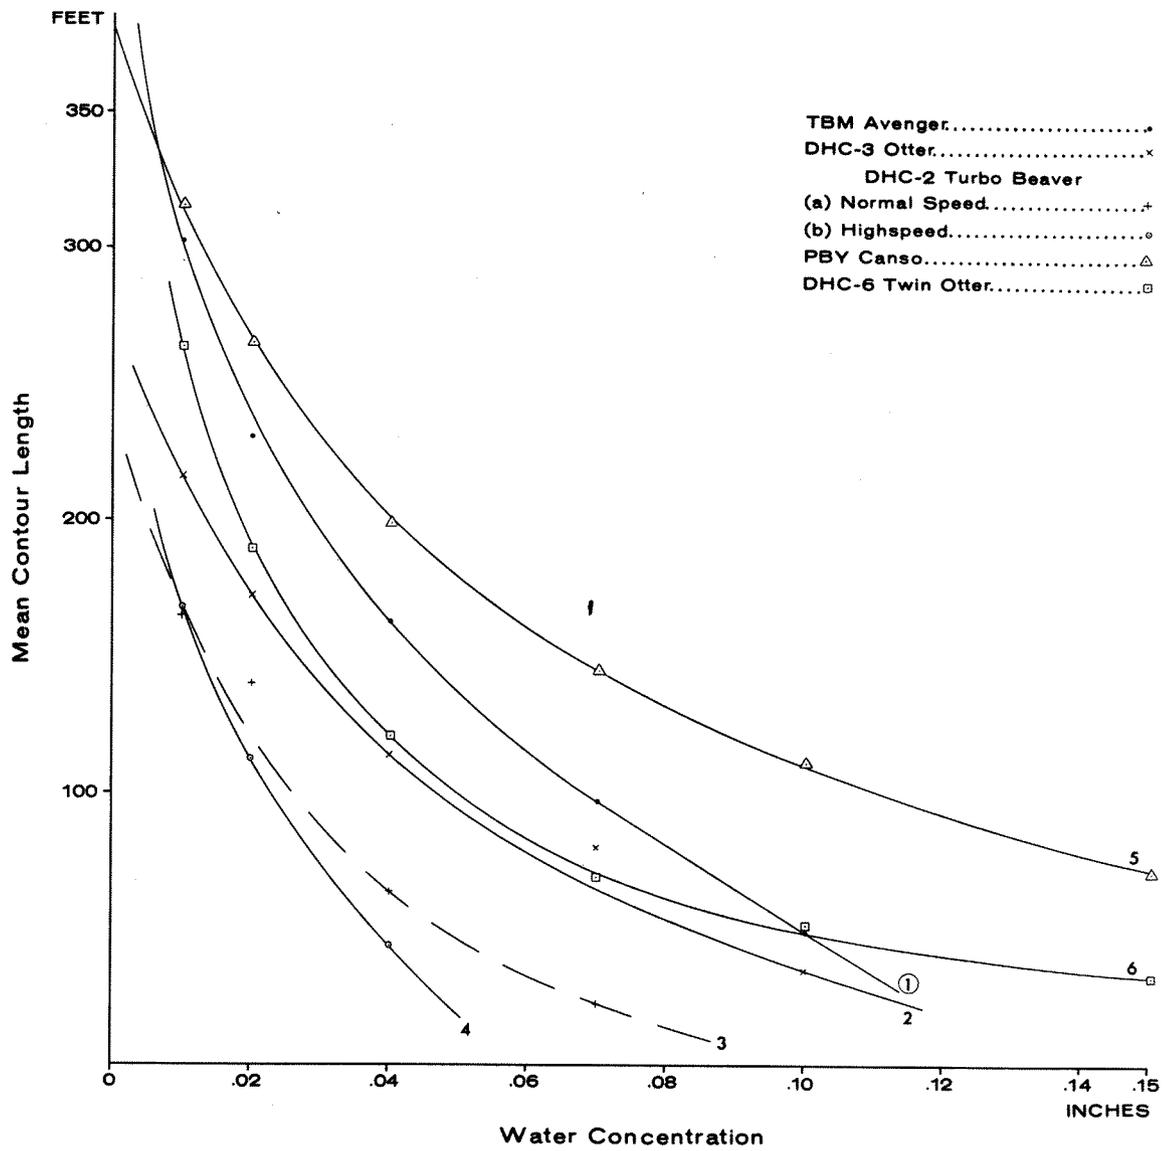
Figure 18. Length of drop patterns for various water concentrations.

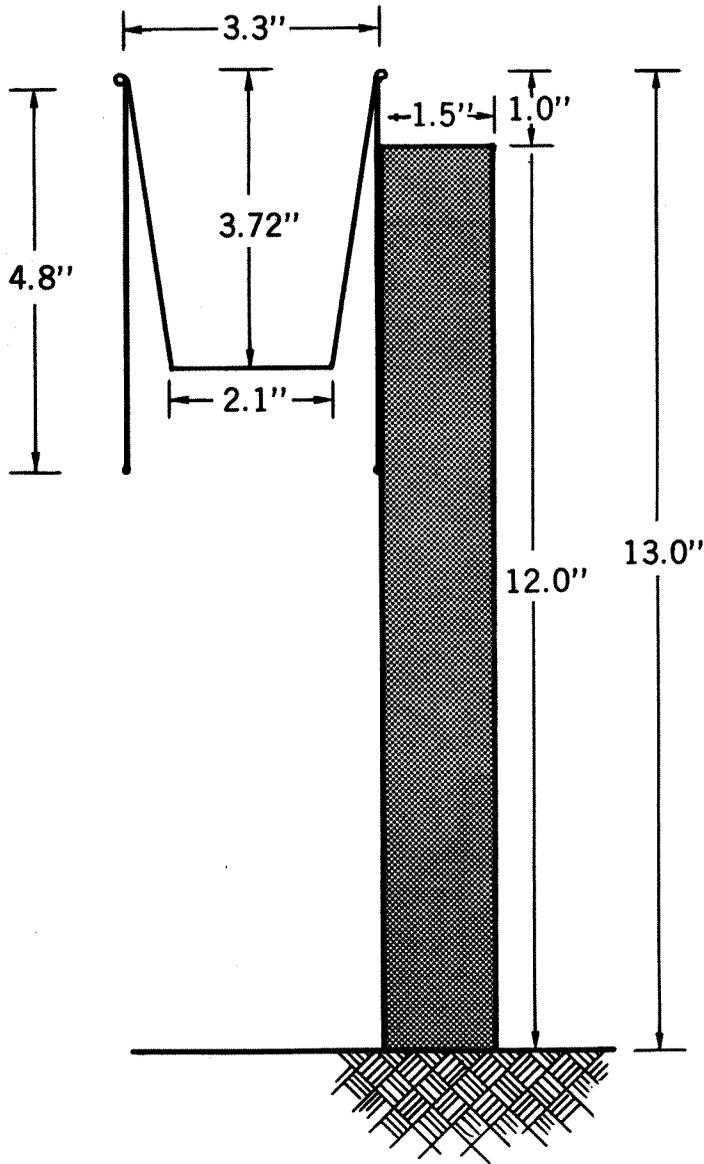
SECTION VIEW
CUP/CAN/STAKE ASSEMBLY

The tin can holders for the paper cups were 4.75 inches deep by 3.25 inches in diameter. The upper inch of the cup holder was crimped by a hand-operated crimping machine to provide a firm fit for the cups. The waxed paper cups were standard 10 fluid ounce interior waxed cups, 3.75 inches deep with a top diameter of 3.3 inches reducing to 2.25 inches at the bottom end. The thickened rolled-over rim of the waxed cup fitted over the can top edge and was held snugly by the crimped upper portion of the can. Total number of cups was 935.

To facilitate removal of the waxed cups after each test drop, the bottom of the tin cans were removed prior to assembly of the picket components. These tin cans were fastened to the stake by 2 flat-head nails and then securely bound with locking wire twisted around the can and stake as a precaution against breakaway from the stake.

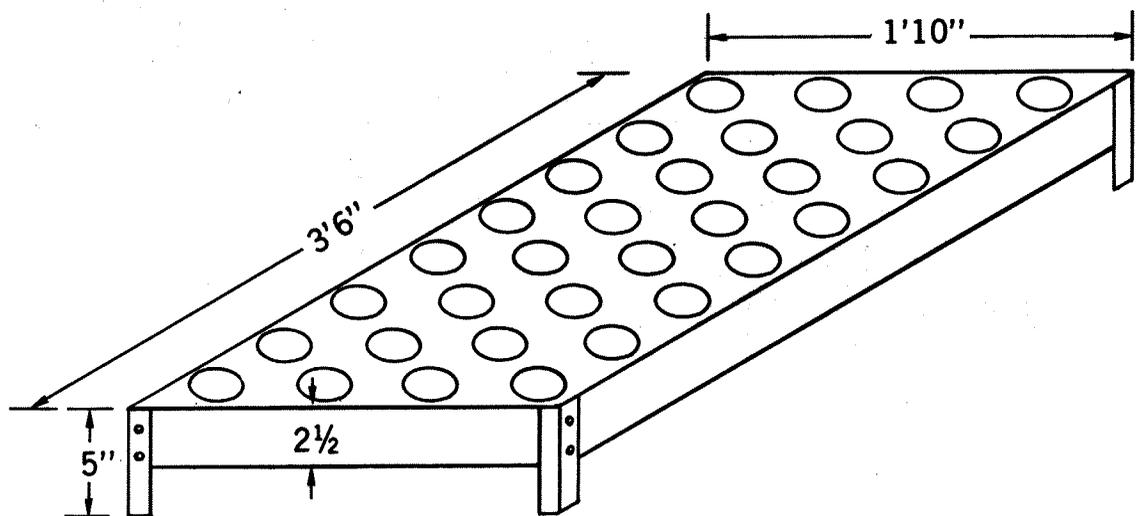
32 CUP ALUMINIUM COLLECTING TRAY

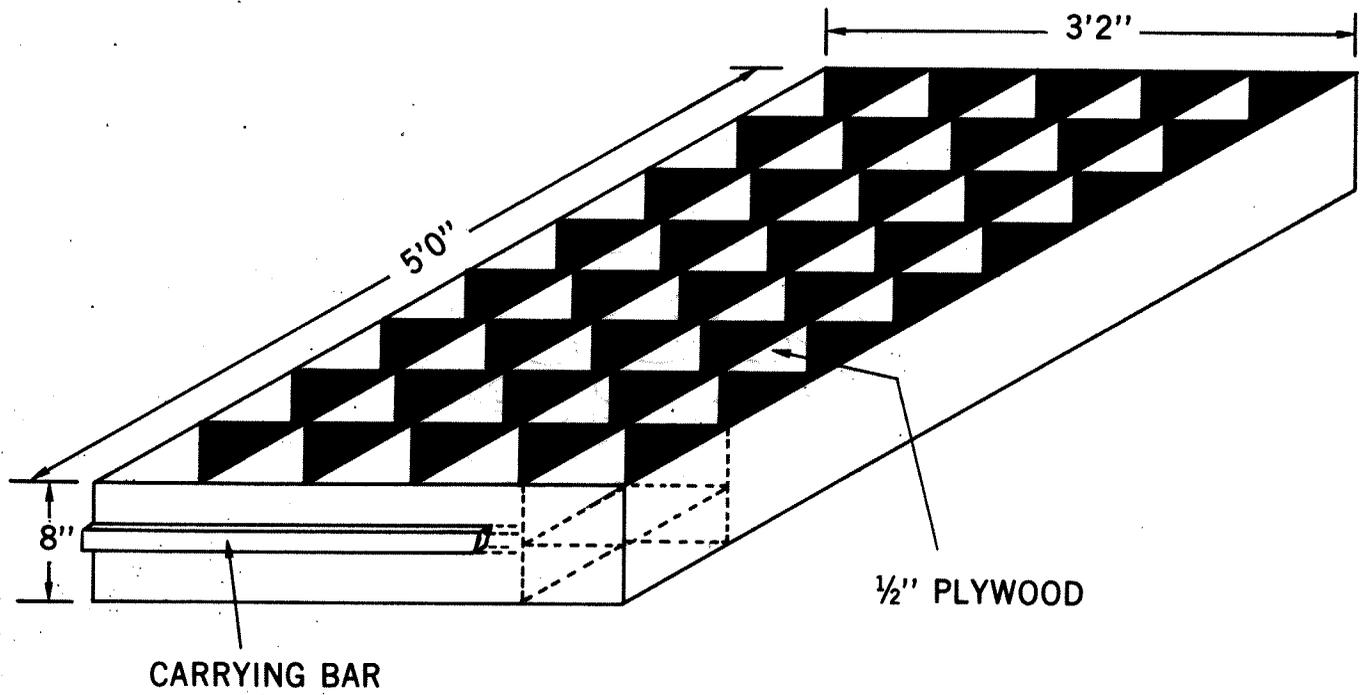
320 CUP
PLYWOOD CARRYING BOX

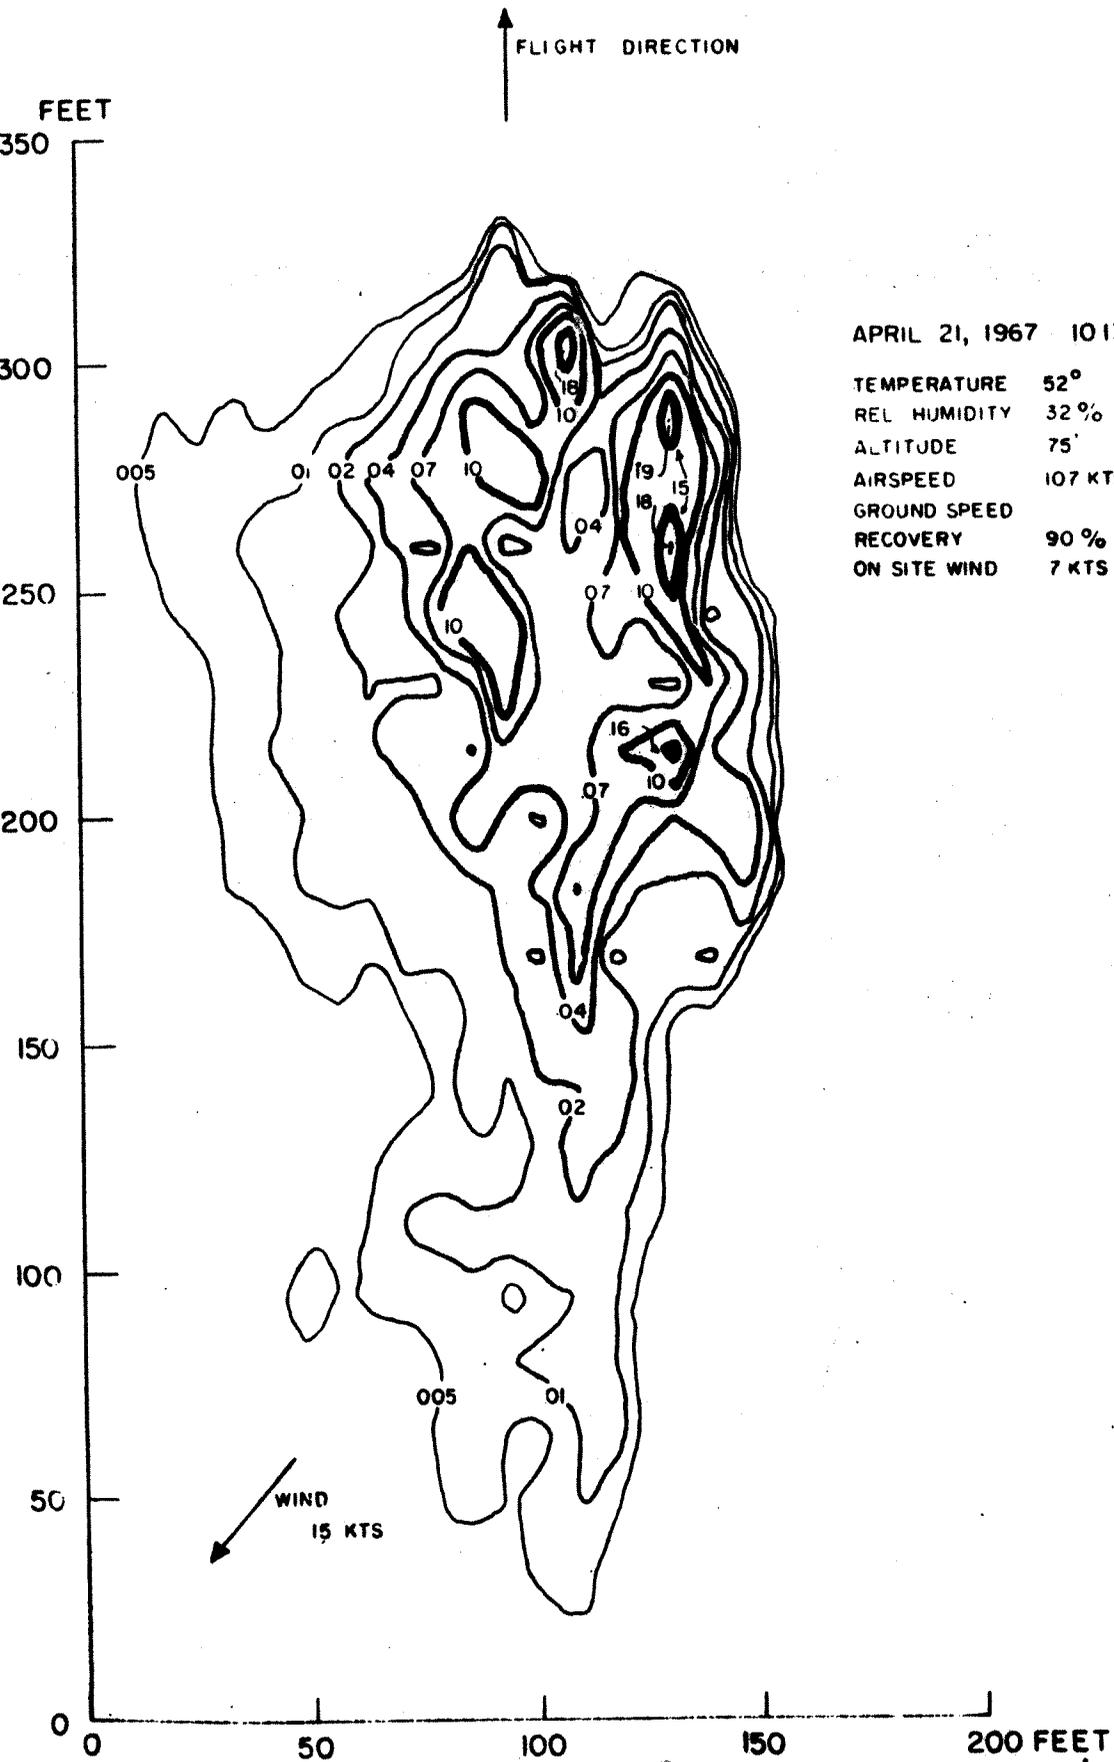
AVENGER DROP NO. 9

TEMPERATURE	50°
REL HUMIDITY	26%
ALTITUDE	70'
AIRSPEED	112 KTS
GROUND SPEED	103 KTS
RECOVERY	91%
ON SITE WIND	6 KTS

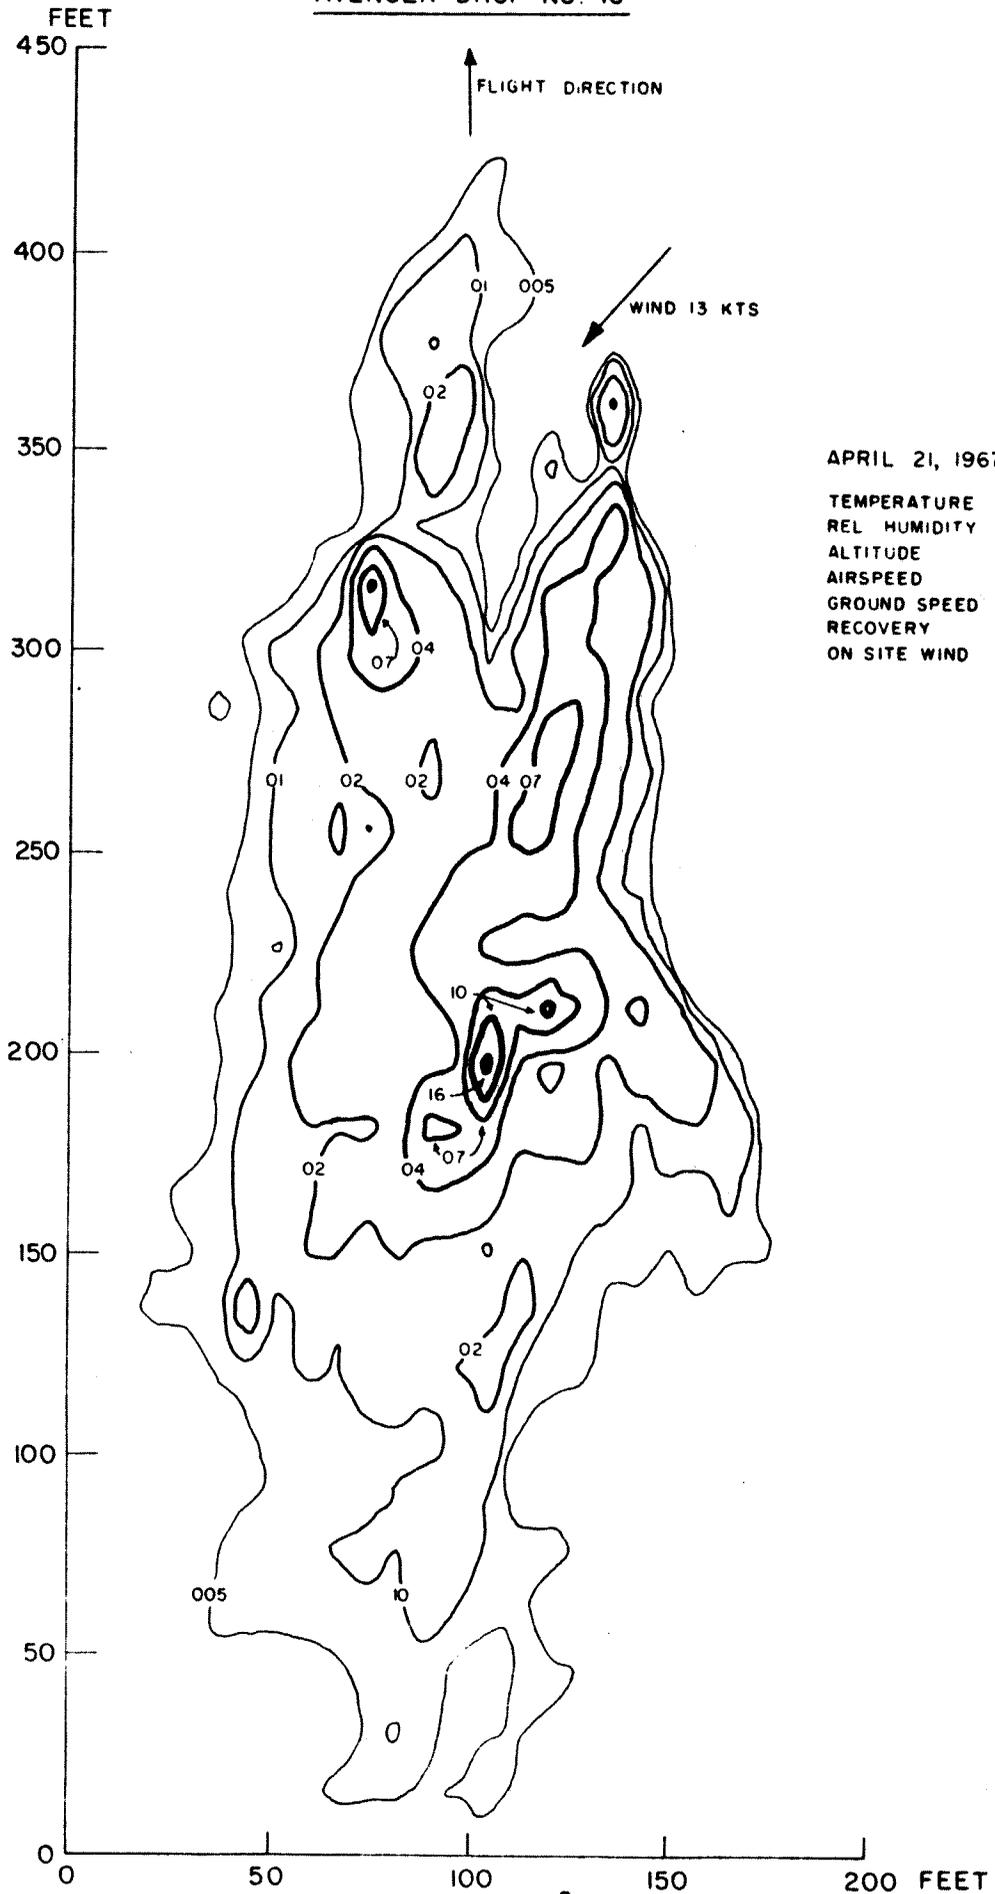
AVENGER DROP NO. 10

TEMPERATURE	50°
REL HUMIDITY	34%
ALTITUDE	80'
AIRSPED	110 KTS
GROUND SPEED	101 KTS
RECOVERY	79%
ON SITE WIND	5 KTS
