ENVIRONMENTAL COSTS IN LOGGING ROAD DESIGN AND CONSTRUCTION

Environmental Costs in Logging Road
Design and Construction

Canadian Forestry Service
Pacific Forest Research Centre,
Victoria, B.C.
Report BC-X-108

Department of the Environment
January, 1975

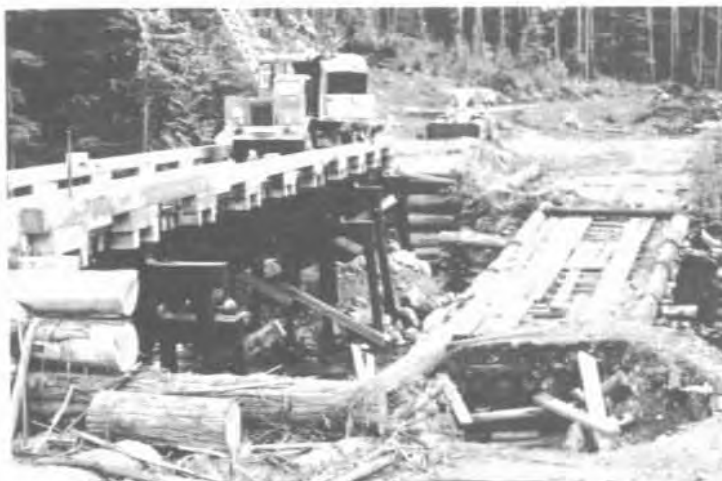
Figure 3 A Glu-Lam bridge replaced the old log stringer bridge across Wilson Creek near Mile 7½.

The road intercepted two larger streams and a few smaller streams. The log stringer bridge across Wilson Creek near mile 7½ was replaced with a 100-foot-long "glu-lum" bridge (Figure 3). Hicks Creek was crossed, using a 96-inch-diameter steel culvert. The installation of this culvert will be discussed separately in this report. Although seepage water occurred throughout the route, it was most prominent at the northern end of the road project, as well as at calcareous tufa deposits near mile 5. Water from seepage and minor streams was contained by adequate ditches and culverts. There was little danger of erosion of ditches since they were constructed in either stable soils or bedrock. Furthermore, erosion and cut bank stability were not serious problems in the northern end of the road despite the prominence of seepages because the terrain was not steep.

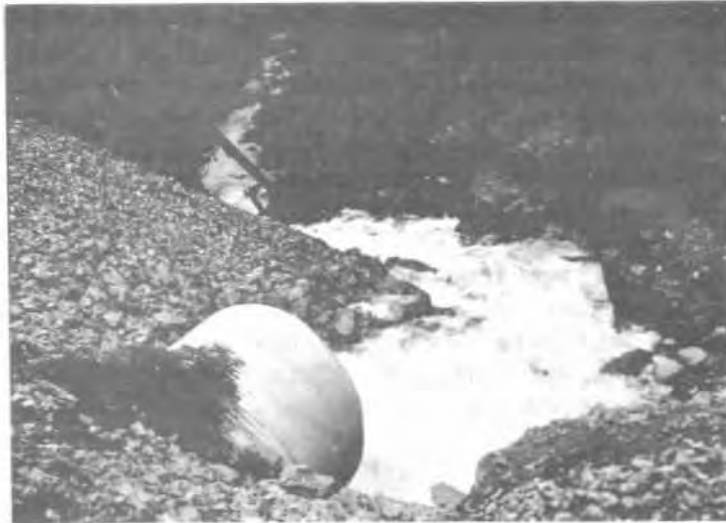
Figure 4 Outlet of the culvert at Hicks Creek.

Hicks Creek, a steep tributary of Wilson Creek, flows in a deep gully and has an average gradient of 15 to 20%. The north wall of the gully is composed of gravelly to stoney glacio-fluvial outwash and kame deposits. The south wall is composed of fractured shale-like bedrock. A 96-inch, instead of an 84-inch-diameter, steel culvert was used to provide a greater margin of safety against a washout. The 84-inch-diameter culvert should be able to withstand a 25-year flood and the 96-inch-diameter culvert, a 50-year flood^{3/}. In addition, measures were taken to prevent the culvert from shifting or washing out. Before the culvert was installed, the level of the creek bed was raised with a rock fill to prevent excessive ponding at the culvert intake. Also, the channel of the creek above the intake was straightened with dikes. The fill and diking material contained only a small proportion of fines so that relatively little sediment entered Wilson Creek.

The outflow was intercepted by a rocky embankment (Figure 4).

For several reasons, the culvert was used instead of a bridge to cross Hicks Creek. Firstly, Hicks Creek does not support fish and interruption of its stream bed and flow caused by the culvert is not an important consideration.

Secondly, a bridge would have been more than twice as costly as the culvert crossing. To maintain the same alignment as achieved with the culvert, the bridge would have to be at least 80 feet long and supported by 30-foot trestles. A structure of this type would cost about \$55,000 compared to \$22,000 for the culvert crossing.

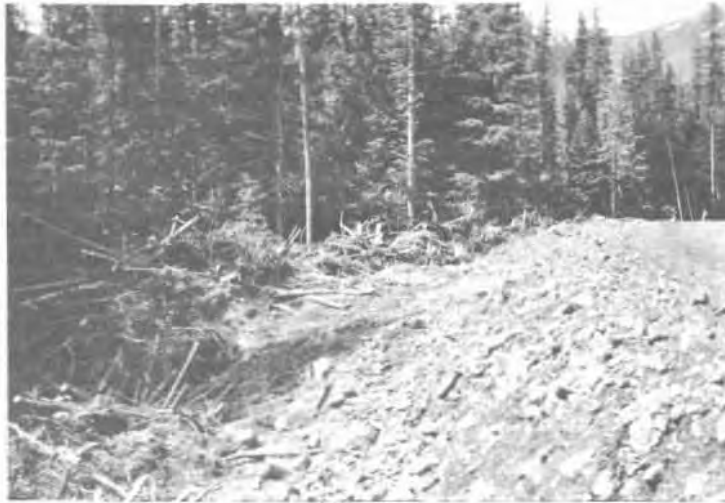
Figure 5 Insufficient fine soil to bury right-of-way debris.

Two other problems, perhaps less serious, occurred in the section of road between miles 4 and 6. Firstly, there was insufficient fine fill in this rocky road section to bury right-of-way debris (Figure 5). Where this problem occurred, debris was pushed to the edge of right-of-way clearing. Not only was it too costly to obtain additional suitable fill to cover the debris, but to do so would have greatly widened the road surface so that the edge of the road would have been right up against the edge of the right-of-way clearing. If additional fill had been obtained by increasing the excavation into the sidehill, not only would the road have been widened on both sides, but more debris would have been created by the additionally necessary right-of-way clearing. Therefore, only debris left after the removal of right-of-way log decks was required to be piled and burned. The rest of the debris was left to be overtopped in a few years by roadside brush.
