FOREST ROAD EROSION
IN NORTHERN ONTARIO:
A PRELIMINARY ANALYSIS

C. R. MATTICE

GREAT LAKES FOREST RESEARCH CENTRE
SAULT STE. MARIE, ONTARIO

REPORT O-X-254

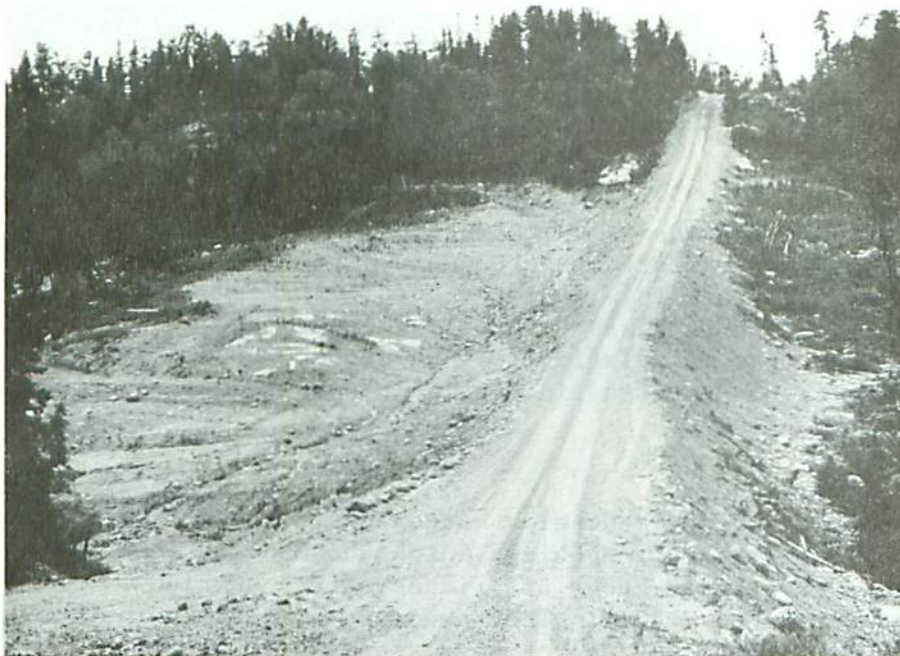
Figure 1

Relatively long-lived and expensive all-weather road near Minaki.

Since there is considerable variation in construction standard of such roads (Fig. 1) it was necessary to classify them. Attempts to adopt an arbitrary classification based on primary, secondary and tertiary access, for example, failed because of the tremendous variability in construction standard within each class. Thus, roads were selected for study on the basis of such physical dimensions as right-of-way width, road surface width, and depth of fill/cut.

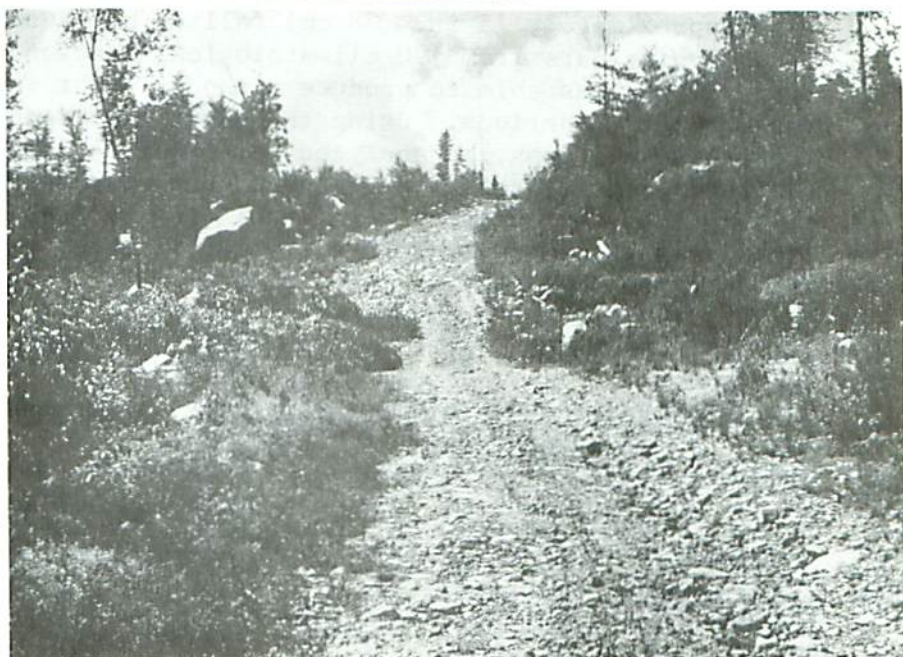
Relatively short-lived all-weather road abandoned after several years' use near Kenora (ELA).

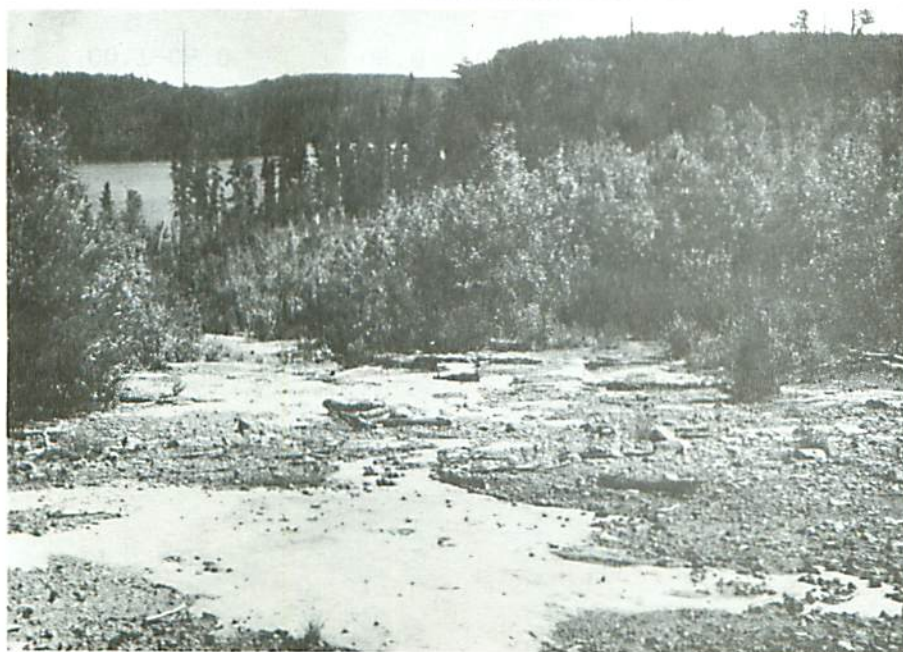
Seasonal haul road used for one winter, then abandoned near Kenora (ELA).

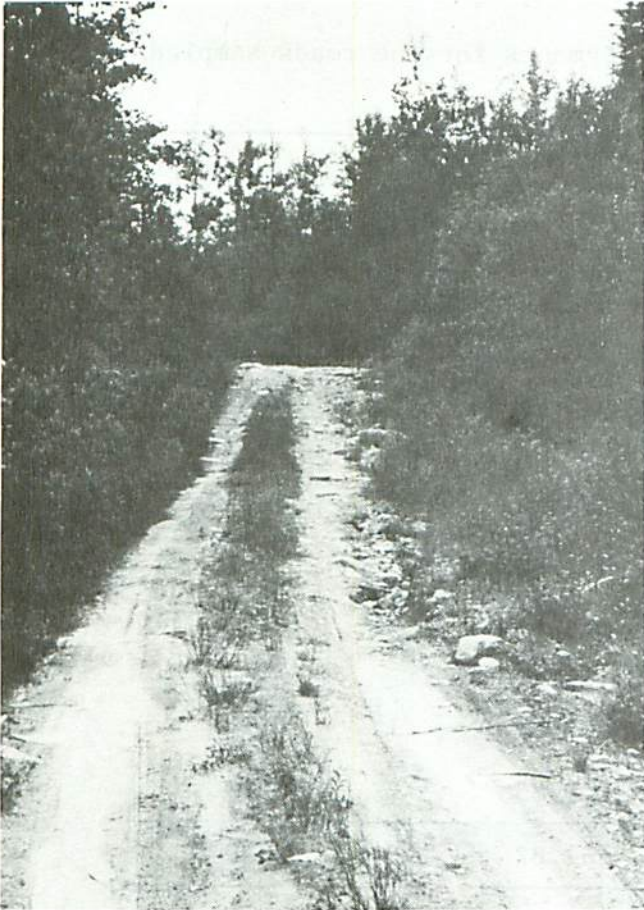
Figure 4

Surface erosion and deposition

To avoid giving a false impression of the precision of erosion determination, the various features were divided into two broad depositional classes and three erosion classes based on the mean depth. They are listed below and illustrated in Figure 4.

i) Surface wash	1 to 2 in.	(2.5 - 5.1 cm)
ii) Rill wash	2 to 12 in.	(5.1 - 30.5 cm)
iii) Gully wash	greater than 12 in.	(30.5 cm)

i) Surface deposit	1 to 2 in.	(2.5 - 5.1 cm)
ii) Deposition	greater than 2 in.	(5.1 cm)

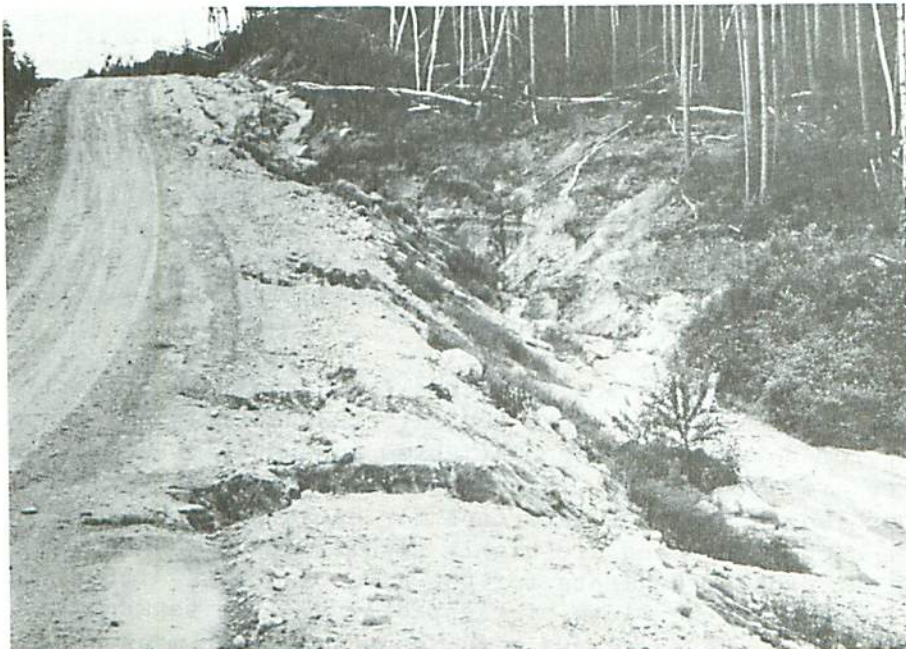
Bank wash and gully erosion (ditch line)

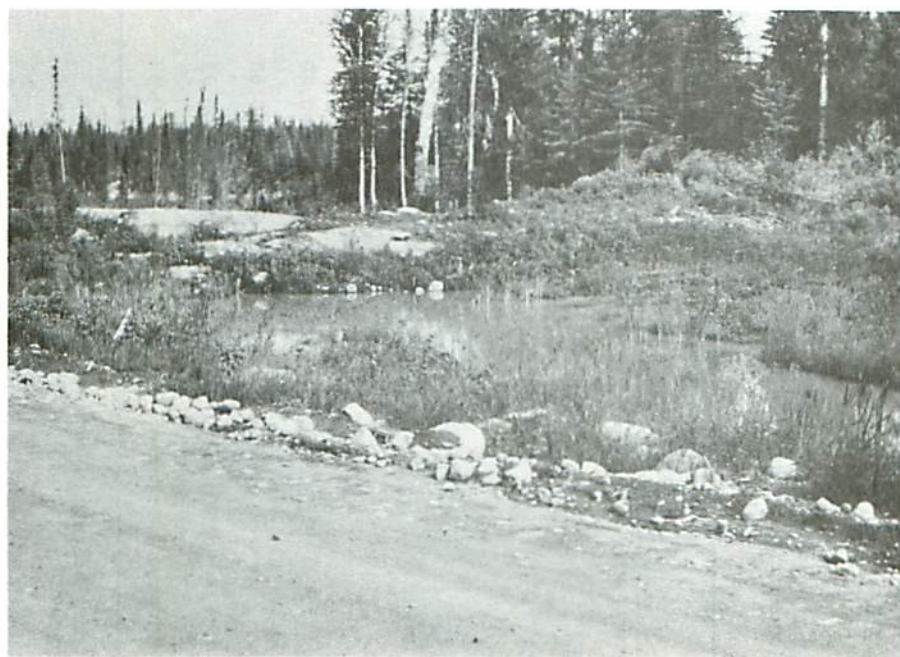
Figure 6. Small depression acts as a sediment pool.

The development and evaluation of techniques to reduce erosion could be a very useful research study. The present study suggested several possibilities worth examining. Small depressions in the off-road portion of the right-of-way could act as sediment pools. Berms of slash across the untravelled part of the right-of-way temporarily dam runoff, causing the deposition of transported material. Undulating the road surface on long slopes diverts runoff from the road. Material which is otherwise buried in pushouts, or burned, could be chipped and applied as a mulch on steep-sloped cutslopes, fillslopes, and backslopes. Techniques such as these may not dramatically increase road costs, yet may reduce erosion.
