FOREST INSECT AND DISEASE SURVEY
PEST REPORT ON SPECIAL PROJECTS
QUEEN CHARLOTTE ISLANDS

FIDS Report 96-7

FOREST INSECT AND DISEASE SURVEY
PEST REPORT ON SPECIAL PROJECTS
QUEEN CHARLOTTE ISLANDS
1995

Prepared for:
South Moresby Forest Replacement Account (SMFRA)

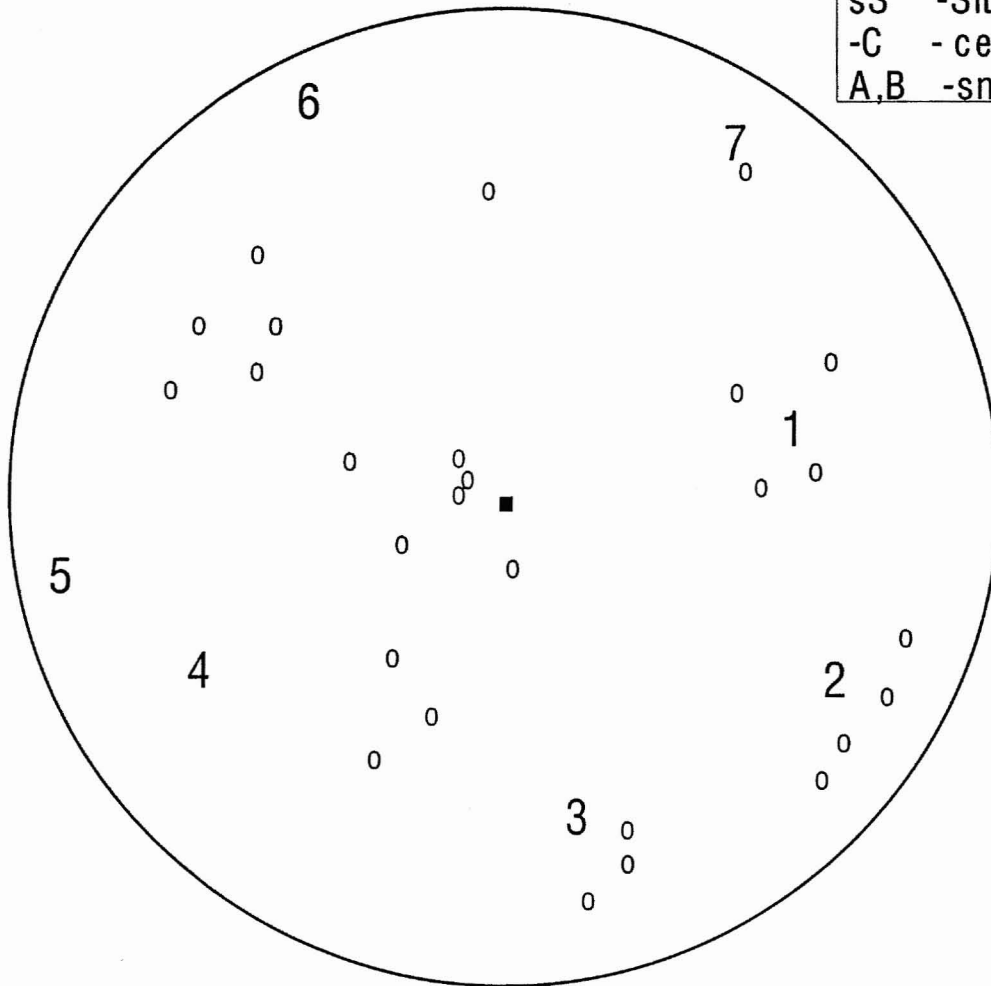
Plot 9 (R.P. - 37; plot not found)

Original tree no.	New tree no.	Species	DBH	Status
1	plot not found	wH	10	crook, felled
2	plot not found	wH	17	crook, felled
3	plot not found	wH	23	sweep, logged
4	plot not found	wH	42	logged
5	plot not found	wH	24	crook, logged
6	plot not found	wH	59	lean, logged
7	plot not found	wH	43	logged
xx		wH		destroyed, under slash

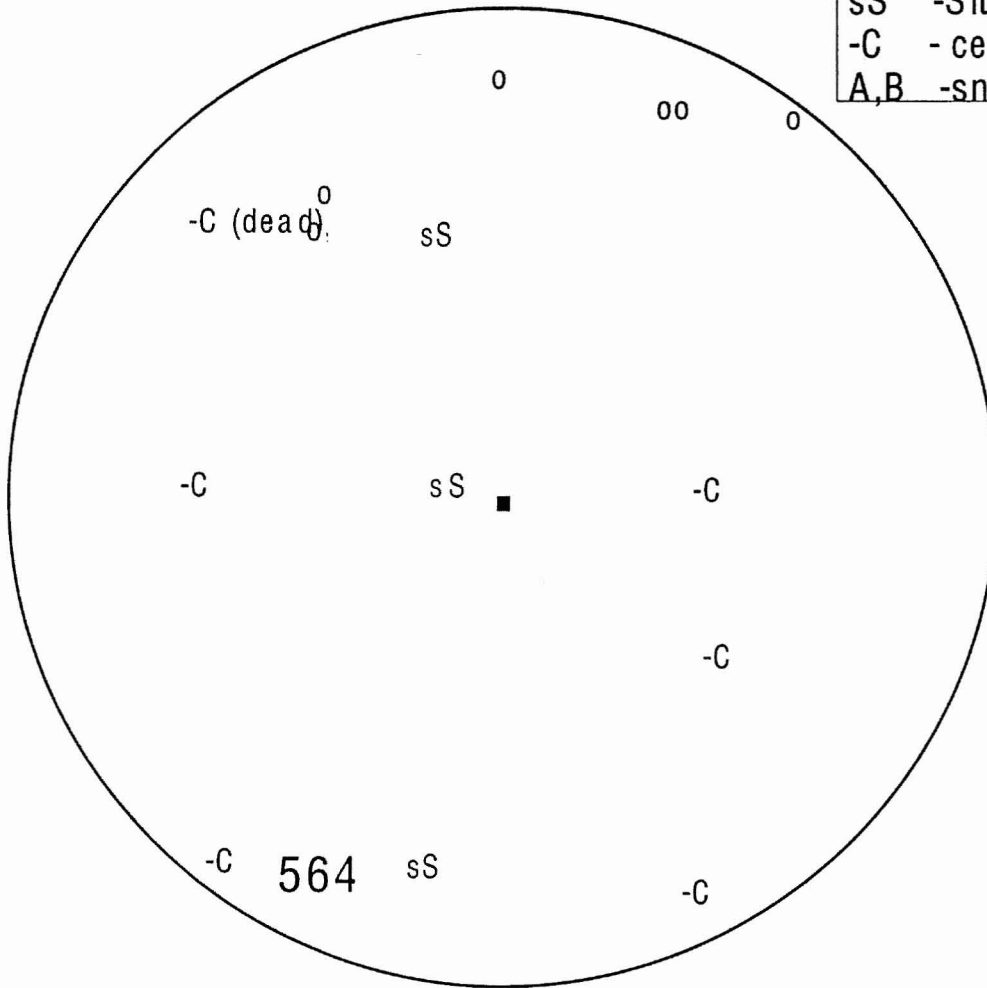
Original tree no.	New tree no.	Species	DBH	Status
1	564	WH	17	stump, heavy slash
xx		WH		destroyed

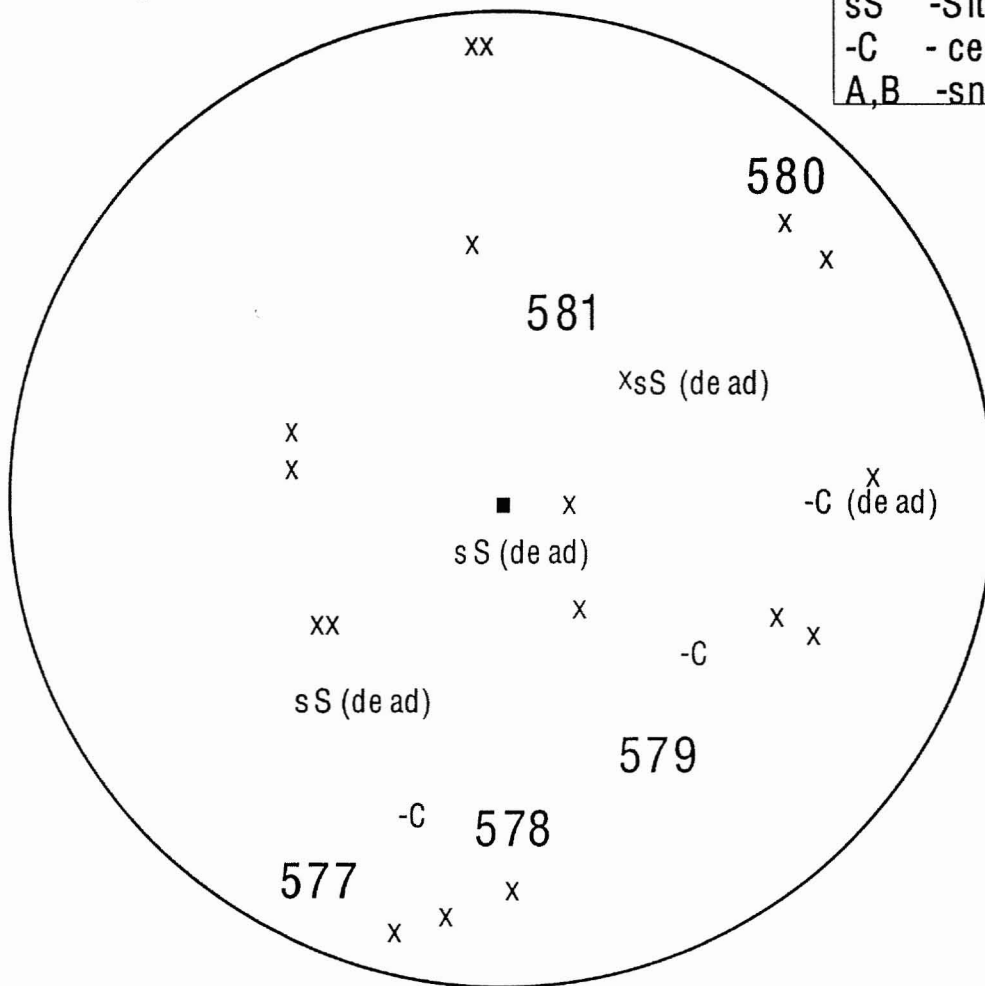
Original tree no.	New tree no.	Species	DBH	Status
1	577	wH	45	crook
2	578	wH	43	
3	579	wH	50	
4	580	sS	75	
5	581	wH	11	
XX		wH
