FOREST FIRE RESEARCH INSTITUTE

PERFORMANCE TESTS ON
WAJAX MARK 26
CENTRIFUGAL PUMP

1970

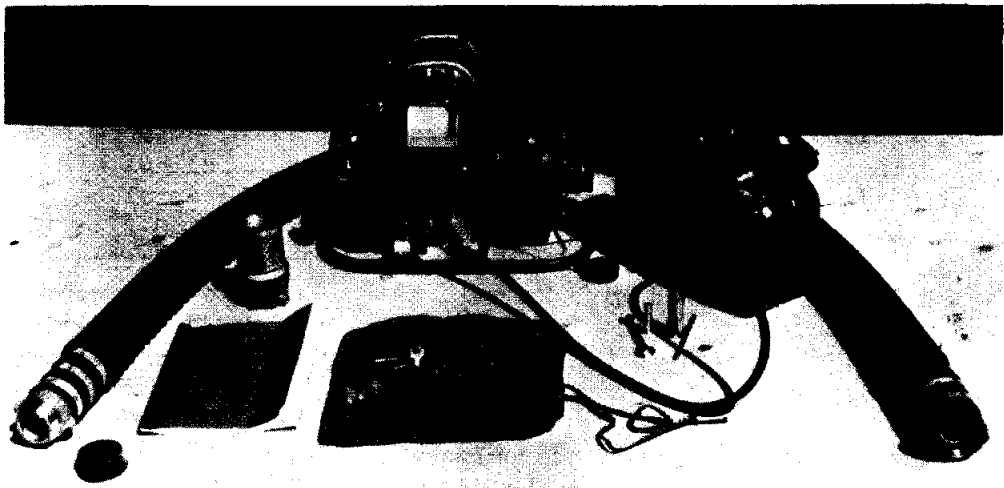
Photo No. 2 *Accessories provided with the
Wajax Mark 26.*

Dry pumping unit	37 lb.	7½ oz.
Suction hose (8')	17 lb.	8 oz.
Foot valve and strainer	1 lb.	9 oz.
Hand primer (Photo No. 5)	2 lb.	8 oz.
2 gallon capacity fuel supply tank (including fuel supply line)	7 lb.	3 oz.
Maintenance tool kit (including grease gun)	1 lb.	15½ oz.
Pump carrying pack (Photo No. 6)	3 lb.	2 oz.
Spring mounted base (Photo No. 5)	13 lb.	10 oz.

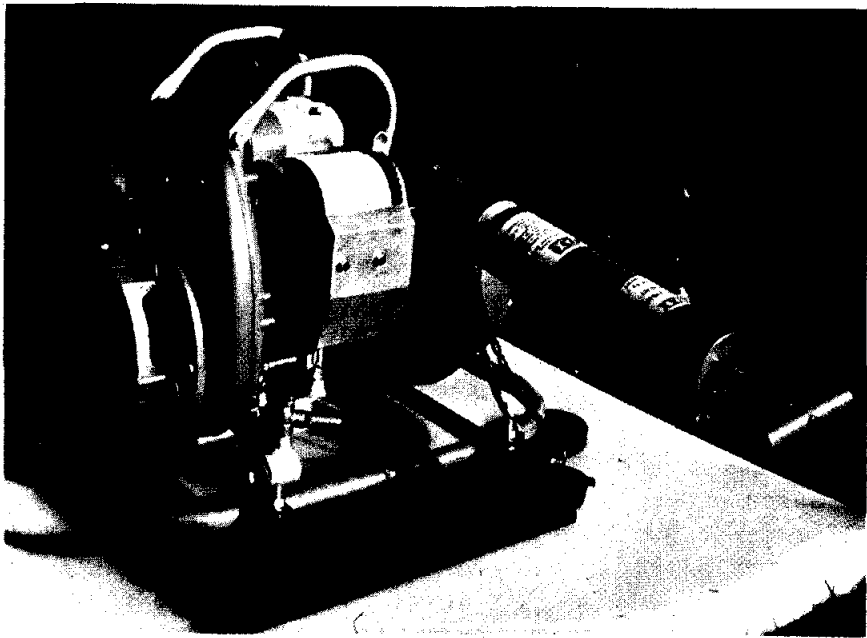
Photo No. 5 *Wajax Mark 26 fitted with
hand primer and spring mounted
base.*

Priming the unit presented no particular problem even though the pump does not have a fill hole in the top of the pump casing. The pump can be conveniently primed by first filling the suction hose with water before connecting it to the pump and then by jabbing the suction hose and foot valve repeatedly into the water source until the system is full. An alternate method would be to use a hand primer which is available from the manufacturer (Photo No. 5).

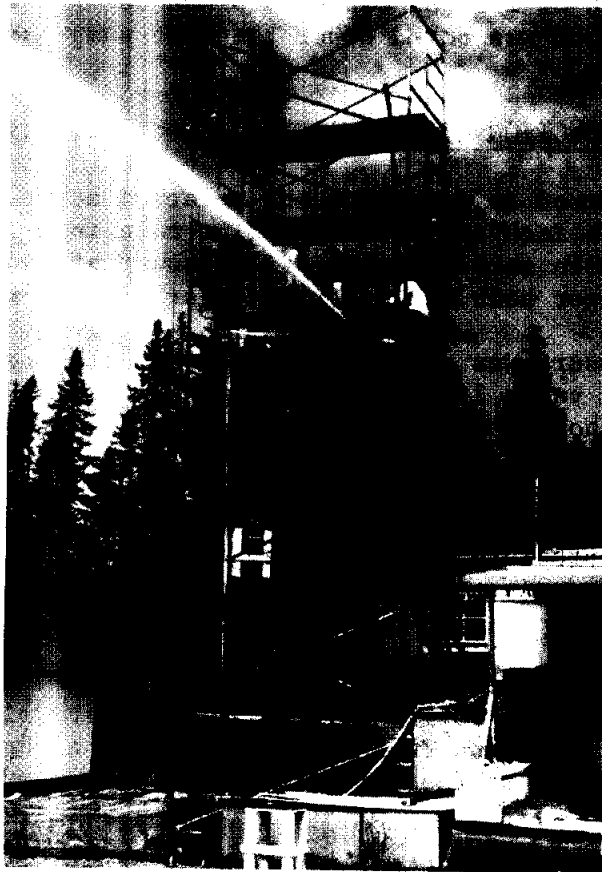
Photo No. 8 *Tower for suction lift test.*

Construction scaffolding was used to erect a tower to provide actual suction lifts for the unit at 5, 10, 15, 20 and 25 feet. (Photo No. 8) At each level, a series of calibrated nozzles were used to determine the pump's performance. The nozzles were attached, in succession, a short distance (2') from the pump outlet and the average discharge pressure was noted over a five-minute interval for each tip. A bypass valve situated close to the pump outlet enabled the operator to change nozzles without interrupting engine operation. Eight-foot lengths of suction hose were coupled together as required and the water source was located directly below the tower.

The results showed that there was little loss in discharge flow rate for pressures of 50, 75 and 100 psi below a suction lift of 15 feet and that there was a negligible loss in discharge flow rate for discharge pressures of 125 and 150 psi at all levels. The results are plotted in Fig. No. 2.

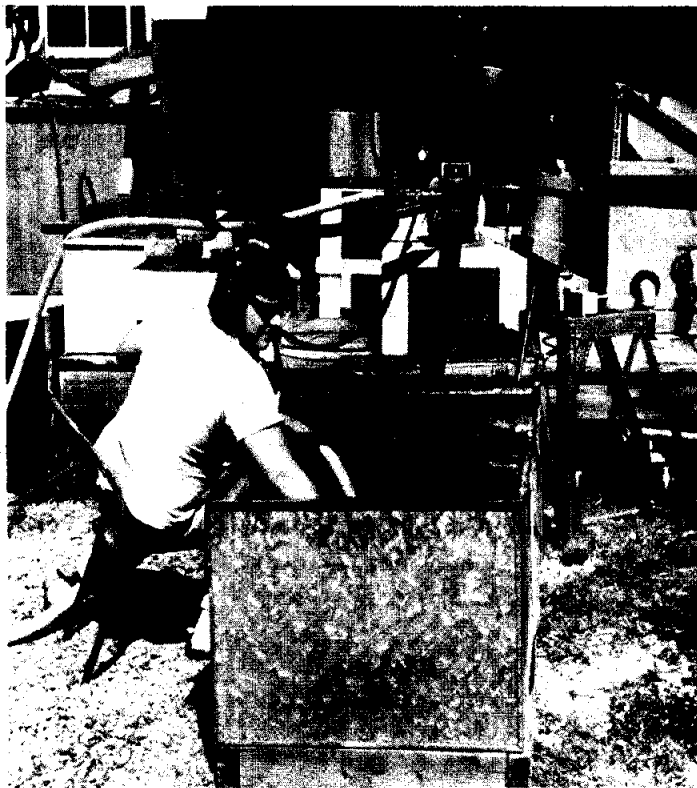
Photo No. 11 *Muddy water test --
Unit "A".*

Unit "A" was operated at near minimum suction lift and full throttle with both the suction hose (foot valve strainer removed) and discharge hose immersed in the muddy water tank. The pump discharge was used in conjunction with a mechanical mixer (Lightin Mixer) to prevent the formation of stagnant pockets of sand in the

tank (Photo No. 11). The muddy water was circulated continuously through the pump for 8 hours, 4 hours at a discharge pressure of 35 psi (1/5 of the shut-off pressure) and 4 hours at a discharge pressure of 117 psi (2/3 of the shut-off pressure).

A loss in discharge flow rate after the muddy water test of approximately 10 Imp. gpm was recorded at free flow. However, a comparison of discharge flow rates for both before and after the muddy water test showed no substantial difference in flow rate above a discharge pressure of 70 psi. The results are plotted in Fig. No. 3.

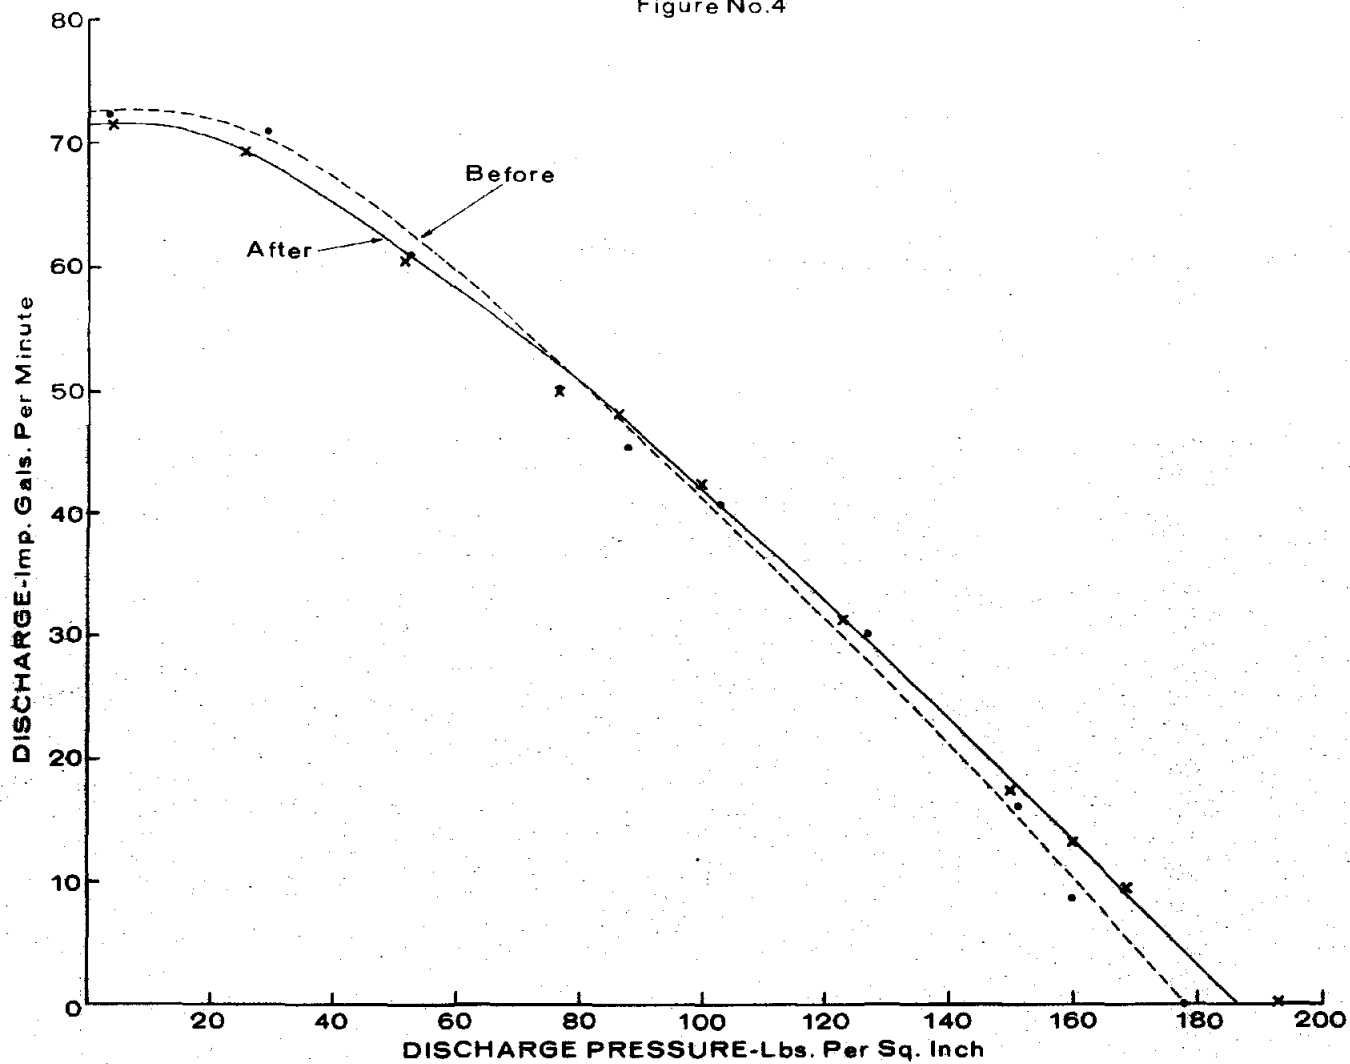
Figure No.4

The results of the two tests showed that there was an increase in pump efficiency after the 200-hour endurance test for pump discharge pressures above 82 psi. A loss in discharge flow rate of approximately 1 Imp. gpm was recorded at free flow in the second test. There was an increase in shut-off pressure from 178 psi to 193 psi between the start and end of the endurance test. The results are plotted in Fig. No. 4.

WAJAX MARK 26 CENTRIFUGAL PUMP
UNIT "B" PERFORMANCE AT 5 FT. SUCTION LIFT
BEFORE AND AFTER ENDURANCE TEST. SPEC. 7.3
