Ergonomics and Skidder Operations in Northern Ontario: A Preliminary Investigation

R.D.G. Webb and R.A. Hope

Information Report DPC-X-15

Canadian Forestry Service
Environment Canada
1983

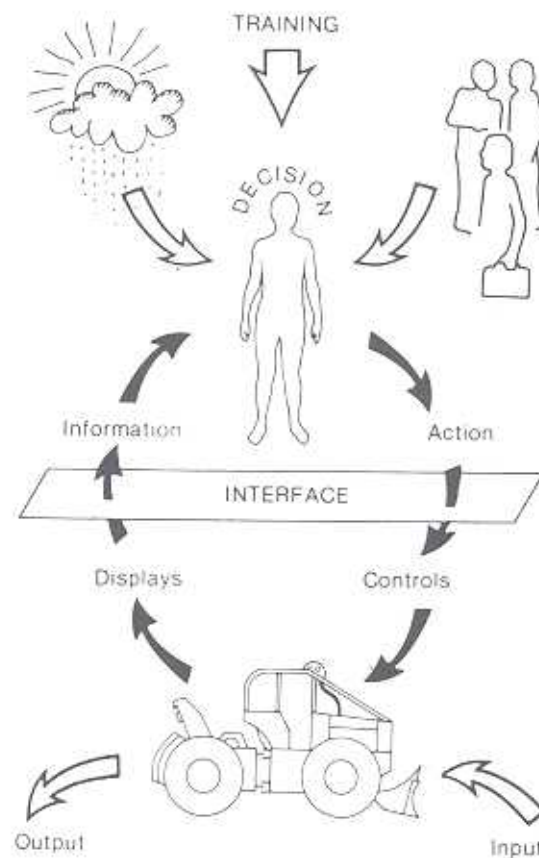
FIGURE 1: A man-machine-environment system

An outline of a simple man-machine-environment system is shown in Figure 1.

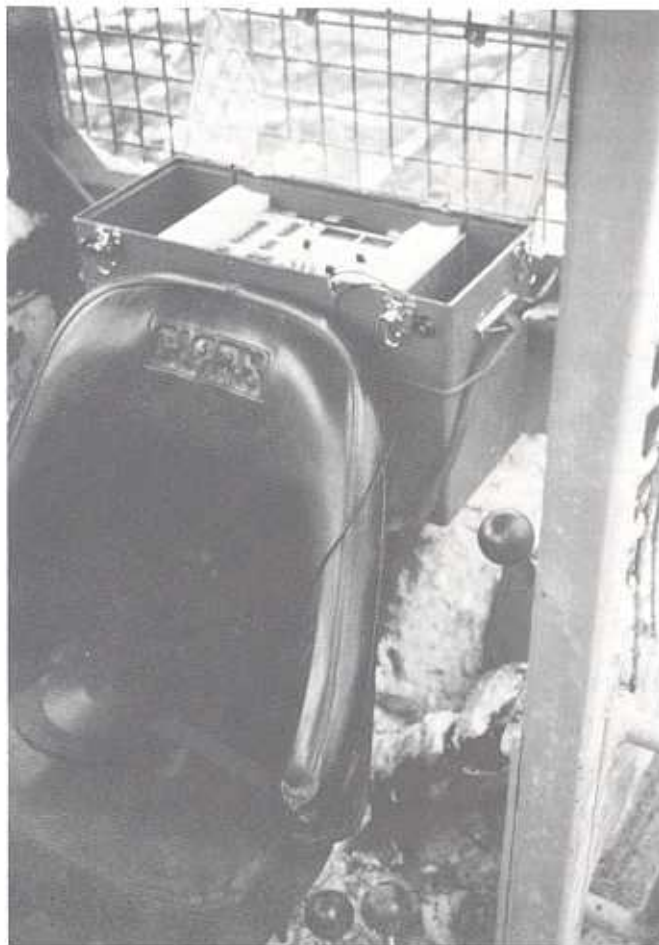
FIGURE 2: Instrument mounting

After this, the seat accelerometer was put in place and the carrying case for its associated instrumentation was securely fixed to the skidder. See Figure 2 for a typical mounting. The use of the noise dosimeter was explained and the dosimeter worn by the operator.
