**The Bowron River Watershed:
A Landscape Level Assessment
of Post-Beetle Change in Stream Riparian Function**

Mountain Pine Beetle working paper 2008-22

MPBI Project # 7.03

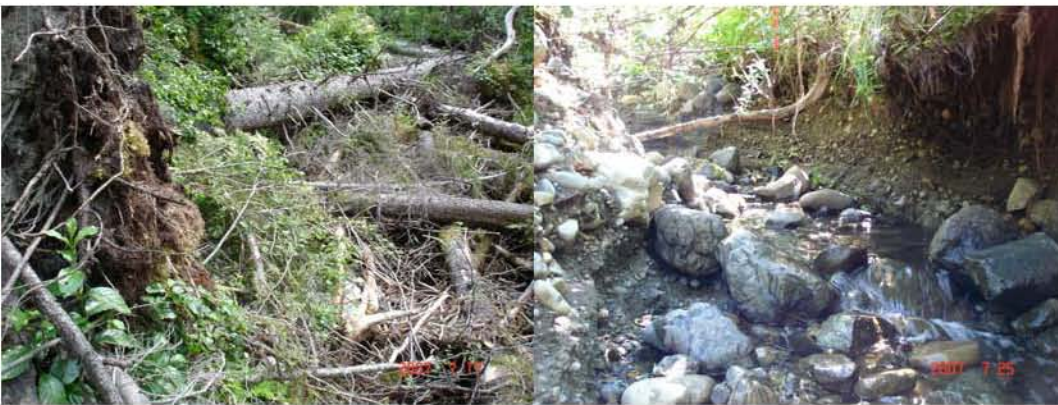
During the field season, a number of factors potentially influencing our results became apparent. The first consistent observation was stream-bank damage caused by high flows in both harvested and reference reaches. Signs of disturbance included fluvial sediment deposits on banks that were several feet above the stream level at the time of sampling, banks with exposed roots, and trees with bark and needles deposited in stream channels (Fig. 2).

Figure 2. In-stream debris (McKenna Creek) and exposed banks (18-Mile Creek) from flooding.

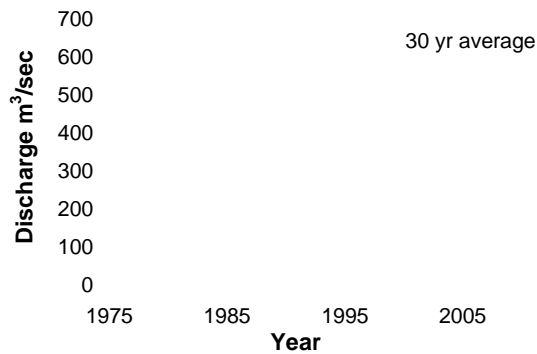
The 2007 peak flow (measured as a daily average) of $420 \text{ m}^3/\text{sec}$ was ranked fourth highest out of thirty since recording began at the Bowron Box Canyon hydrometric station in 1977 (Lynne Campo, Water Survey of Canada, Vancouver, BC, pers. comm). This follows four years of peak flows that were below the average of $319 \text{ m}^3/\text{sec}$ (Fig. 3). Although the 2007 peak flow was not remarkably high, it may have been sufficient to cause further damage to an already unstable system that had not recovered from previous high water levels. The 1990 record high of $580 \text{ m}^3/\text{sec}$ was 82% higher than the 30 year average of peak flows and may have compromised the integrity of stream banks and reduced their ability to withstand smaller flood events in later years. Channel bank disturbance, moss and aquatic connectivity indicator failures were likely influenced by flooding; these failures will be discussed further.

Figure 3. Peak flows at the Bowron Box Canyon Hydrometric Station.

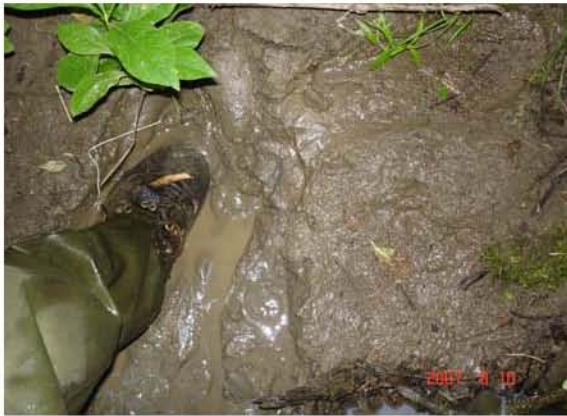
Another frequently noted issue was the fine bed and bank material in many streams throughout the watershed. Glacial-lacustrine and glacial-fluvial material dominate the Bowron watershed and large amounts of clay and silts were seen at all sites, including reference reaches (Fig. 4). This natural sediment source primarily influenced the fine sediment indicator but also affected moss and fish cover, and will be discussed further in the results.

Figure 4. Fine sediments observed at stream margin and in stream bank at Lower Bowron reference sites. A stream with fine substrate such as this rarely displays macrophytes, boulders or void spaces for fish cover.

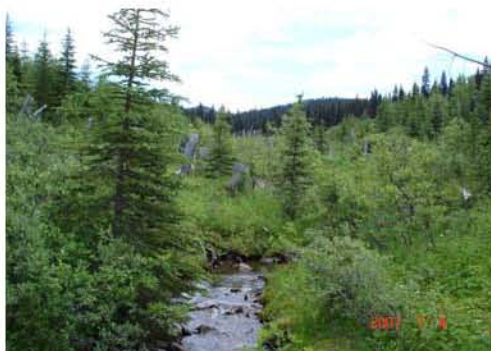
Figure 5. Cut stumps next to stream with poor riparian re-growth in Haggen Creek upper sub-basin

Most of the failures of the harvested upper-site indicators can be attributed to logging the riparian zone. The protocol allows for some disturbance provided minimum thresholds for riparian criteria are met. However, in many cases the riparian vegetation was completely removed and regeneration was not sufficient to provide the stream with adequate shade or a satisfactory LWD supply. Not only was the riparian plantation too young to yield LWD but most of the trees were smaller in diameter than existing accumulations found in the channel, indicating any contribution from the stand would not be of sufficient size to be functional (Hyatt et al. 2004). Future woody debris supply at these reaches is almost certainly going to be scarce for decades, potentially affecting fish habitat (Mossop and Bradford 2004), distribution of sediments and coarse particulate organic matter (Anderson and Sedell 1979) channel morphology (Nakamura and Swanson 1993) and nutrient dynamics (Aumen et al. 1990). Another frequent indicator failure for harvested upper-sites addresses the question of riparian structure and diversity. A recovery time of less than 30 years after clearcutting did not allow for the regeneration of a riparian forest that was representative of an unmanaged forest as required by the protocol (Tripp et al. 2007).

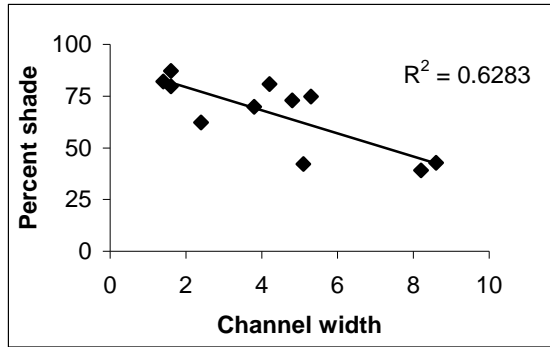
Figure 6. Negative relationship of shade and channel width at 11 non-harvested reference reaches.

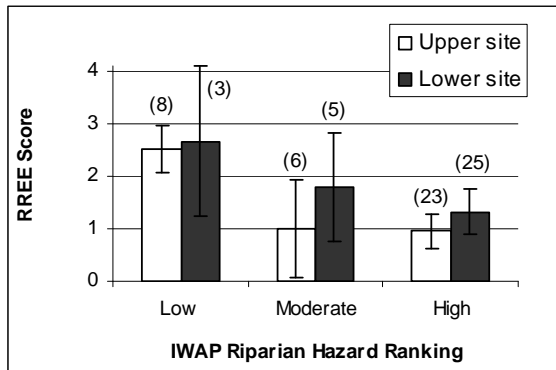
ranking and then RREE scores were averaged for those groups (0=not properly functioning to 3=properly functioning). Reference sites representing the low-risk group scored better overall (i.e. passed for more indicators) than the other two groups despite some failure in stream indicators (Fig. 7). The low-risk group's scores were significantly higher compared to scores in the moderate-risk and high-risk groups in the upper-basin category (ANOVA $P < 0.05$). There was no significant difference between the moderate and high-risk categories, but this could be because there were three IWAP risk categories and four RREE outcomes, which results in some overlap. There were also no significant differences among the lower sites, which could be due to the large variance associated with small sample size.

Figure 7. IWAP riparian hazard ranking vs 2007 effectiveness evaluation score. 0 = not properly functioning, 1 = functioning at high risk, 2 = functioning at risk, 3 = properly functioning. Error bars = 95% CI (n).

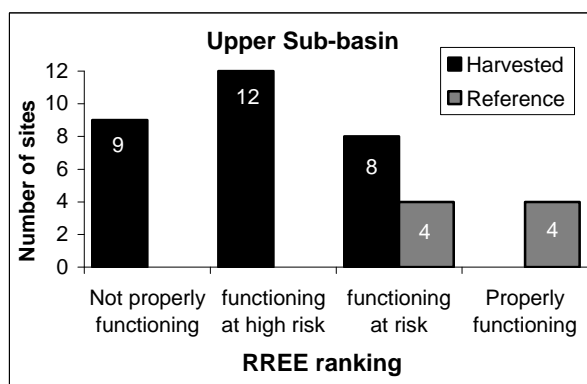
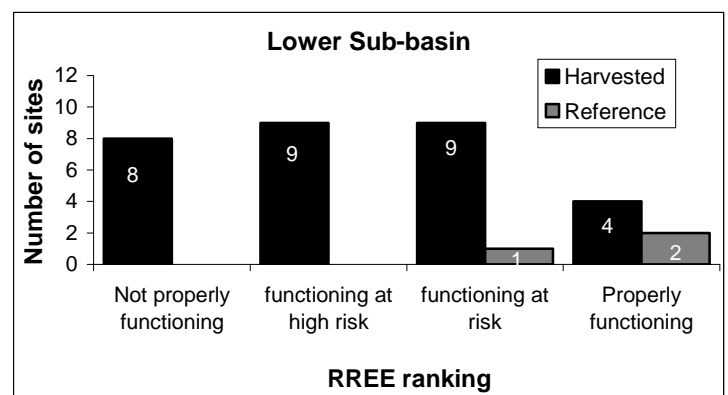
Harvested sub-basins had a lower percentage of properly functioning streams than the reference sites in both the upper and lower basins. None of the sites in the upper basin and only four sites in the lower basin were scored as properly functioning, representing 13% of the lower-basin sample size (Fig. 8). Three of these four sites had a riparian area of 75 m or more on both sides and the remaining site was only logged to the stream bank on one side, lending credibility to the inference that buffers are critical. All other harvested streams ranged from functioning at risk to not properly functioning.

Figure 8. RREE scores of total number of harvested and reference sites in a) upper and b) lower sub-basins.

Reference sites scored as either properly functioning or functioning at risk (Fig. 8). Four sites out of eight and one out of three sites were at risk, representing 50% and 33% of the sample size in the upper and lower basins respectively. The lower site received failures for banks that were not intact, stream morphology (not enough pools) and absence of moss. Three out of the four upper sites also had failures for the moss and intact bank indicators. The remaining failures among upper basin sites were shared among indicators for fines, fish cover and aquatic connectivity.
